**DRIVER AND/OR PASSENGER SEAT WARMER(S) ARE
INOPERATIVE OR CANNOT BE TURNED OFF AND DTC B1520:49
MAY BE STORED**

Bulletin No.: 09-002/23

2023 CX-50 (with front seat warmer and without driver-side memory power seat) and (produced before December 2022)

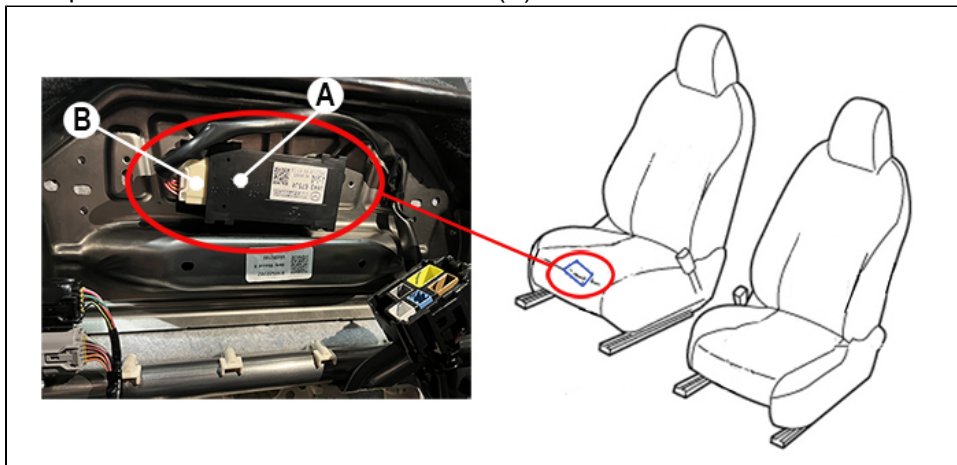
Some customers may complain that the front seat warmers are inoperative or cannot be turned OFF and DTC B1520:49 may be stored. This may be caused by an electrical noise of the front seat warmer control unit. To correct this issue, the anti-electric noise performance of the front seat warmer control unit has been improved.

1. Verify the customer concern.
2. Replace the seat warmer control unit located on the front passenger seat according to the instructions in MGSS ([FRONT SEAT REMOVAL/INSTALLATION](#)).
3. Disconnect the Seat Warmer Control Unit connector [0913-101 \(B\)](#).
4. Replace the Seat Warmer Control Unit (A).

5. Install in the reverse order of removal. See MGSS ([FRONT SEAT REMOVAL/INSTALLATION](#)).
6. Verify the repair.
