Technical Service Bulletin

Subject: FUEL-FILLER LID DOES NOT LOCK	Bulletin No.: 09-004/23
	Last Issued : 01/09/2023

2019-2021 Mazda3 (Japan built) with VINS starting with JM1
2020-2021 CX-30

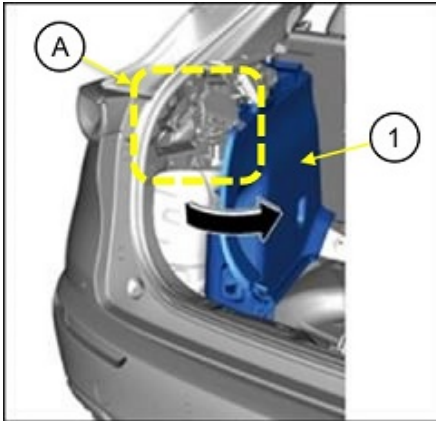
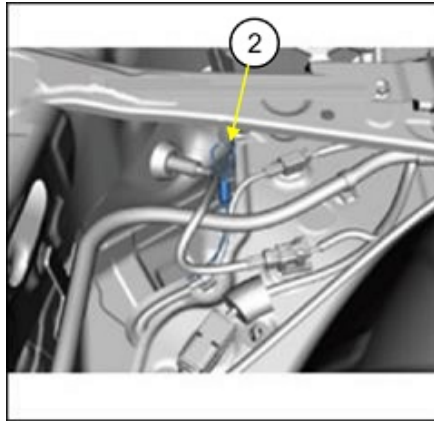
(1) Trunk side trim

Detail A: (2) Fuel-filler lid opener cable

1. Verify the customer concern by locking the doors and pressing the fuel-filler lid after 2 minutes to see if it opens.
 - If the fuel-filler lid can be opened, adjust the fuel-filler lid opener cable position using the Adjustment Procedure of Fuel-Filler Lid Opener Cable below.

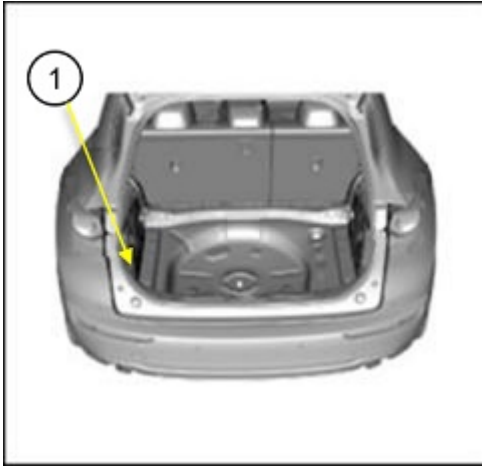
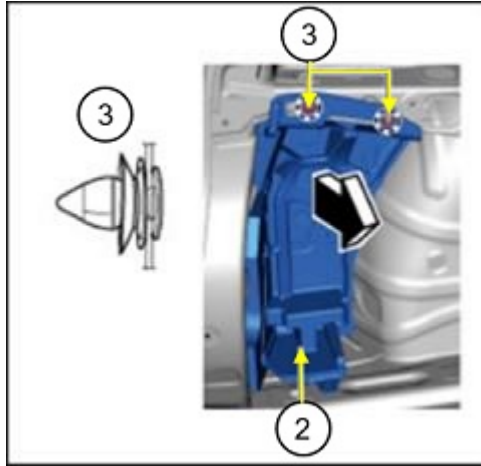
(1) Location of Trunk side insulator

(2) Trunk side insulator
(3) Clip (2pcs.)

3. Remove the trunk side insulator.

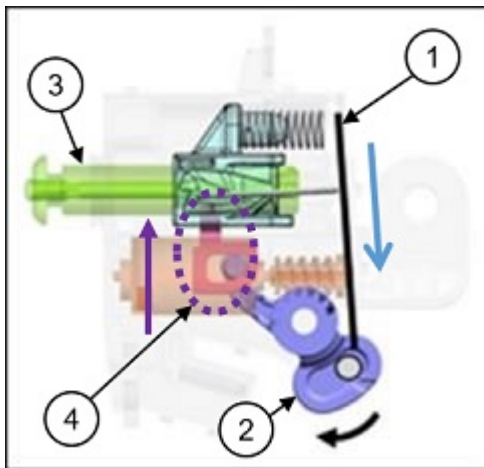
Inside of Fuel-Filler Lid Lock Actuator

TIP: By pushing the opener cable (1), the lock connected to the opener lever (2) inserts into the cam hole and the actuator rod (3) is locked.

- (1) Opener cable
- (2) Opener lever
- (3) Actuator rod
- (4) Lock
