Technical Service Bulletin

GROUP	NUMBER
BODY	23-BD-002G
DATE	MODEL(S)
JANUARY, 2023	ALL

SUBJECT: INFORMATION FOR LAMP CONDENSATION

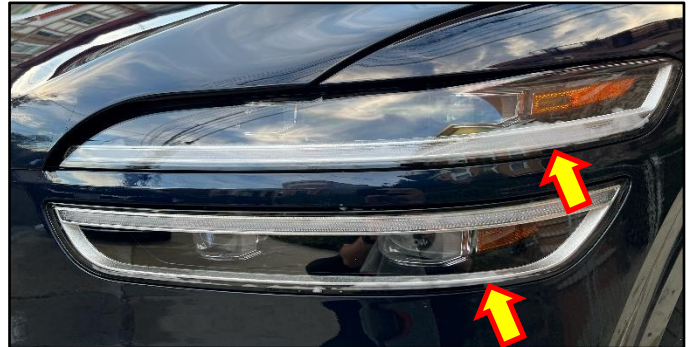
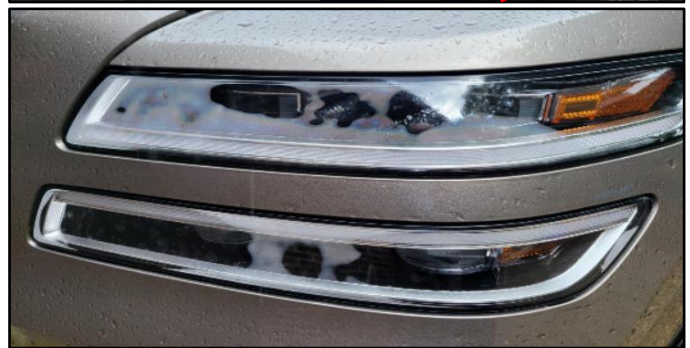
1. Normal Condensation
Condensation occurring inside the lamp assembly after rain or a car wash cycle is considered a natural occurrence. Condensation can also occur after the vehicle is parked outside during cold temperatures. This condition occurs when water vapor inside the lamp assembly is exposed to temperature variations.

This condensation is **NORMAL** and replacement is **NOT REQUIRED**.

Normal condensation in the headlamp

See page 4 for the service procedure to remove normal condensation.

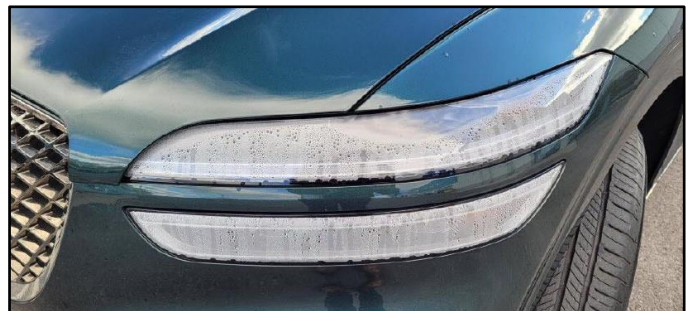
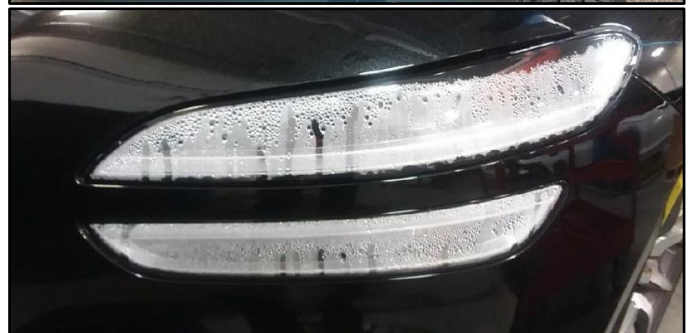
2. Water Leak
If water is collecting at the bottom of the lamp assembly, water streaks are present, or the condensation remains after the lamps have been on for 30 minutes or more, there may be a water leak in the assembly. The leak may be caused by a poor seal between the lamp housing and lens, cracks in the lamp assembly, or poor fitment.

Water collecting inside the headlamp

The condition should be diagnosed and repaired as necessary.

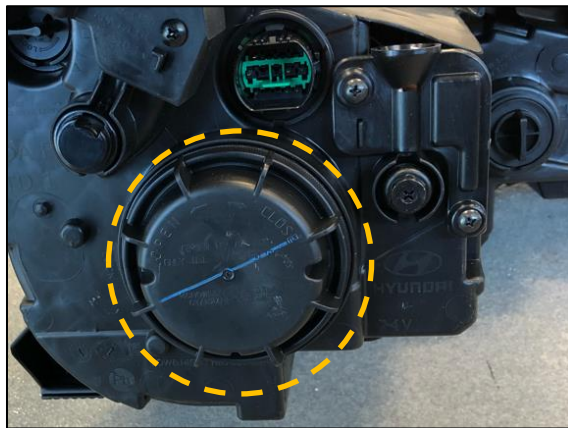
Example location of the dust cap

- Ensure that the vehicle is parked in a well-ventilated area and that the dust cap(s) have been removed prior to drying the lamp assembly.
- Certain lamp assemblies may have two dust caps. Remove both dust caps if applicable.
- To avoid battery discharge, the engine must be running while the lamps are on.
- Allow the vehicle to idle for 30 minutes with the engine running and lamps turned on for the condensation and moisture to evaporate.
- Reinstall the dust cap(s) after drying the lamp assembly.
- If condensation still remains, replace the lamp desiccant or moisture absorbent pack, if equipped, and repeat the lamp assembly drying procedure again.
