| HYUNDAI Technical Service Bulletin | GROUP BODY ELECTRICAL | NUMBER 23-BE-001H |
| | DATE JANUARY, 2023 | MODEL(S) SANTA FE (TMA) SANTA FE HYBRID (TM HEV) SANTA FE PLUG-IN HYBRID (TM PHEV) PALISADE (LX2) |
| SUBJECT: TPMS DTC(S) WITH SURROUND VIEW MONITOR | | |

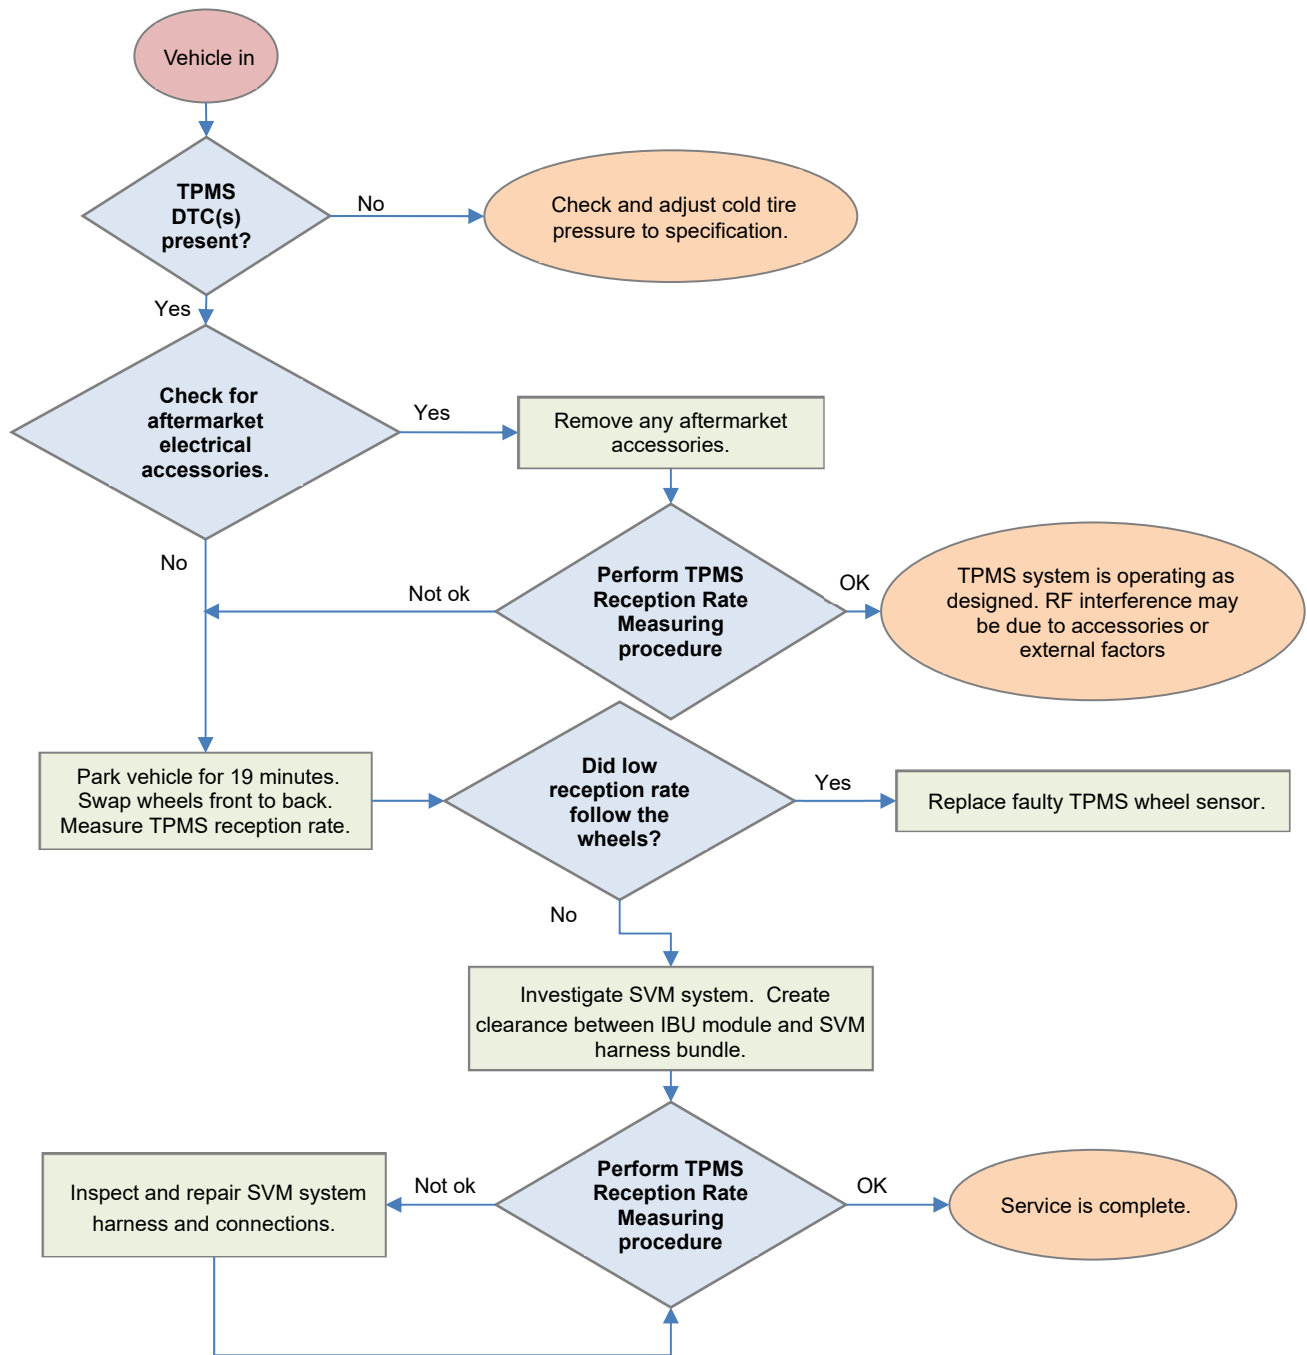
Service Diagnostic Flowchart:

In the presence of any combination of the mentioned DTCs, follow the service diagnostic flowchart and the service procedures described below.

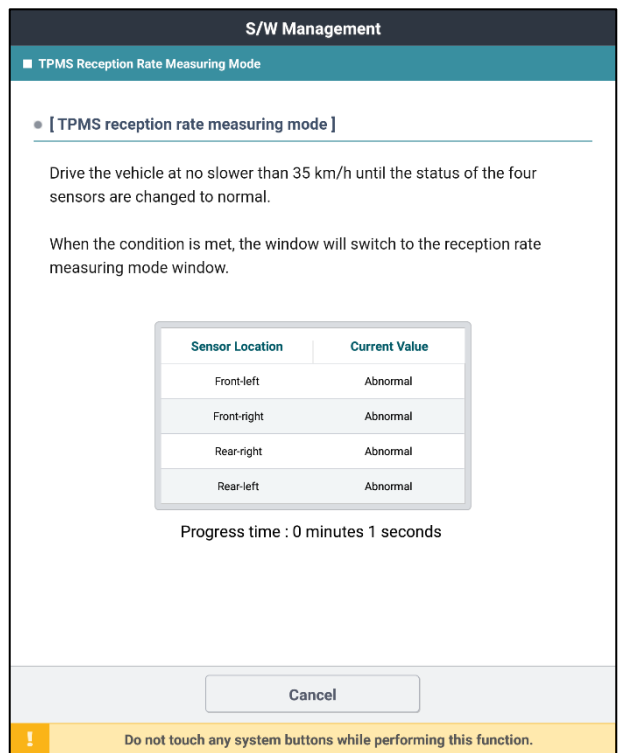
If the RF signals from the TPMS wheel sensors are confirmed during this process, the Current Value will change from “Abnormal” to “Normal.”

If the status does not change to “Normal” after the drive, there is likely RF interference.

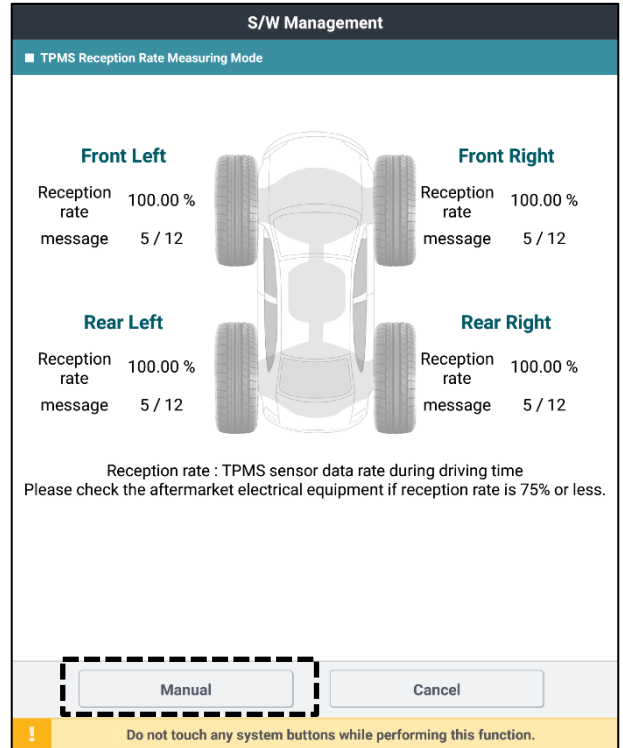
- 5. After driving for a minimum of 10 minutes, check the TPMS reception rate. For further information click the “Manual” button.

A reception rate of 75% or higher is considered acceptable TPMS performance.

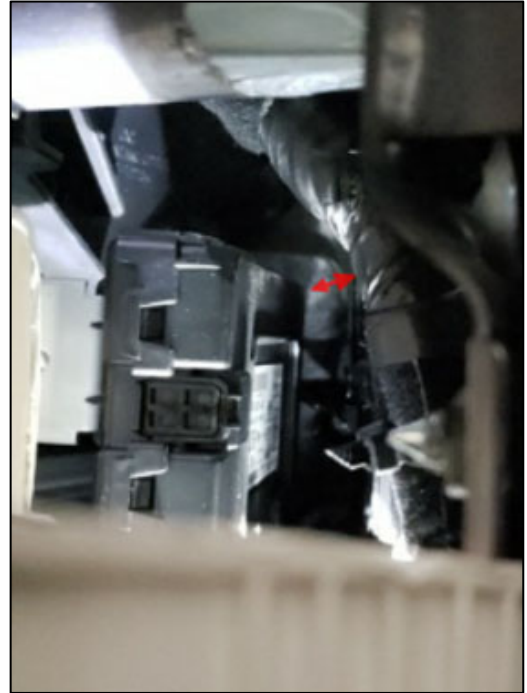
1. Locate the IBU (integrated body control unit) and the coaxial cable wiring.

Create as much distance as possible between the IBU and the coaxial wiring bundle by taking up any available slack.

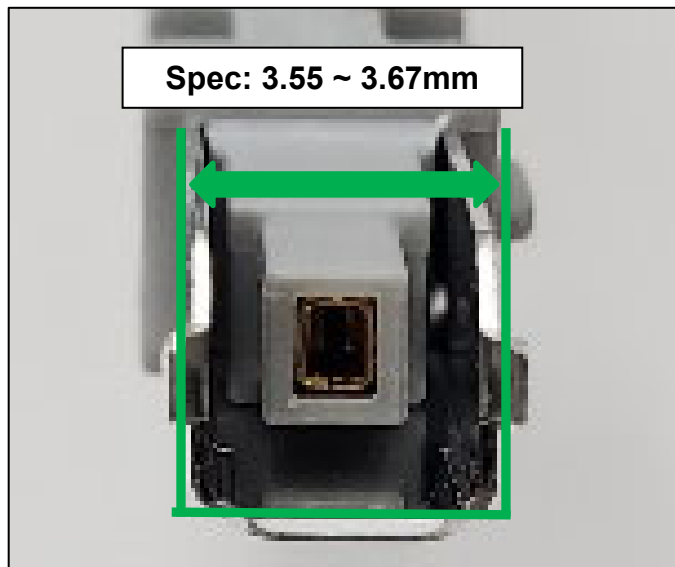
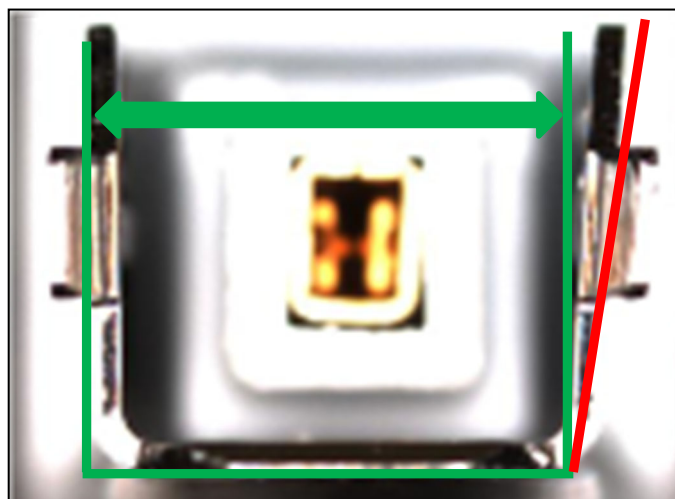
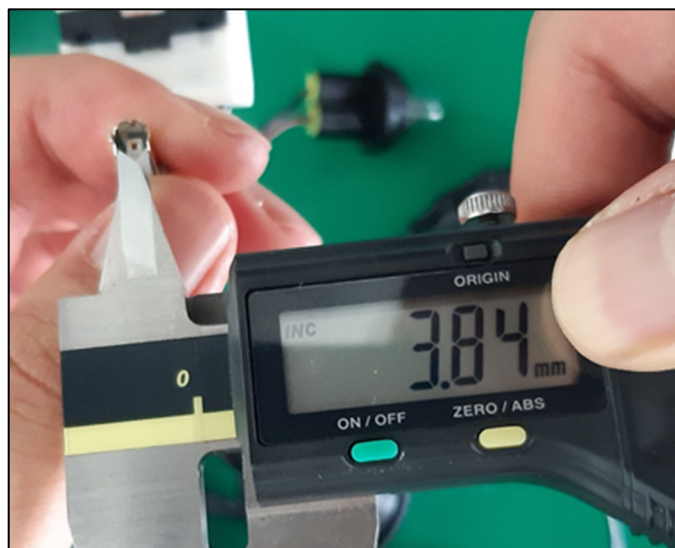
Inspect the female pins for deformation. Measure the distance between vertical sides to ensure they are within specification.

Spec: 3.55~3.67mm

The pins are U-shaped and should form 90 degree angles (square corners).

This is an example of the U-shape pin misshapen, and is splaying outwards (not square).

It is also out of specification when measured using a digital caliper.

- If necessary, reshape the pin to specification using a pair of long-nose pliers.
