GENESIS

## Technical Service Bulletin

23-01-001G

SIDE SILL BODY PANELS INSPECTION AND REPAIR  
(SERVICE CAMPAIGN T23G)

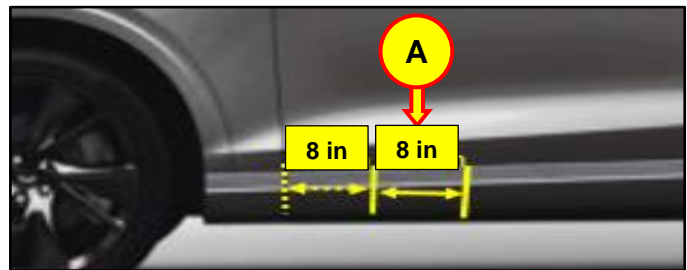
2. Inspect the underside and backside of side sill body panel in the indicated area (A).

Inspect the indicated area (A) on both sides of the vehicle.

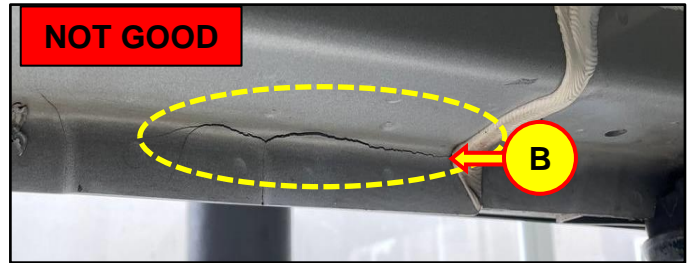
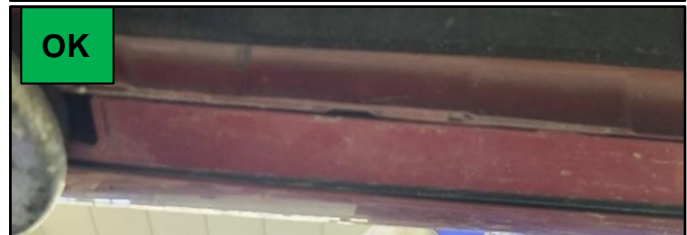
3. If crack(s) (B) are found as shown, proceed to the service procedure on the next page to repair the affected side sill(s).

If no cracks are found on both LH and RH side sills, no further action is required.
