Technical Service Bulletin

50 Water ingress into the longitudinal member and footwell

50 23 10 2060335/4 January 19, 2023. Supersedes Technical Service Bulletin Group 50 number 20-05 dated December 18, 2020, for reasons listed below.

Model(s)	Year	VIN Range	Vehicle-Specific Equipment
A6, and A7	2019 – 2021	All	Not Applicable
A6 allroad, S6, and S7	2020 – 2021		
RS 6 Avant, A7 e quattro, and RS 7	2021

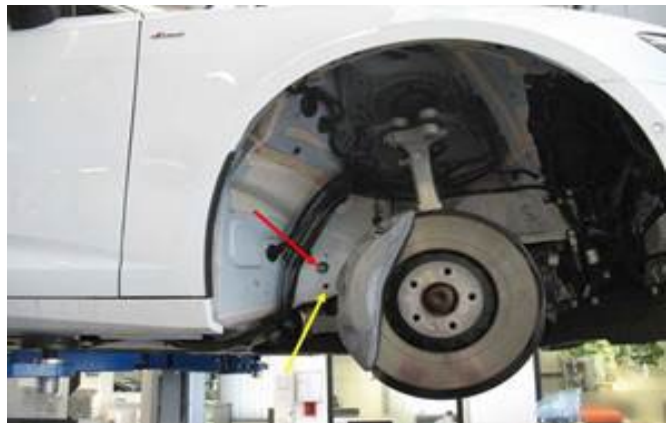
Figure 5. Point of entry for the borescope.

1. Remove front wheel housing liner from the affected side of the vehicle. Remove the plug indicated by the red arrow. This is the opening where the sealer will be applied. The opening indicated by the yellow arrow is the opening that will be used to inspect the area with a borescope (Figure 5).

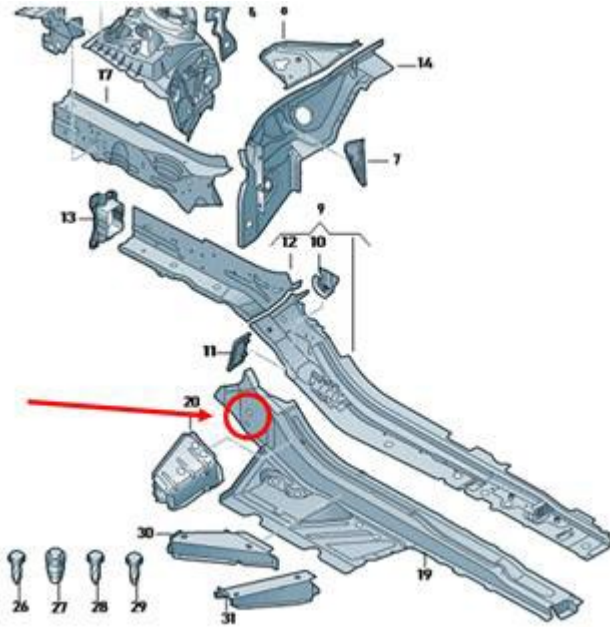
Figure 6. ETKA drawing (803-000) showing the location of the openings in the wheelhouse.

- ETKA drawing (803-000) shows the location of the openings in the wheelhouse where the borescope is to be inserted and where the repair is performed (Figure 6).

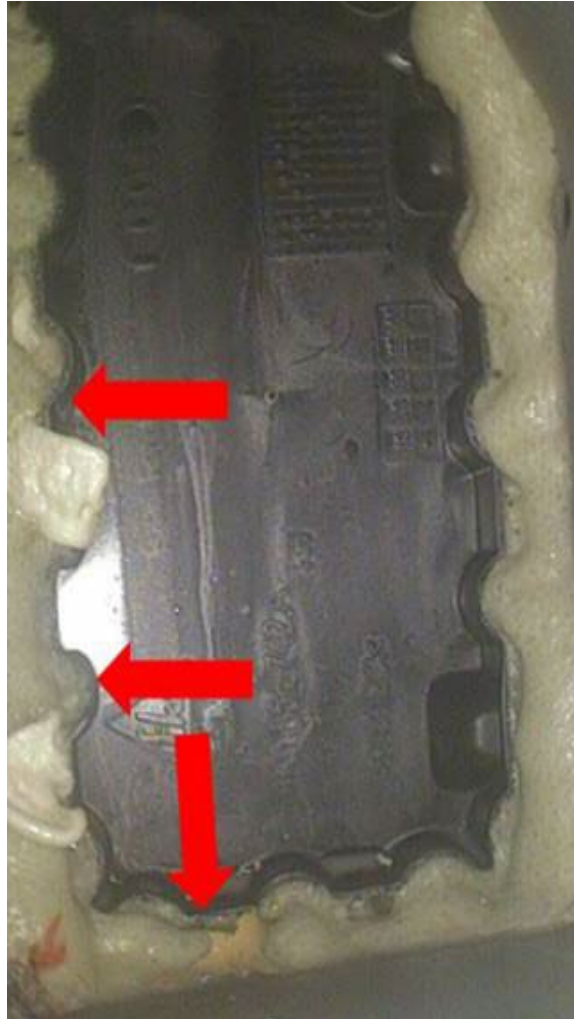
1. The cause for the water ingress is due to incorrect bonding of the sound absorber inside of the longitudinal member (Figure 1).
2. ETKA drawing (803-000) shows the location of the sound absorber inside the longitudinal member (Figure 2).
3. Remove any necessary underbody covers to gain access to the longitudinal member plugs (Figure 3).

Figure 7. Sound absorber to be completely sealed off.

3. The sound absorber is to be completely sealed in the longitudinal member with 1k adhesive sealant D 511 500 A2 (or alternatively Loctite 5510) (Figure 7).

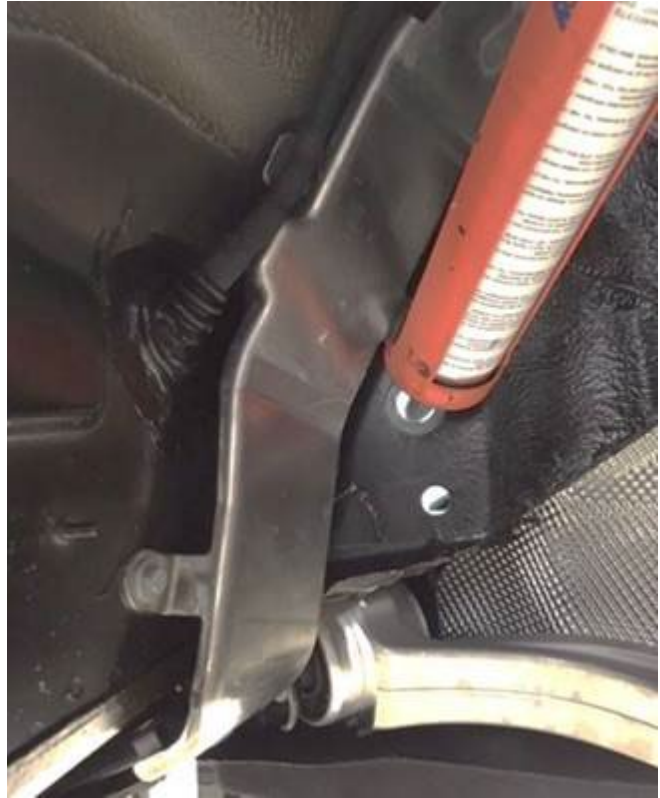
Figure 8. Sealant application.

4. Inject 1k adhesive sealant D 511 500 A2 (or alternatively Loctite 5510) using the VAG1628 (or equivalent) through the opening shown in Figure 6 onto the sound absorber (Figure 8).

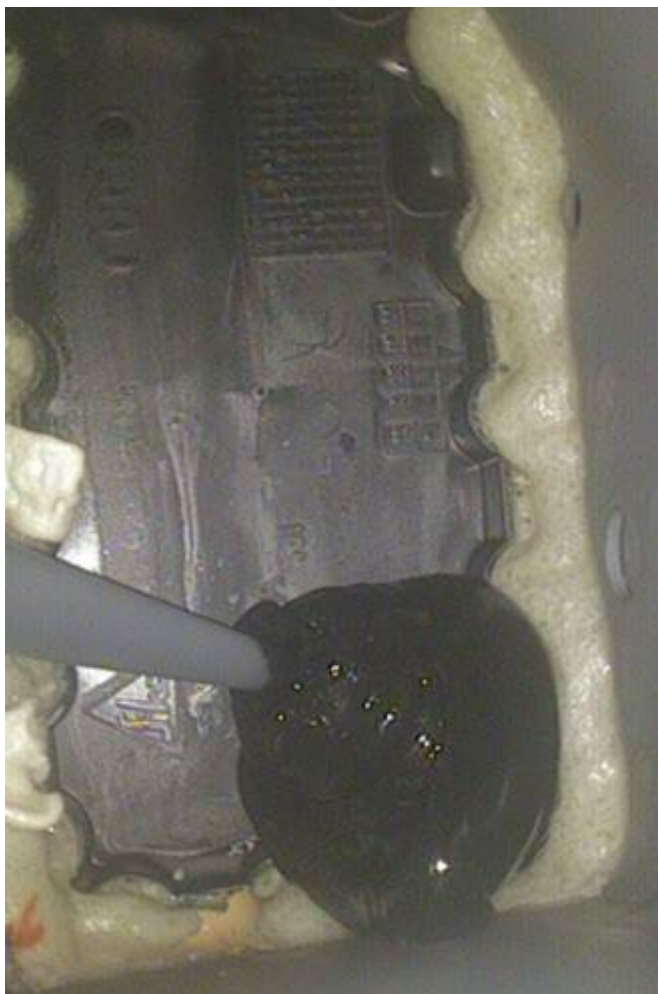
Figure 9. Applying sealer.

5. Apply an amount of sealer sufficient to cover the surface and perimeter of the sound absorber (Figure 9).

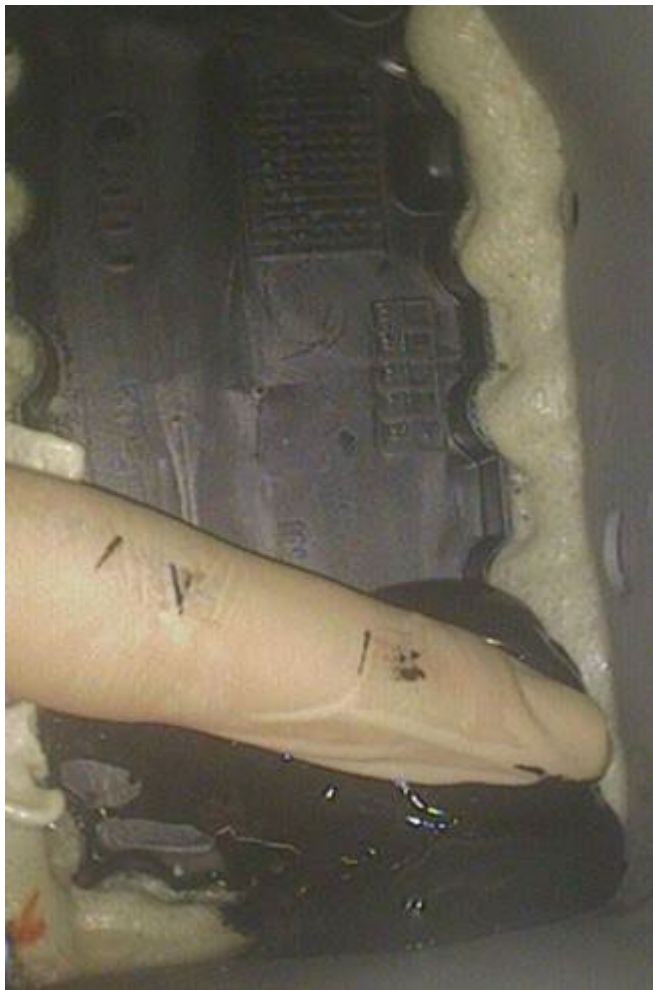
Figure 10. Distributing sealer over the web plate.

6. Spread the sealer using your gloved finger (Figure 10).

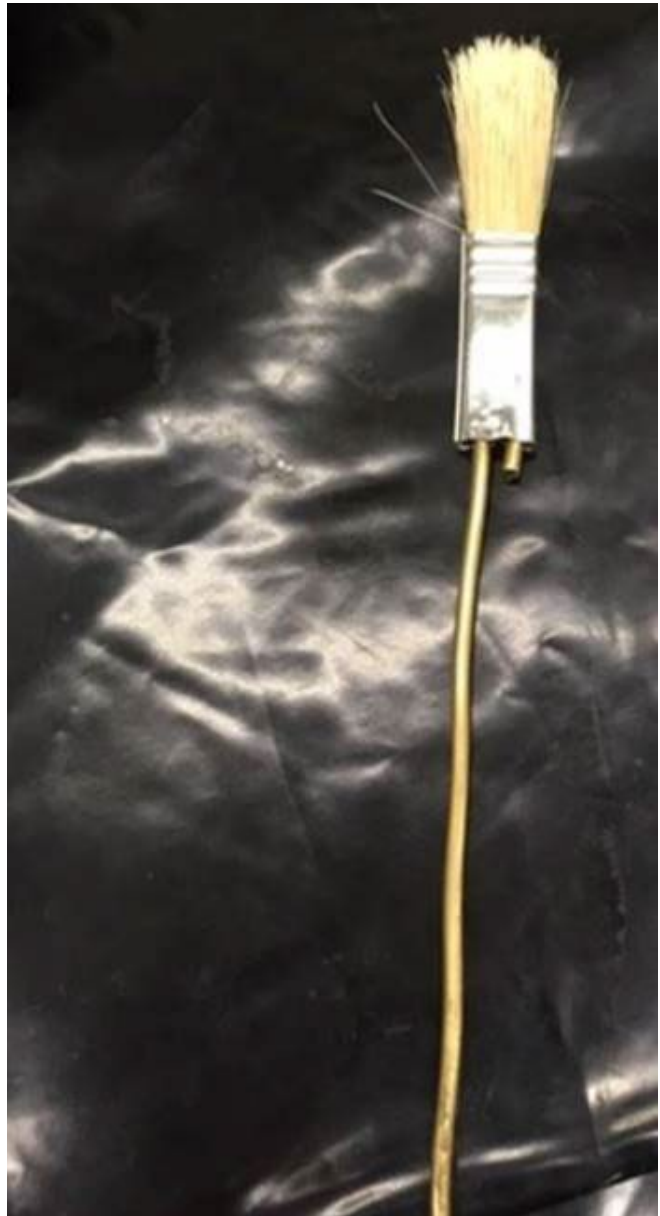
Figure 11. Modified brush.

7. Alternatively, a brush can be fashioned to distribute the sealer as shown in Figure 11. If this is the method chosen, ensure that no brush fragments are left inside the longitudinal member.

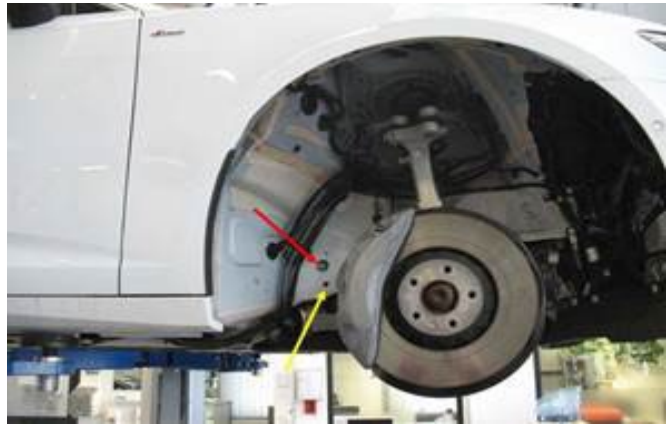
Figure 12. The yellow arrow indicates the opening where the borescope will be inserted to inspect the completeness of the sealant application.

8. Insert a borescope to confirm visually complete sealer coverage. The borescope can be inserted in the hole indicated with a yellow arrow (Figure 12).

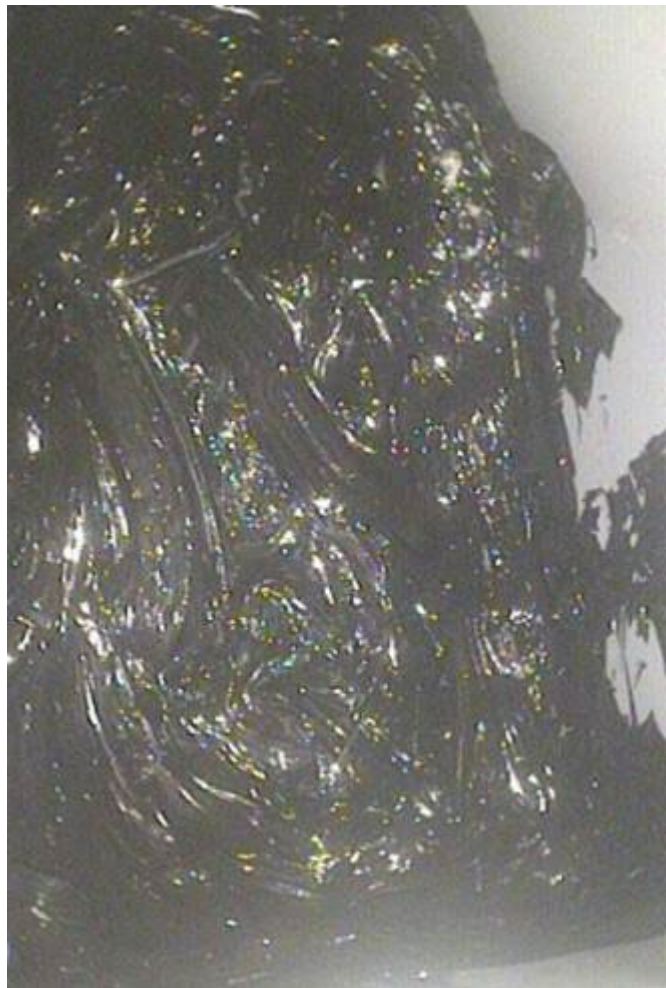
Figure 13. Sealer is completely applied and distributed.

9. Figure 13 illustrates a completed seal over the sound absorber as viewed with the borescope.

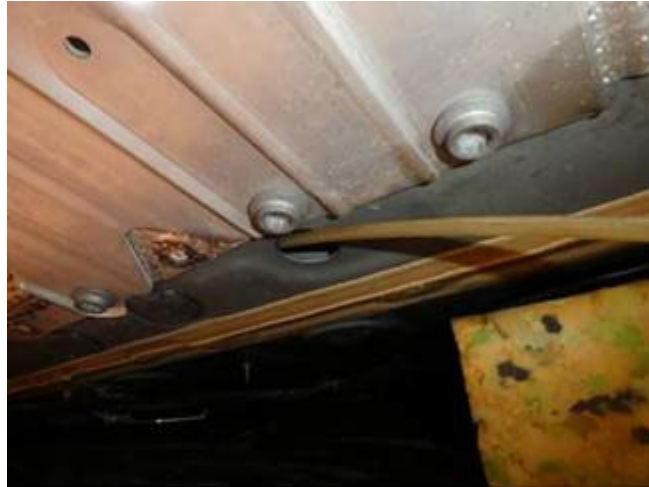
Figure 14. Conservation wax application.

10. After the sealing procedure is completed and the sealer has fully cured, coat the inside of the longitudinal member with cavity preservative D 330 KD2 A1 through the opening shown (Figure 14).

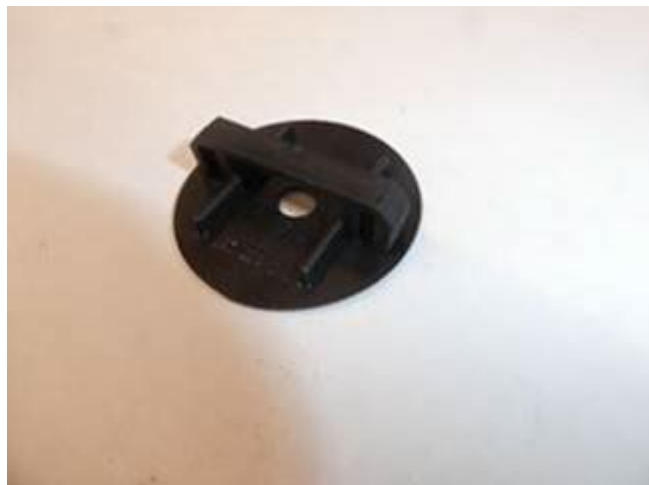
Figure 15. New longitudinal member plugs with integrated drain.

11. After cavity conservation is carried out, the removed plugs 1 and 5 on right and left are to be replaced with plugs 8K0 805 267 with an integrated drain (Figure 15).
