Technical Service Bulletin

91 MIB3: Software Update Instructions

91 23 63 2060523/2 January 27, 2023. Supersedes Technical Service Bulletin Group 91 number 20-05 dated August 27, 2020, for reasons listed below.

Model(s)	Year	VIN Range	Vehicle-Specific Equipment
All Audi vehicles	2020 – 2024	All	MIB3

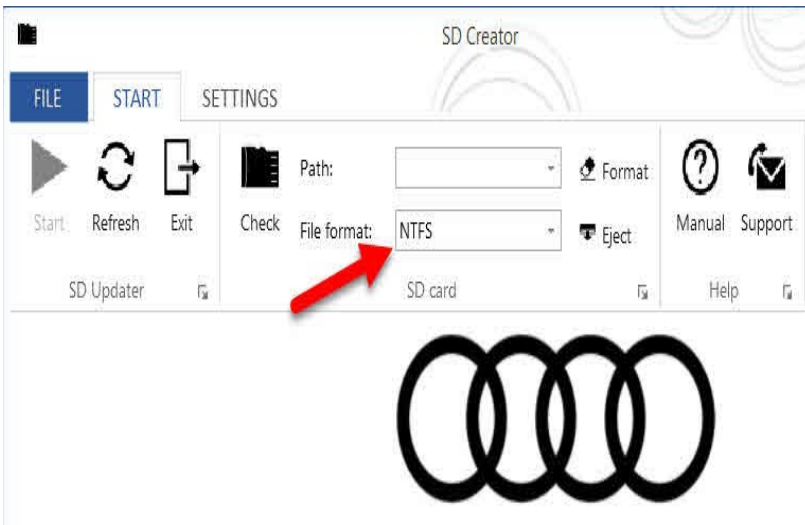
For MIB3 vehicles, a **USB flash drive** has to be used instead of a SD card. **Do not** use a USB SD card reader and an SD card to attempt the update. The USB flash drive should be formatted as “NTFS”. To do so, select “NTFS” from the “File Format” dropdown on the ribbon of SD Creator.

Figure 1. SD Creator selection for NTFS.

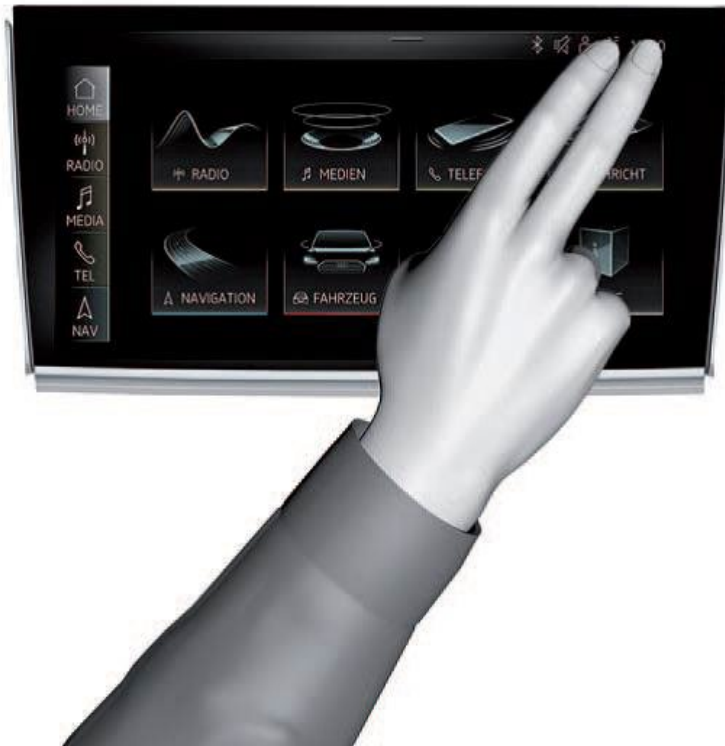
Figure 2. Gesture to enter the red engineering menu.

1. Enter the red engineering menu by touching the screen with two fingers in the top right corner (Figure 2).

2. Use the volume control to navigate the red engineering menu (left and right for scrolling, push to select):
 - Select "Update" and the source of the update medium, USB.
 - All control units to be updated are shown, scroll all the way down and start the update.
3. After the manual successful update perform the SVM code again so that the ODIS tester can make the necessary configuration and report the new vehicle configuration to the SVM server.
