INFINITI

# TECHNICAL SERVICE BULLETIN

ITB22-017A

## DTC B2E01-96 (INTERNAL BATTERY) STORED AS CURRENT IN IVC

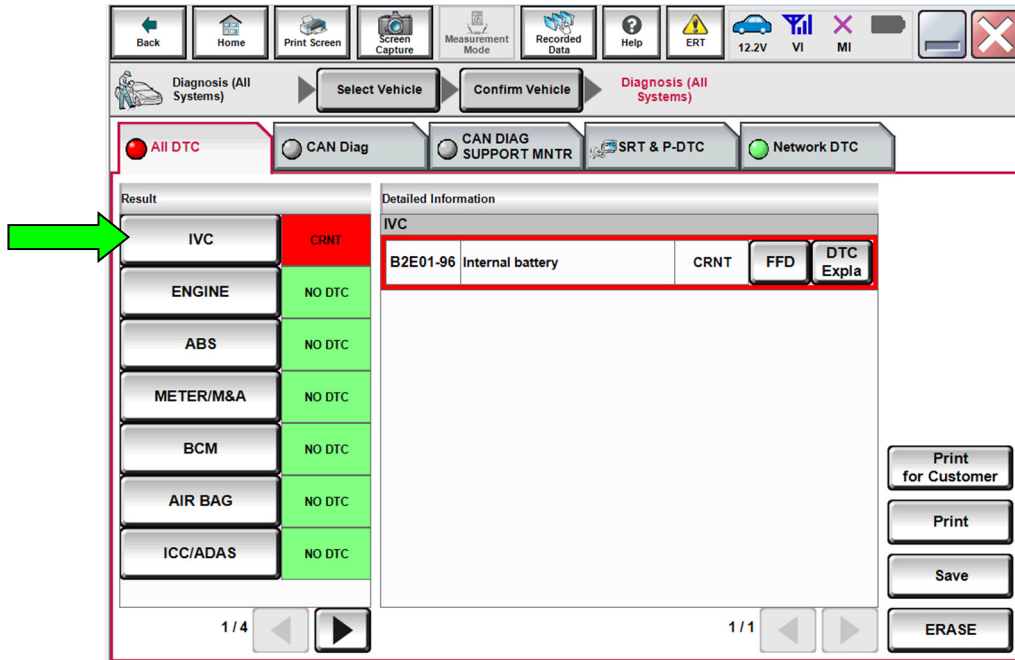
Figure 3

11. Confirm that DTC B2E01-96 for Internal battery is “CRNT” in the **IVC**.

- If only DTC B2E01-96 is present, select **IVC** (Figure 3) and then proceed to step 12.
- If additional DTCs, other than B2E01-96, are present in the **IVC**, refer to the ESM for further diagnostic information and repair first, and then proceed to step 12.
