**Porsche Mobile Charger Connect (PMCC) Software Bugs, Loss of Power Setting**

**Vehicles Affected**

**Revision History**

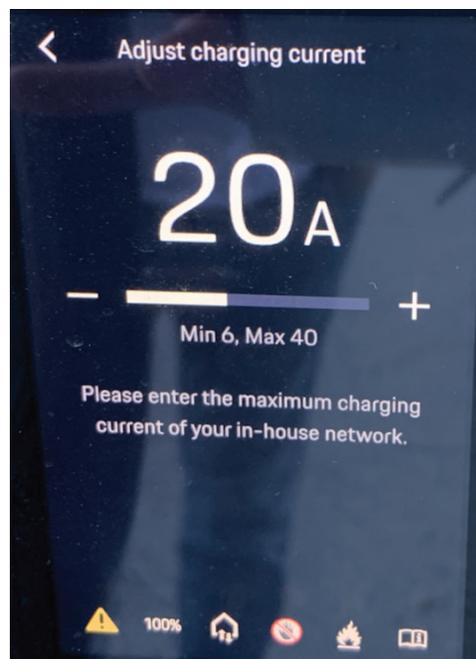
Figure 1

PMCC Communication Board (CommBoard) Software (SW) Version 3014 was released to address software bugs in SW version 2934, e.g. "server authentication error". Unfortunately, SW 3014 introduced a new bug that can cause the PMCC to lose the desired "last mode" setting for charging current / output in conjunction with PowerBoard SW 4100 or lower. That means the power setting reverts to 50% when the charger is unplugged or when the charger enters a sleep cycle.

Communication Board Software 3014 was available via online and update for 8 days before it was stopped.
