# Service Bulletin

Bulletin No.: 18-NA-020

**Subject: Malfunction Indicator Lamp Illuminated with DTCs P0300, P0299, P0234 and/or P2227 Set**

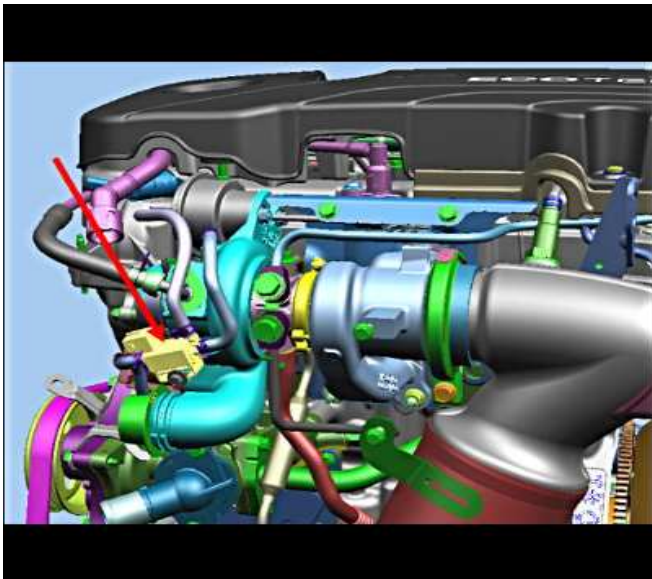
6055063

Inspect the Turbocharger Control Valve (TCV) to ensure it is not frozen.

1. Remove Turbocharger Wastegate Regulator Solenoid Valve.
2. Drain Turbocharger Wastegate Regulator Solenoid Valve (TCV) by turning valve upside down.

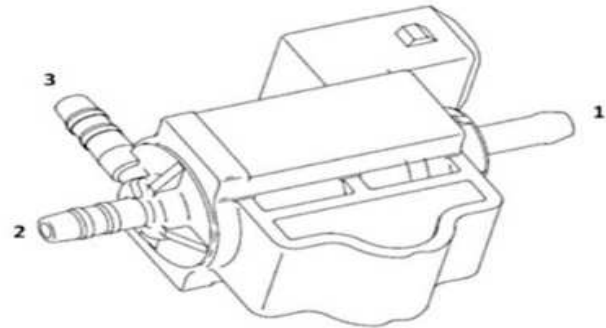
6055068

**Note:** Check port #2 to assure the spring gets lifted off the seat. This will be determined by the compressed air not dead heading when applied to port #2. When applying air to this port a small amount of air should be observed at port #3 and even less air will be noticed at port #1. If this does not happen, the TCV plunger may have hardened deposits from hot operating conditions which will impede TCV plunger movement, and the Turbocharger Wastegate Regulator Solenoid Valve should be replaced.

3. Using clean shop air regulated to 80-100 PSI (551-689 kPa), blow through all three ports (1, 2 & 3) for 5 seconds each. Repeat this step twice.
