Subaru Announcement

UPDATE Safety Recall: WRL-22 PTC Heater Ground Bolt

Updated, Service Procedure

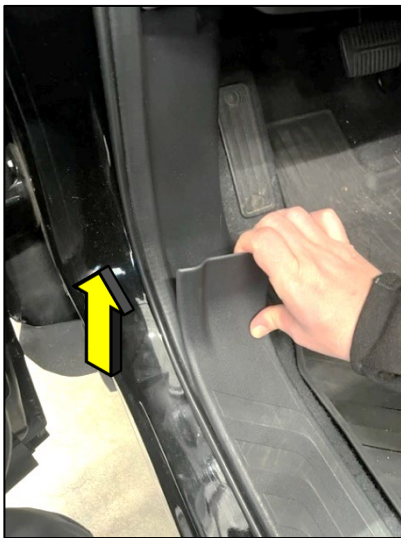
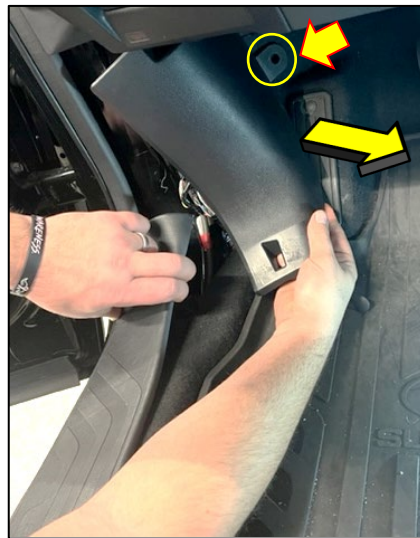
Higher than expected breakage of the Left rear side sill cover (aka. driver's side door-sill trim) has been occurring during this service procedure. The latest update to the WRL-22 Technical Service Bulletin addresses this, and provides recommendations for accessing the PTC heater, without the need to fully remove the Left rear side sill cover. It is recommended that retailers implement this new procedure as soon as possible. Edits to the TSB are shown below.

STEP 3: Remove the mounting nut securing the left front side sill cover. CAREFULLY detach the front section of the left rear side sill cover. While holding the front section, use your other hand to detach and remove the left front side sill cover.

CAUTION: ALWAYS remove the cover when it is or has reached room temperature. Any attempts of removal in cold ambient temperatures may result in unwanted breakage. DO NOT use excessive force when pulling the covers. This may cause damage to the covers.
