**Rear Lid Does Not Open / Rear Lid Lock is Faulty: Performing Water Ingress Test (246/22)**

Model Line: **Taycan Cross Turismo (Y1B) / Taycan Sport Turismo (Y1C)**

Model Year: **As of 2021 up to 2023**

Concerns: **Lower part of rear lock (rear lid lock)**

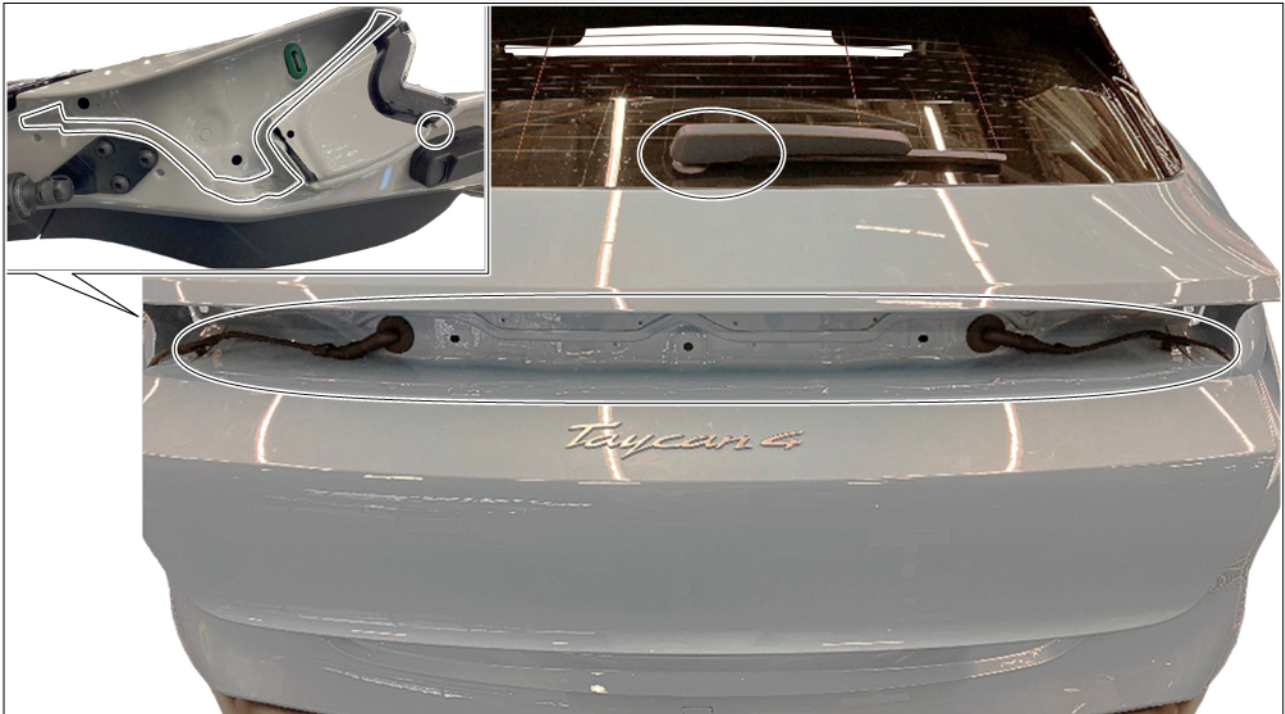
*Rear lid areas*

Focus on the following areas:

- Gaps in the rear lid
- Center body for the rear and brake lights
- Windshield wiper seal

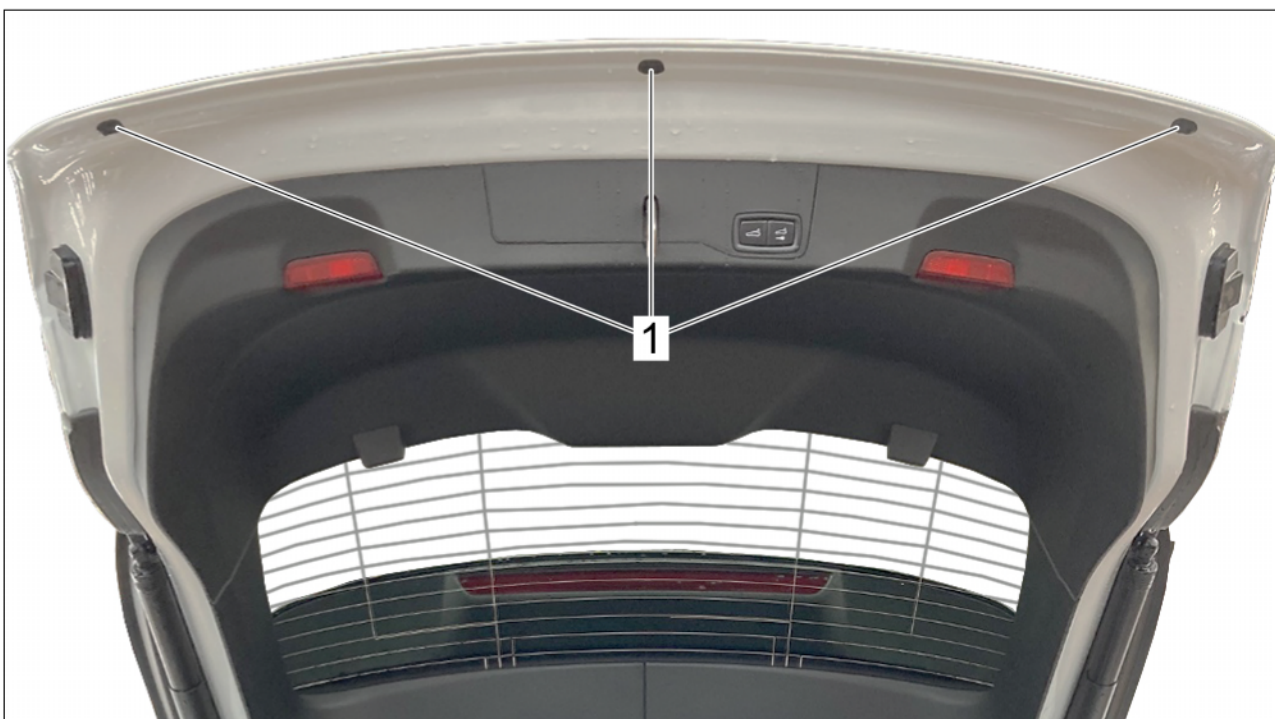
*Stopper in rear lid*

- 4 Lower the rear lid, and check for leaking water at the openings on the stoppers that were previously removed.
- 5 If water ingress could be detected, search for the cause in the following areas primarily:

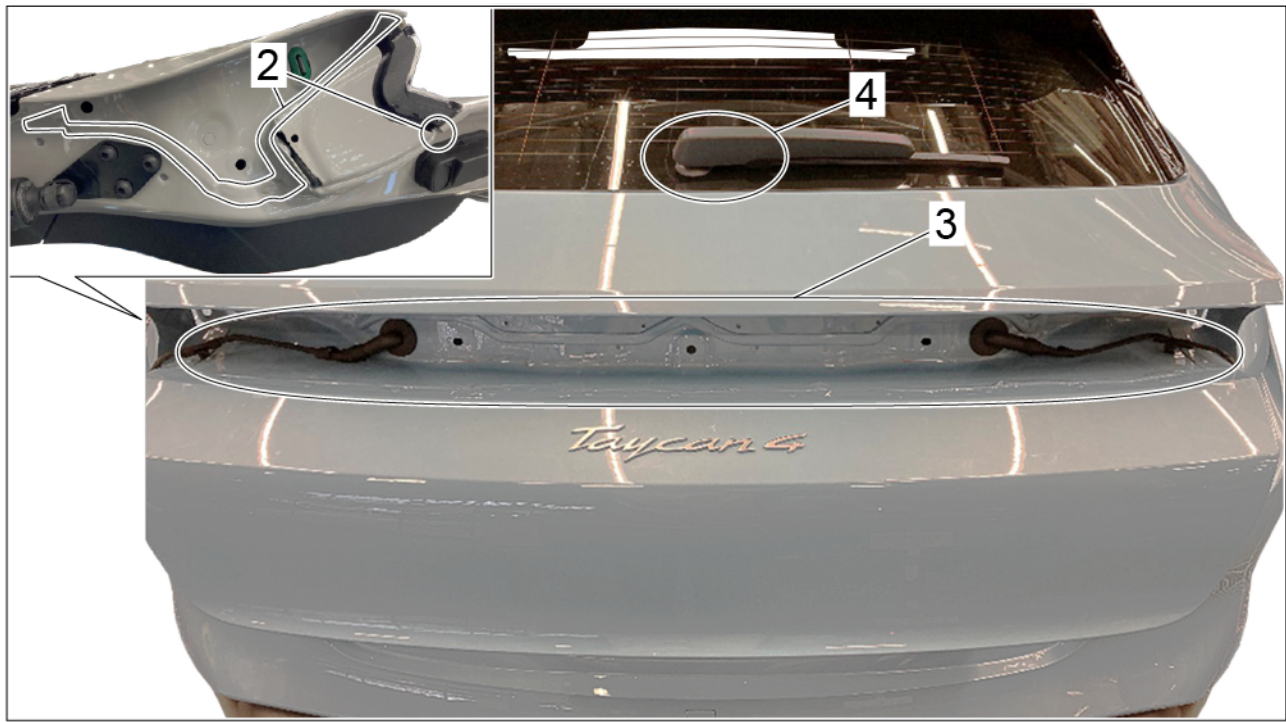
Rear lid

- Body seal ⇒ *Rear lid -2 and 3-*
  - On the washer water line for the rear window washer system
  - Rear wiper seal ⇒ *Rear lid -4-*
  - 5.1 After the water ingress has been clearly located, depending on the leakage point either:

- Seal the affected body area with body sealant, and then rework with a touch-up stick.
    - Replace the rear wiper seal.
    - Repair/replace the washer water line.
 Then ⇒ *Stopper in rear lid -1-* re-insert the stoppers in the rear lid.

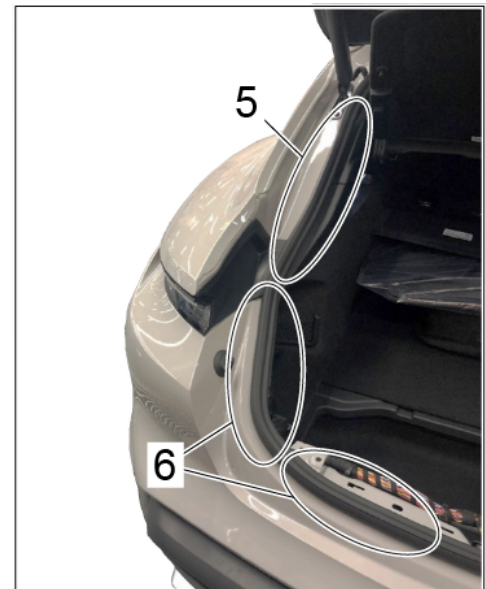
*Overview of luggage compartment seal*

- 5 Check luggage compartment in the area ⇒ *Overview of luggage compartment seal -6-* for traces of water.
- 6 Repeat the procedure on the other vehicle side of the vehicle.
- 7 If water is found to have entered the luggage compartment, find the cause on the respective side of the vehicle in the area of the rear lid seal or on the body seal area ⇒ *Water ingress into rear lid seal -7-*.

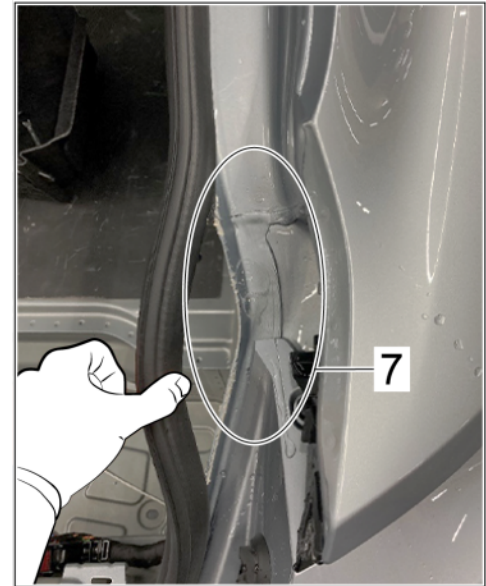
*Water ingress into rear lid seal*

If the rear lid seal is partially or completely removed, it must be replaced.

- 7.1 Once the water ingress has been clearly located, seal the affected area with body sealant, and rework with a touch-up stick.
