Body/Chassis – Water Leak From Roof Area

22-23MY Range Rover, 23MY Range Rover Sport SVR

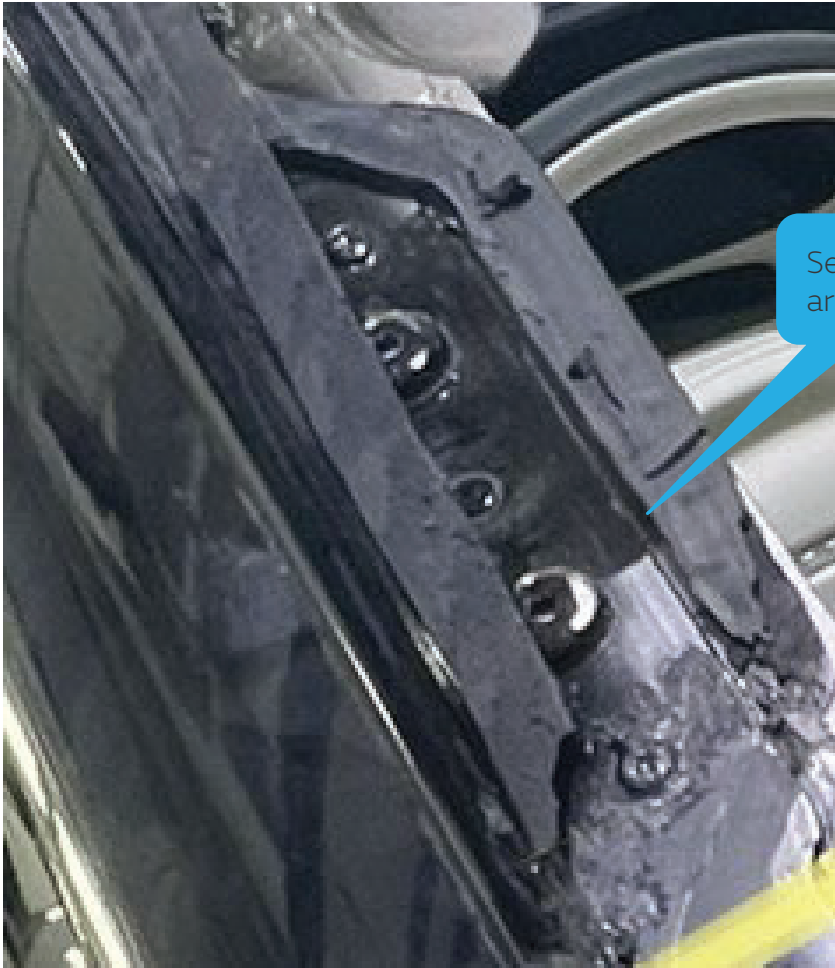
- Water may enter the vehicle cabin through a roof body seam or gap in the panoramic roof opening panel cassette sealant.

Seal this area
