Subject: **Safety Recall Campaign # 23V009**

This is to inform you that we are recalling a series of steel step deck trailers with the beavertail as these units may contain a defect that could affect the safety of a person.

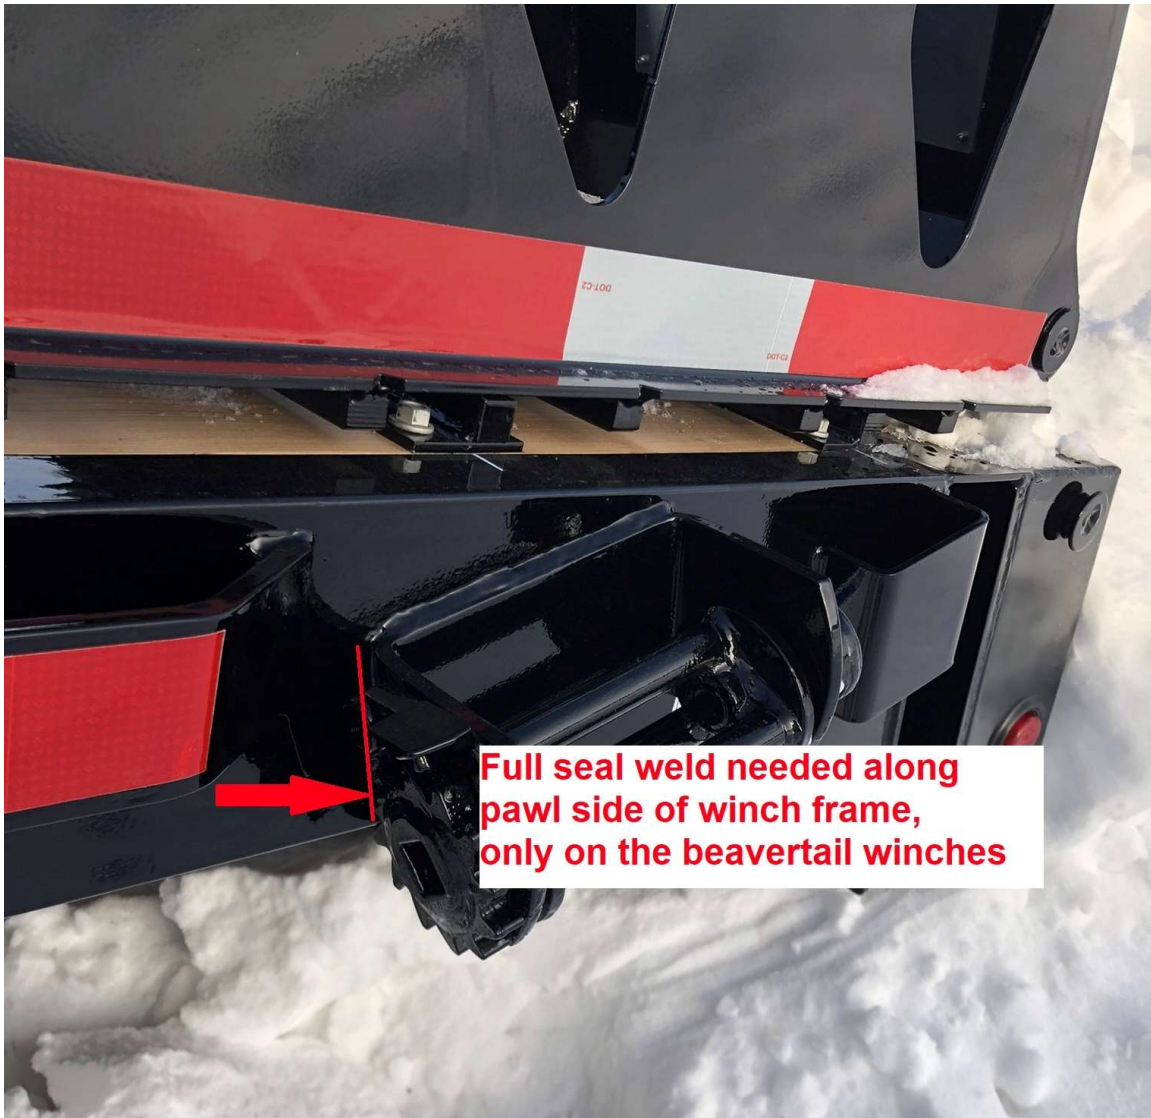
- b. This non-compliance relates to the welding employed to attach the cargo winches onto the side rail of the beavertail section of the trailer. A weld is missing that needs to be added. See the accompanying picture below.

test, the affected winches fail at approximately 13,000 lbs of force. To achieve the required strength, the winches need to be welded to the side rail on three sides: top, bottom, and on the pawl end of the winch body. These defective winch installations are missing the pawl end weld. See the accompanying picture. This was an error of omission during the manufacturing process.

g. The corrective action for this deficiency is to simply add the missing weld on the pawl end of the winch. A touch up of the paint after welding will restore the appearance of the area; no additional parts are required. We will be directing customers to bring their trailers back to your dealership for this rework, or if they wish to do it themselves, please contact our Service and Warranty Manager noted below to make arrangements for cost reimbursement.
