Service Bulletin

Bulletin No.: 21-NA-174

Subject: I/P Wiring Harness Fuse Block or Body Wiring Harness Junction Block Terminal Retention Repair

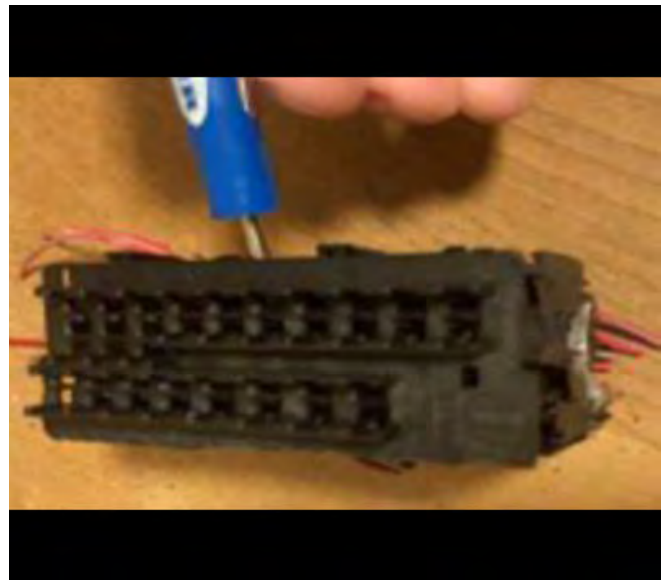
5876065

- 2.2. Locate the damaged pocket position.
