Service Bulletin

Bulletin No.: 22-NA-128

Subject: Malfunction Indicator Lamp (MIL) Illuminated - DTC P0172, P026D, P2459, and/or P2A00 Set

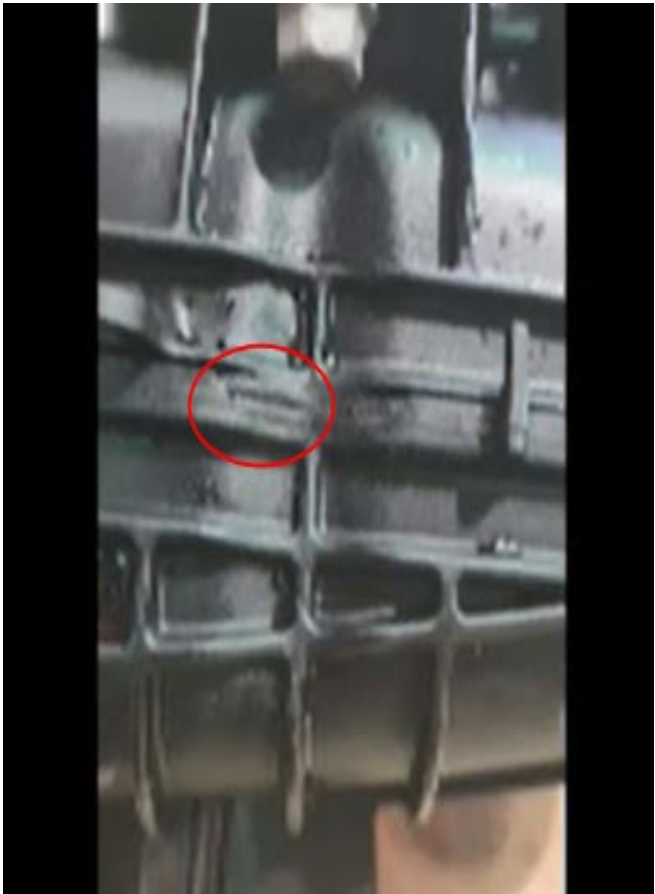
<p>Cause</p>

<p style="text-align: right;">6102369</p>
<p>Correction</p>	<p>This condition may be caused by a leak at the intake manifold.</p> <p>The technician can find this leak by testing using the <i>Component/System Leak Test in SI</i> or bulletin PIP5684.</p> <p>If a leak is found in the intake manifold, replace the intake manifold.</p>

Refer to *Intake Manifold Replacement in SI*.
