Service Bulletin

Bulletin No.: 22-NA-129

Subject: Transmission Fluid Leak from Center of Vehicle

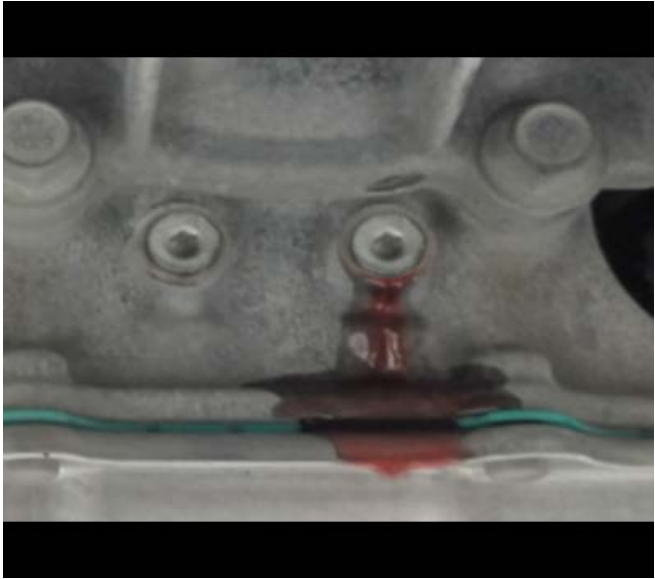
Involved Region or Country	North America, Middle East, Argentina (Mercosur), Chile (West), Colombia (West), Ecuador (West), Paraguay (West), Uruguay (West), Thailand (ASEAN)
Condition	Some customers may comment that transmission fluid is leaking from the center of vehicle.
Cause	Note: 4WD shown, 2WD similar.
