# Service Bulletin

Bulletin No.: 22-NA-171

**Subject:** Malfunction Indicator Lamp (MIL) Illuminated On the Driver Information Center (DIC) - DTC's P0171 and/or P0174 Set

Brand:	Model:	Model Year:		VIN:		Engine:	Transmission:
		from	to	from	to		
Chevrolet	Colorado	2017	2022	-	-	3.6 (LGZ)	-
GMC	Canyon

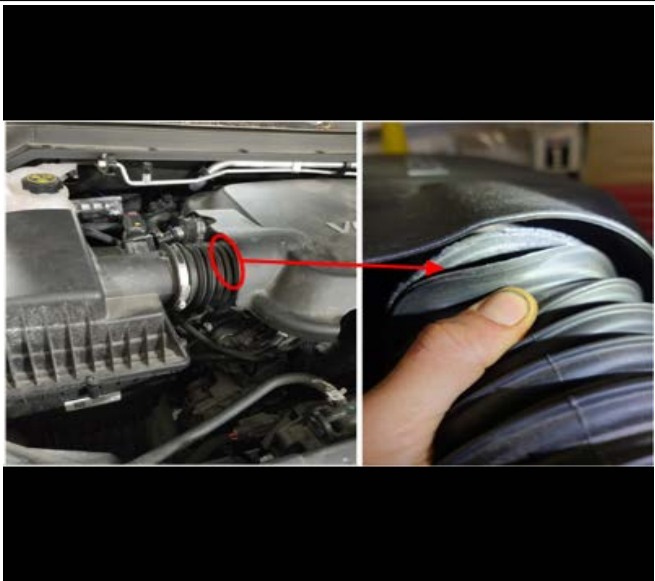
<b>Involved Region or Country</b>	North America, GM Korea Company
<b>Condition</b>	<p>Some customers may comment that the MIL is illuminated. Some technicians may find one or more of the following DTCs set in the Engine Control Module (ECM):</p> <ul style="list-style-type: none"> <li>• P0171: Fuel Trim System Lean Bank 1</li> <li>• P0174: Fuel Trim System Lean Bank 2</li> </ul>
<b>Cause</b>	<div style="text-align: right; font-size: small;">6137633</div>

<p>This condition may be caused by possible cracked/failed rubber intake boot.</p>
<b>Correction</b>	<p><b>Note:</b> Do Not remove engine cover when performing leak check.</p> <p>Inspect rubber boot for cracking or weld failure:</p> <ul style="list-style-type: none"> <li>• If the intake boot is found to have cracking or weld failure. Refer to the Service Procedure below.</li> <li>• If the intake boot is found to be in working condition. Refer to SI for further diagnostics.</li> </ul>

Refer to *Air Cleaner Outlet Duct Replacement in SI*.
