# TECHNICAL SERVICE BULLETIN

Classification: AN20-039B	Reference: NTB20-085B	Date: January 23, 2023
------------------------------	--------------------------	---------------------------

## TELEMATICS CONTROL UNIT RESET AFTER AUTOMATIC COLLISION NOTIFICATION

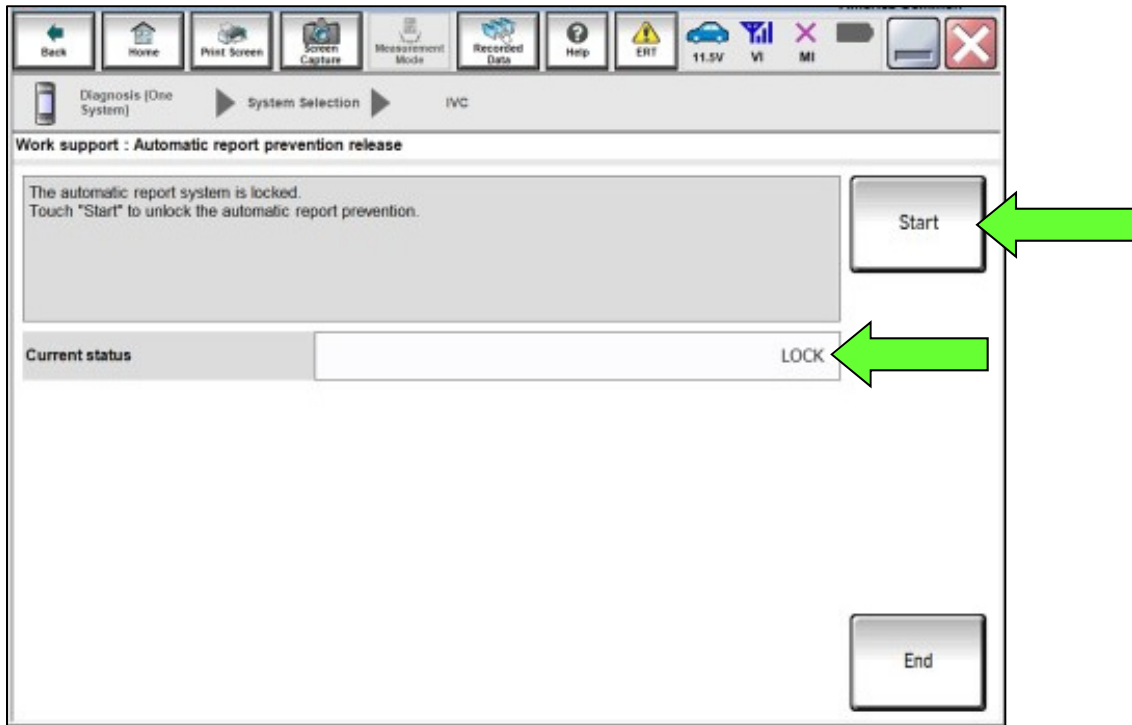
Figure 4

**HINT:** If “UNLOCK” is displayed next to **Current status**, the TCU does not need to be reset. Select **End**.

11. If “LOCK” is displayed next to **Current status**, select **Start**.
