# TECHNICAL SERVICE BULLETIN

Classification: DA22-001A	Reference: NTB22-038A	Date: January 24, 2023
------------------------------	--------------------------	---------------------------

## RAB WARNING LIGHT ON IN INSTRUMENT PANEL AND/OR DTC B2724-23 STORED

**APPLIED VEHICLES:** 2019-2021 Altima (L34)  
2019-2022 Murano (Z52)  
2019-2021 Rogue Sport (J11)  
2019-2021 Versa (N18)

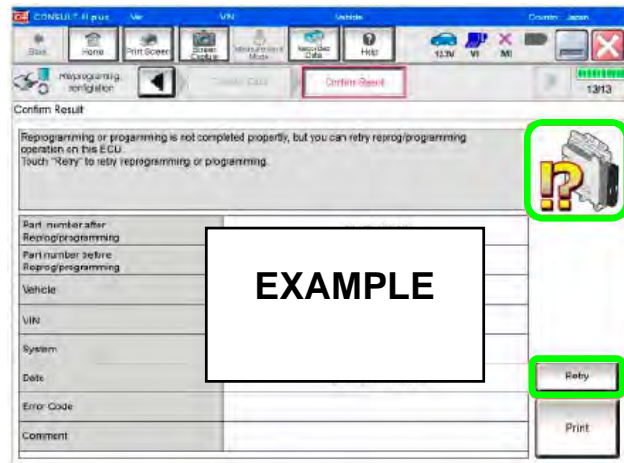
Figure 22

If reprogramming does not complete and the “!?” icon displays, as shown in Figure 22:

- Check battery voltage (12.0 - 15.5 V).
- Ignition is ON, engine OFF.
- External Bluetooth® devices are OFF.
- **All electrical loads are OFF.**
- **Select retry and follow the on screen instructions.**
- **“Retry” may not go through on first attempt and can be selected more than once.**
