TECHNICAL SERVICE BULLETIN

Classification: DA22-004A	Reference: NTB22-073A	Date: January 24, 2023
------------------------------	--------------------------	---------------------------

REAR AUTOMATIC BRAKING WARNING LIGHT ILLUMINATED AND/OR DTC C1B56-04 AND/OR C1B56-97 STORED IN THE ADAS CONTROL UNIT

APPLIED VEHICLES: 2019-2022 Altima (L34)

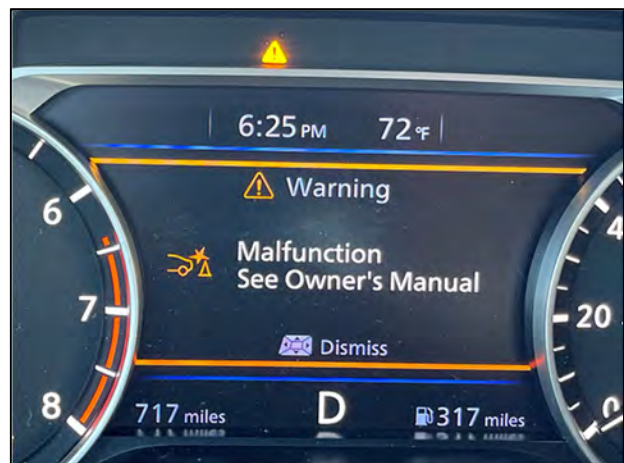
Figure 1

The customer states the rear automatic braking (RAB) warning light is illuminated, with “Malfunction See Owner’s Manual” appearing in the vehicle information display,

DTC C1B56-04 (SONAR CIRCUIT) and/or C1B56-97 (SONAR CIRCUIT) is stored in the ADAS Control Unit.

Reprogram and configure the Sonar Control Unit using the **SERVICE PROCEDURE** in this bulletin, if applicable.

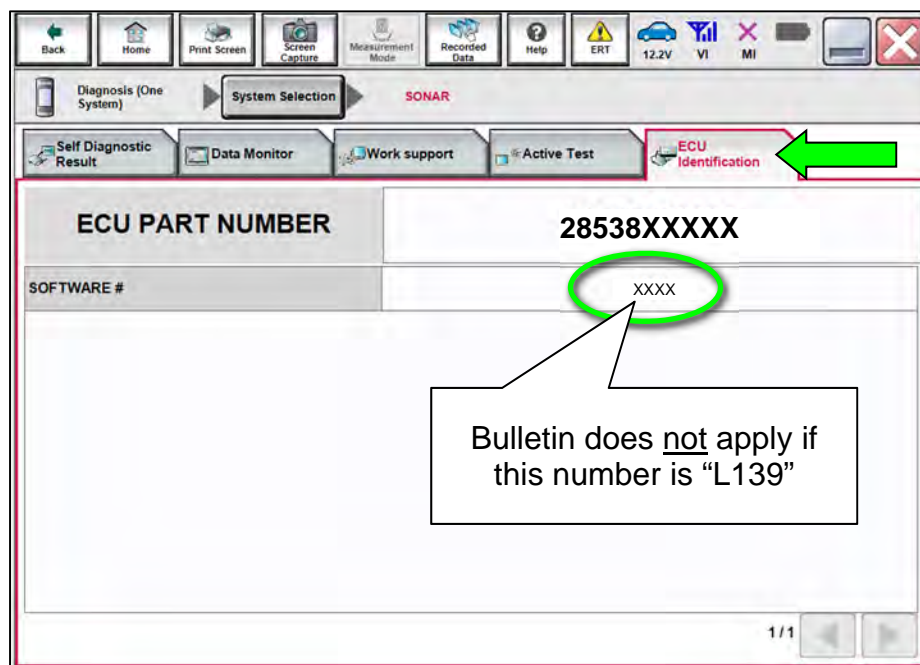
Figure 5

16. Confirm the current **SOFTWARE #** (Figure 5).

- If the **SOFTWARE #** is “L139”, this bulletin does not apply. See the Electronic Service Manual (ESM) for further diagnostic information.
- If the **SOFTWARE #** is not “L139”, proceed to step 17 on page 6.

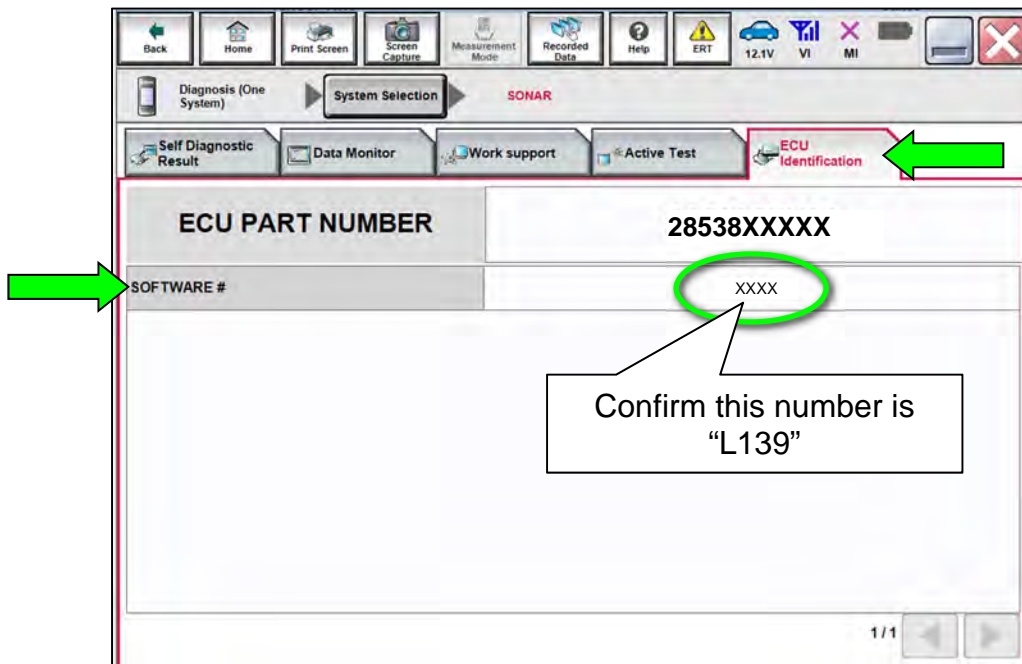
Figure 36

60. Confirm the **SOFTWARE #** (Figure 36).

- If the **SOFTWARE #** is "L139", proceed to step 61 on page 24.
- If the **SOFTWARE #** is not "L139", reprogramming did not successfully complete. Go back to step 18 on page 6 and perform the procedure again.
