JLRTB02052NAS2  
**TECHNICAL BULLETIN**  
30 JAN 2023

501-03

Rear Doors Difficult To Open

MODEL:	MODEL YEAR:	VIN:	ASSEMBLY PLANT:	APPLICABILITY:
Defender (LE)	2020 Onwards	000431 Onwards	Nitra (Slovakia)	5-Door

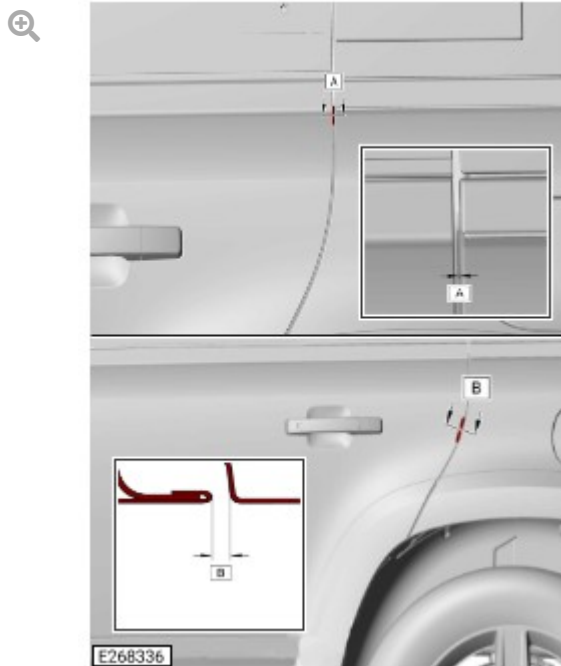
Check the alignment of the rear door(s) in the areas shown in the illustration.

SECTION	DESCRIPTION	GAP	PROFILE
A	Rear door to rear quarter	N/A	0.0 ± 0.5 mm
B	Rear door to rear quarter	3.5 ± 0.7 mm	0.0 ± 0.7 mm

- If the rear door alignment is within tolerance, continue to Service Instruction B.
- If the rear door alignment is out of tolerance, continue to the next step.

Adjust the rear door(s) to be within tolerance (see TOPIx Workshop Manual section 501-26: Body Repairs: Vehicle Specific Information and Tolerance Checks - General Procedures - Rear Door Alignment).

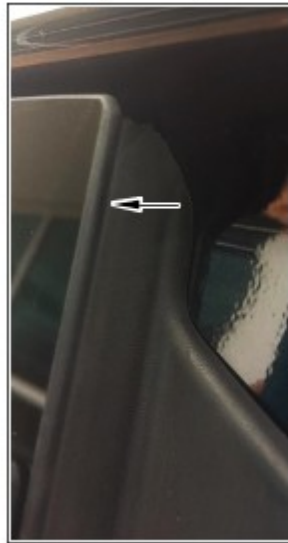
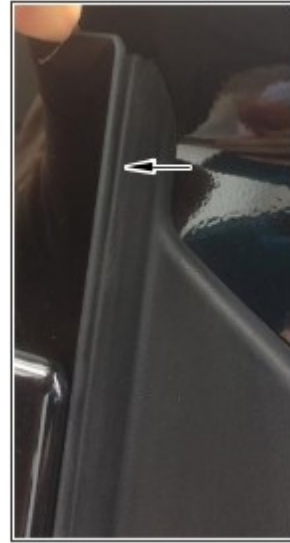
E268337

- Remove the adhesive tape backing.
- **Make sure the C-pillar exterior finisher trim protrudes 1-1.5 mm away from the rear quarter window, as shown in the illustration, before fully securing.**  
The image with the **RED 'X'** shows the C-pillar exterior finisher trim installed incorrectly behind the rear quarter window.  
The image with the **GREEN '✓'** shows the C-pillar exterior finisher trim installed correctly with a 1-1.5 mm protrusion from the rear quarter window.

Install the new C-pillar exterior finisher trim.
