## **Service Bulletin**

Brand:	Model:	Model Year:		VIN:		Engine	Turnensierien
		from	to	from	to	Engine:	Transmission:
Cadillac	CT6	2019	2020			LM2, L84, L87,	MHS, MHT, MHW, MHX, MI1, MI2, MI4,
	CT4	2021					
	CT5	2020	2022				
	Escalade Models	2021					
	Silverado 1500 (New Model)	2019	2019				
	Silverado LD						
Chevrolet	Silverado 1500	2020	2021				
	Silverado 1500 - LTD (RPO J21, VIN Digit 5 = W/Y)	2022	2022				
	Silverado 1500 - New (RPO J22, VIN Digit 5 = A)						
	Suburban	2021			LSY, LGX	MQA, MQB, MQC	
	Tahoe						
GMC	Sierra 1500 (New Model)	2019	2019				
	Sierra Limited	2019	2019				
	Sierra 1500	2020	2021				
	Sierra 1500 - Limited (RPO J21, VIN Digit 5 = 8/9)	- 2022	2022				
	Sierra 1500 - New (RPO J22, VIN Digit 5 = H/U)						
	Yukon Models	2021	2022

## Subject: Diagnostic Tip for 10 Speed Oil Pump Drive Gear

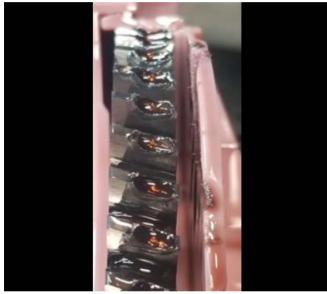
6196003

Note the damage to the oil pump idler gear.

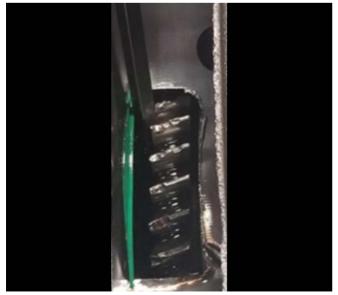
6196006

Note the side-to-side movement in the oil pump
idler gear.

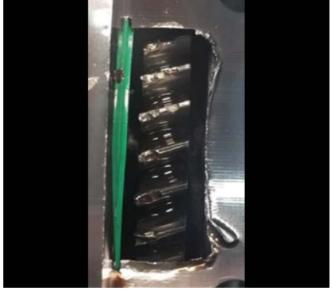
6196005

Note the damage to the oil pump driven gear.
