# Service Bulletin

Bulletin No.: 19-NA-037

**Subject: No Start, Hard Start with Belt Squeal, Belt Break, Loss of Power Steering and/or Power Brake Assist**

Brand:	Model:	Model Year:		VIN:		Engine:	Transmission:
		from	to	from	to		
Chevrolet	Express	2018	2023			4.3L — LV1	All
GMC	Savana	2018	2023			6.6L — L8T

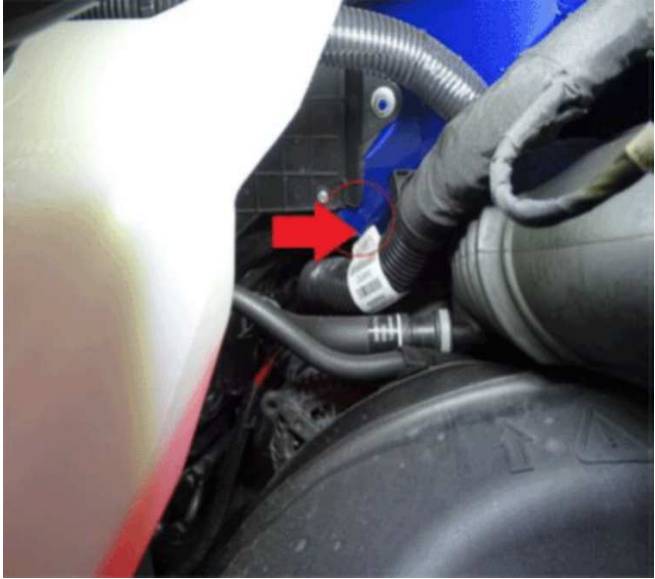
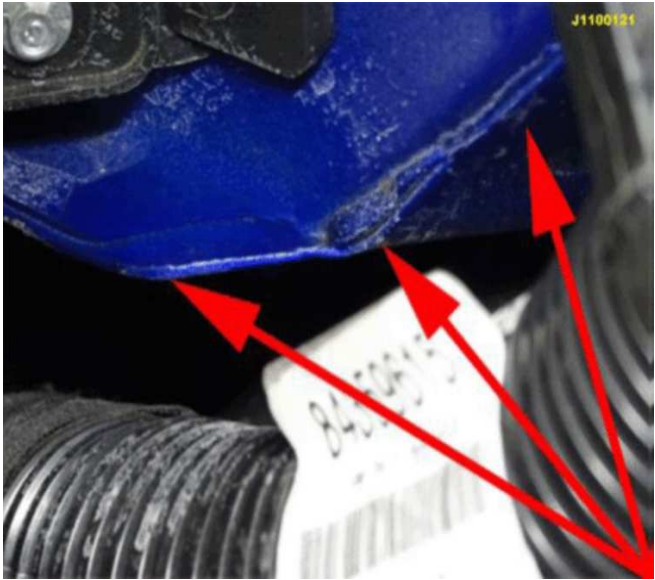
<p style="text-align: right; margin-right: 10px;">J1100124</p> <p style="text-align: right; margin-right: 10px;">5246049</p> <p><b>Note:</b> The common location of the water leak path is shown in the graphics above.</p> <ul style="list-style-type: none"> <li>Seal water leak at cowl with Kent Automotive High-Tech™ Clear Seam Sealer, following the steps in the Service Procedure below.</li> </ul>
--	---

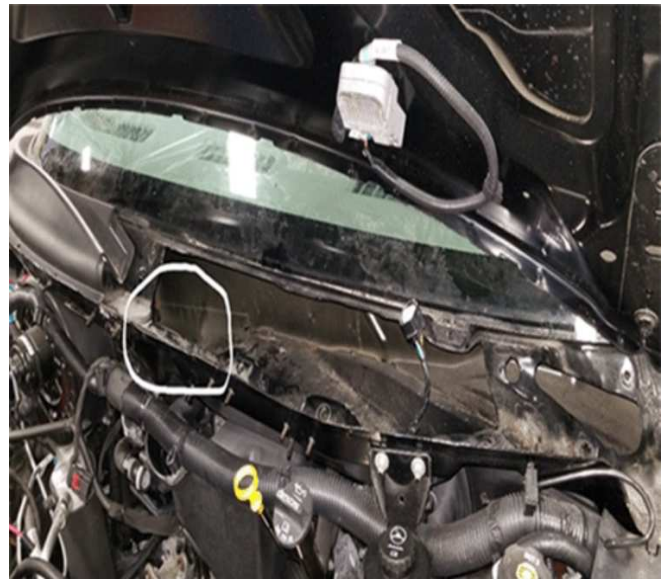
5246055

2. Note the location of the inner lower right side seam circled in the graphic above.
