Service Bulletin

Bulletin No.: 20-NA-203

Subject: Information on Manual Regeneration Displayed on Drivers Information Center (DIC)

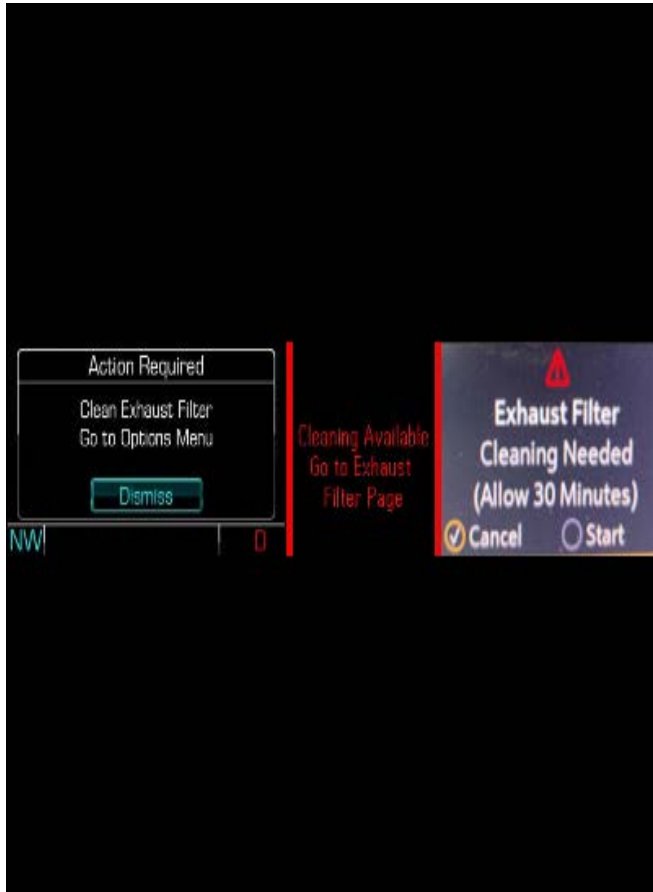
5654544

At approximately 90% soot load in the DPF, one of the messages in the graphic above will be displayed on the DIC.

These messages indicate that Manual Regeneration is available. No action is required; however, the operator may choose to perform a manual regeneration. See performing a manual regeneration below. If the message is dismissed and the vehicle has not performed a regeneration, this message will appear again on the next key on cycle.

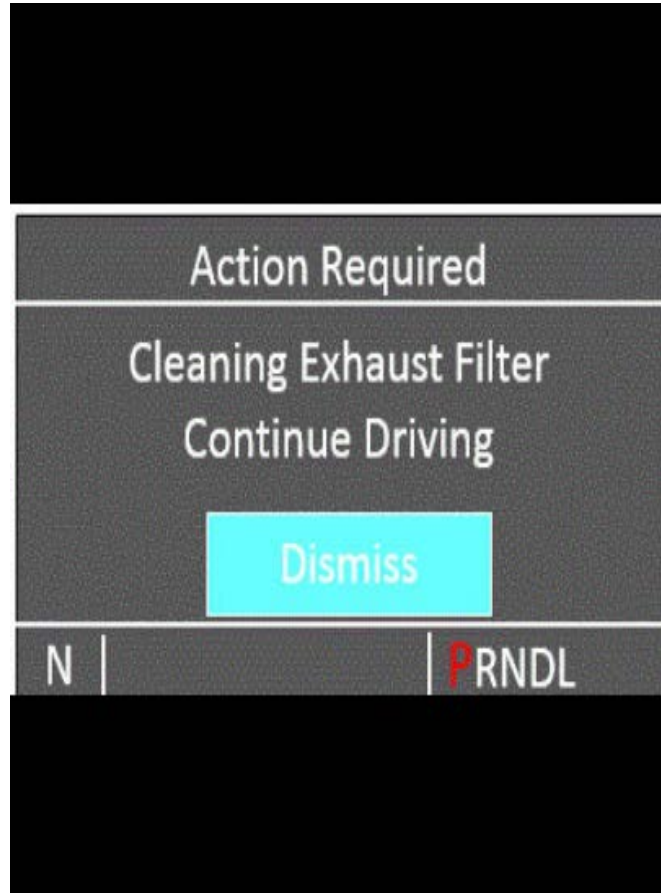
5654545

If the soot level climbs to a level near 110 - 115% in the DPF while the vehicle is moving and the vehicle is still not able to start an automatic regeneration, the message in the graphic above will display.

If the message is displayed, continue driving safely at a steady speed as close to the posted speed limit as possible until the message turns off. This can take up to 30 minutes.

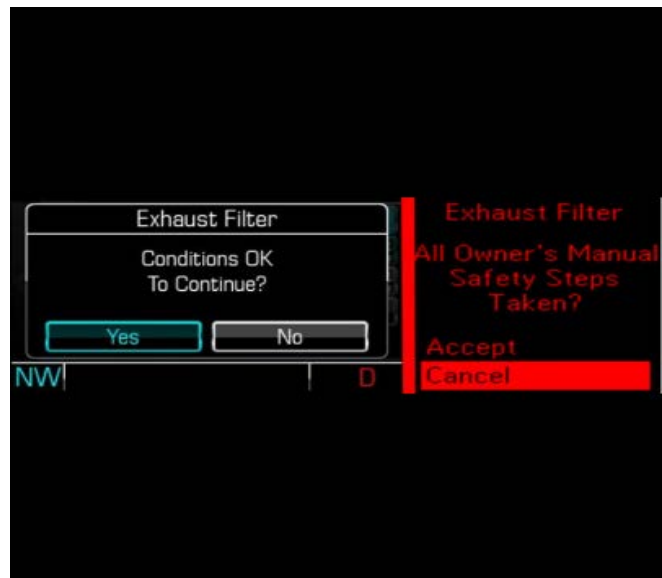
5654762

After making sure all the safety conditions have been met, press the trip odometer reset stem or the Check-Mark on the steering wheel control for at least one second to select Start on the DIC. The DIC will display in the graphic above.

If the DIC returns to the previous screen, then one or more of the necessary operating conditions has not been met. If you cannot determine which condition has not been met, refer to www.gmupfitter.com to contact the GM Upfitter Integration Group for assistance.

Follow the instructions in the DIC messages. Select Yes or Accept to acknowledge that all the safety conditions have been met and to activate regeneration.

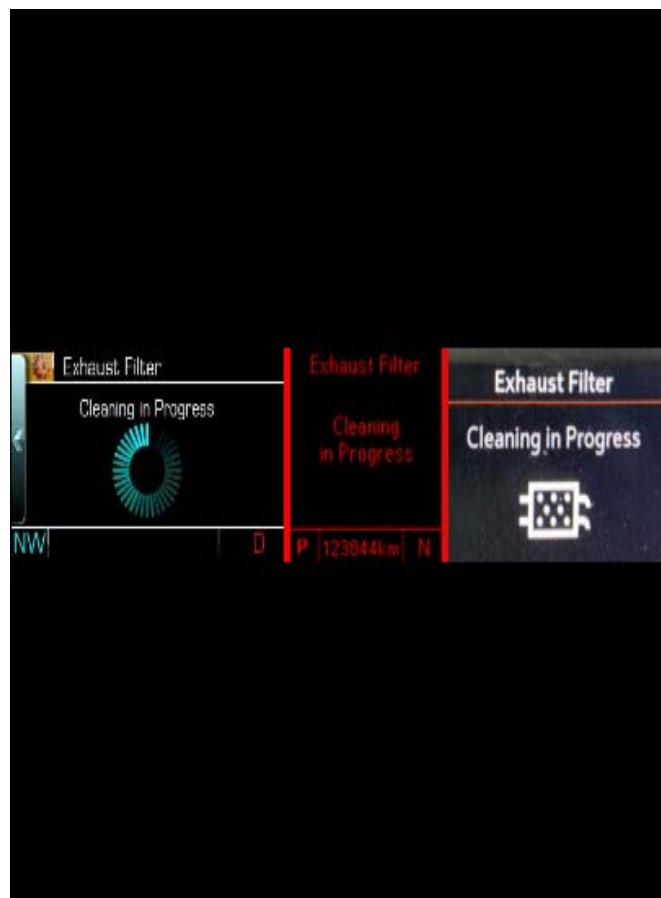
5654694

When manual regeneration begins, the engine speed increases, the engine cooling fan sound increases and the message in the graphic above will be display.

Cleaning could take up to 30 minutes. Upon completion, the engine will return to normal idle, but exhaust components will remain hot for several minutes. Do not move the vehicle until the exhaust has had time to cool. Manual regeneration can be canceled at any time by pressing the brake pedal or turning the engine off. Unusual noises may be heard if regeneration is interrupted.
