Service Bulletin

Bulletin No.: 21-NA-138

Subject: Squeak, Grind or Clunking Noise from Rear Leaf Springs

Brand:	Model:	Model Year:		VIN:		Engine:	Transmission:
		from	to	from	to		
Chevrolet	Silverado HD	2015	2018	—	—	—	—
	Silverado 2500HD/3500HD	2019	2023				
GMC	Sierra HD	2015	2018				
	Sierra 2500HD/3500HD	2019	2023

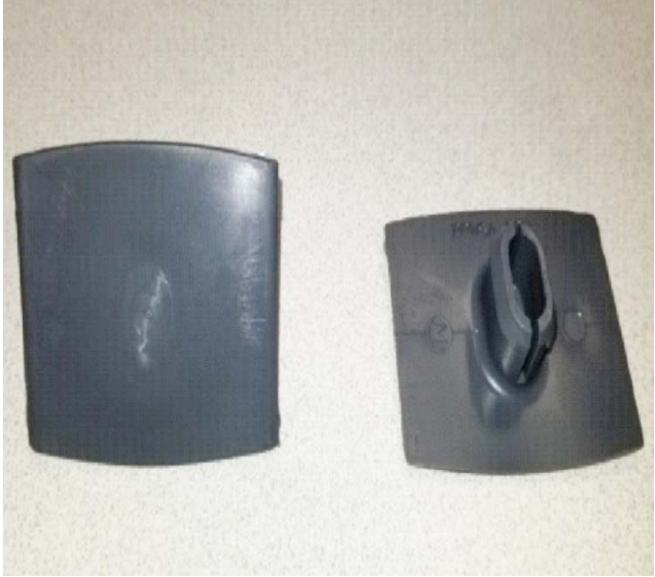
Involved Region or Country	North America, Middle East, Israel, Australia and New Zealand
Condition	Some customers may comment that a squeak, grind or clunking noise can be heard from the rear leaf springs.
Cause	This condition may be caused by the spring insert interacting with the leaf spring. Note: Some noise is characteristic with leaf spring suspensions when going over bumps.
Correction	<div style="text-align: center;">

</div> <p style="text-align: right; font-size: small;">5341853</p> <p>A new insert with a graining pattern will help reduce this noise. Replace the rear spring inserts utilizing a plastic trim tool or plastic wedge in between the leaf springs.</p> <p>Important: After new spring tip inserts are installed per this bulletin, new inserts have a break-in period of up to 1610 km (1000 miles), where some noise can be expected.</p>
