Service Bulletin

Bulletin No.: 23-NA-005

Subject: Rattle or Flutter Noise Under the Vehicle at Highway Speeds

Brand:	Model:	Model Year:		VIN:		Engine:	Transmission:
		from	to	from	to		
Buick	Envision	2023	2023

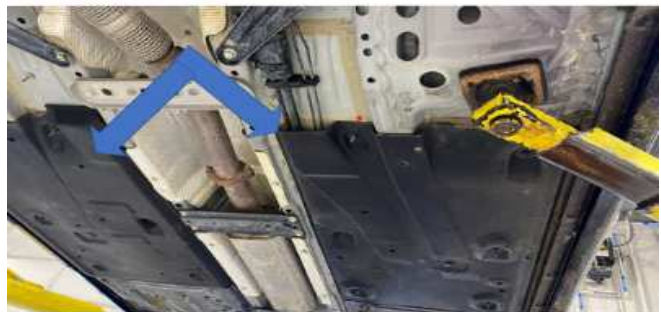
6258344

Involved Region or Country	North America
Additional Options (RPOs)	Equipped with FWD (Front Wheel Drive Only)
Condition	Some customers may comment on a rattle or flutter noise heard under the vehicle at highway speeds.
Cause	The cause of the condition may be the lower panel on FRONT WHEEL DRIVE vehicles only may be making contact with the subframe assembly.
Correction	Remove both panels and add 5 mm of adhesive foam tape to area.

2. Remove both trim panels illustrated above.
