# TECHNICAL SERVICE BULLETIN

Classification: EC22-012	Reference: NTB23-006	Date: January 18, 2023
-----------------------------	-------------------------	---------------------------

## MIL ON WITH DTC P0101 AND/OR P010B STORED IN THE ECM

APPLIED VEHICLES: 2023 Z (Z34)

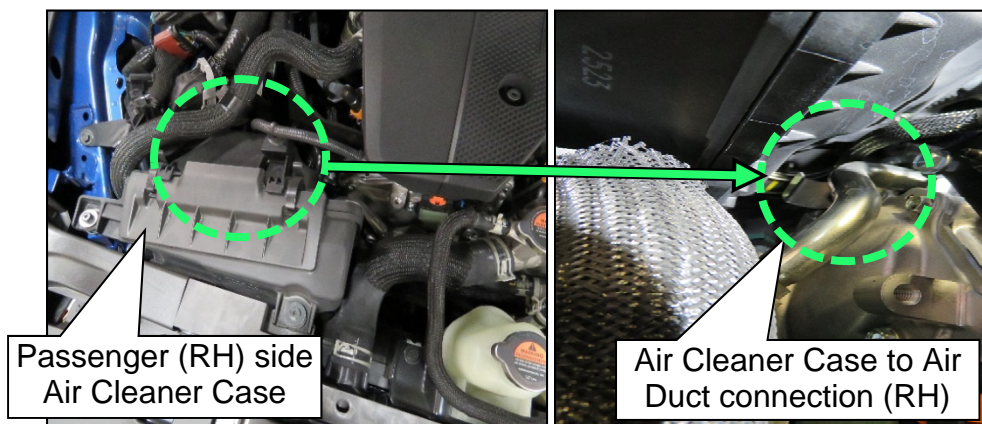
Figure 2

- Never shock the Mass Air Flow Sensor.
  - Never disassemble the Mass Air Flow Sensor.
  - Never touch the sensor of the Mass Air Flow Sensor.
1. Inspect the applicable Air Duct(s) for any leaks or poor connections.
    - For DTC P0101, inspect the passenger (RH) side Air Duct (Figure 2 and Figure 3).
    - For DTC P010B, inspect the driver (LH) side Air Duct (Figure 5 and Figure 4).

2. Disconnect/remove the Air Duct as needed, and then correctly reconnect/reinstall the Air Duct, ensuring there are no leaks.
  - Refer to ESM: **ENGINE > ENGINE MECHANICAL > REMOVAL AND INSTALLATION > AIR CLEANER AND AIR DUCT > Removal and Installation**
