# QUALITY ACTION

# CAMPAIGN BULLETIN

## Front Bumper/Headlamp Dealer Inventory

Reference: P2A21  
Date: January 18, 2023

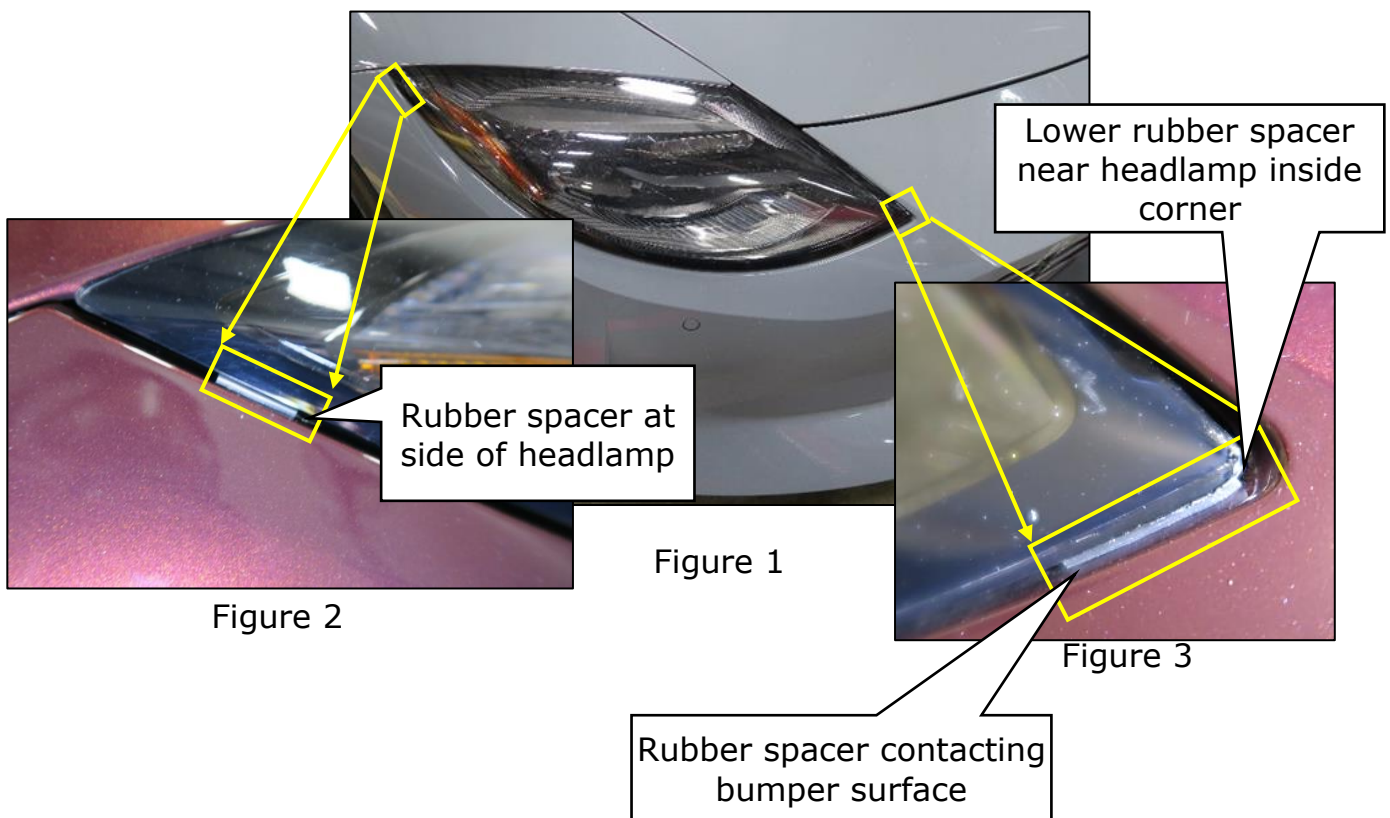
1. Inspect for the presence of the side rubber spacers and the position of the lower rubber spacers in the areas shown in Figure 1.

- The side rubber spacer should be visible between the headlamp and front bumper in the area location shown in Figure 2
- The lower rubber spacer should be positioned near the inside corner of the headlamp and **MUST** be contacting the front bumper surface as shown in Figure 3

- If Rubber spacers are present **AND** in the correct location, continue to **Step 2** for clearance check.
- If the Rubber spacers are **NOT** present **OR** are in the incorrect location, skip to **Step 3** for paint inspection, then continue to **Step 4** for spacer installation.

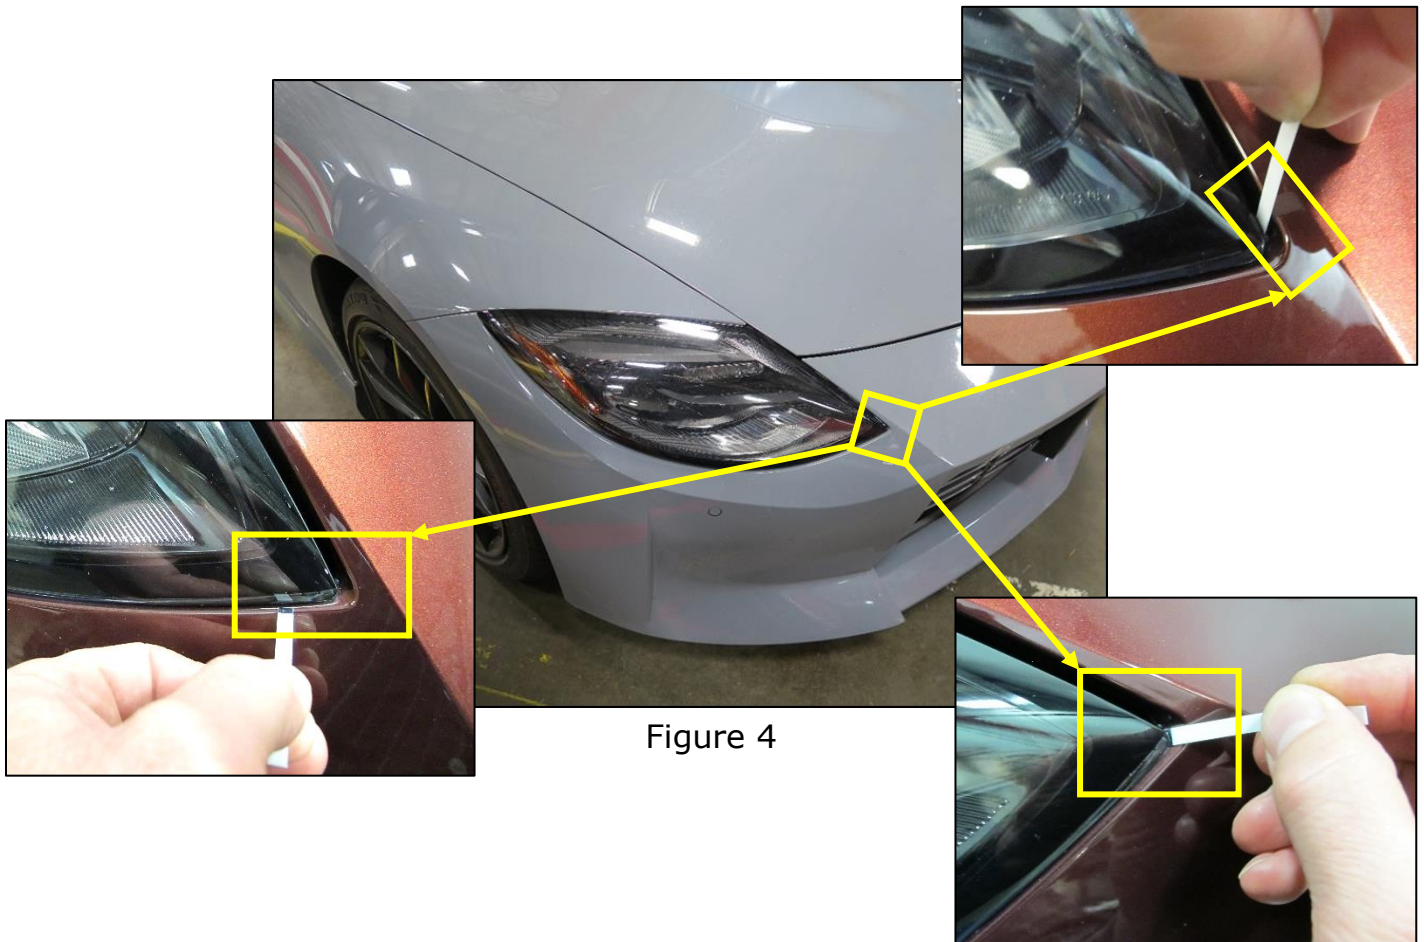
Figure 4

2. Using a 0.5mm (0.020") white plastic gap gauge from the parts kit, check the clearance between the headlamp and the front bumper in the areas shown in
- Tool should easily slide between front bumper and headlamp

In some cases the rubber spacer may prevent the gap gauge from entering between the bumper and headlamp. This condition is normal and the spacer should **NOT** be replaced for this condition.

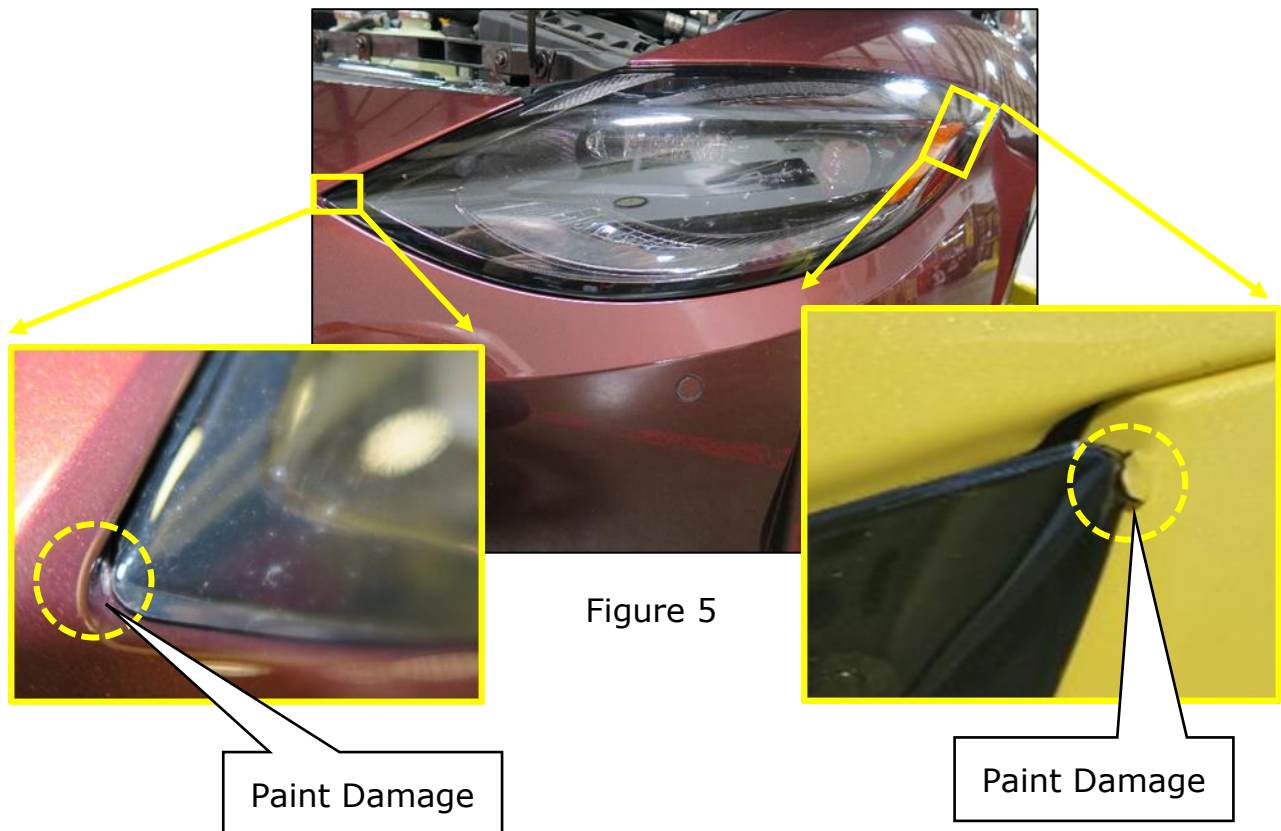
3. Visually inspect the corners of the front bumper for paint damage. (Examples of damage shown in Figure 5)
- If **Steps 1, 2 AND 3** inspections are **OK**, no further action is needed, the procedure is complete. Submit claim using OP Code P2A210.
  - If **ANY** of the inspections from **Steps 1-3** are found **NG**, proceed to **Step 4** for repairs.

**YES** - If the front bumper has paint damage in the area inspected in **Step 3**, perform the necessary paint repairs before continuing with **Step 24**.

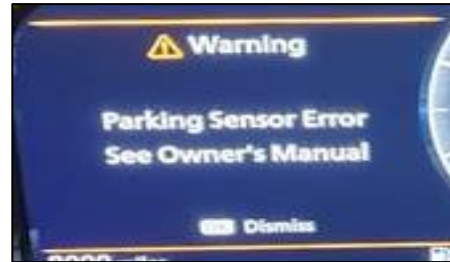
- Verify there are NO parking (sonar) sensor errors are present in the combination meter (gauge cluster)
  - If **NO** errors are present,
    - Turn the engine off
  - If an error similar to the one shown in Figure 50 is present, verify the connectors behind the RH front fender liner are connected and locked
    - If both connectors are connected and locked, remove the front bumper and locate the sonar sensor connector that is not connected or not fully seated
