# Technical Service Bulletin

## 01 Noises/rattling from turbocharger (V6 2.9 L. TFSI)

01 23 42 2066547/2 February 7, 2023. Supersedes Technical Service Bulletin Group 01 number 22-18 dated March 21, 2022 for reasons listed below.

Model(s)	Year	VIN Range	Vehicle-Specific Equipment
RS 5, and RS 5 Sportback	2021	All	Not Applicable

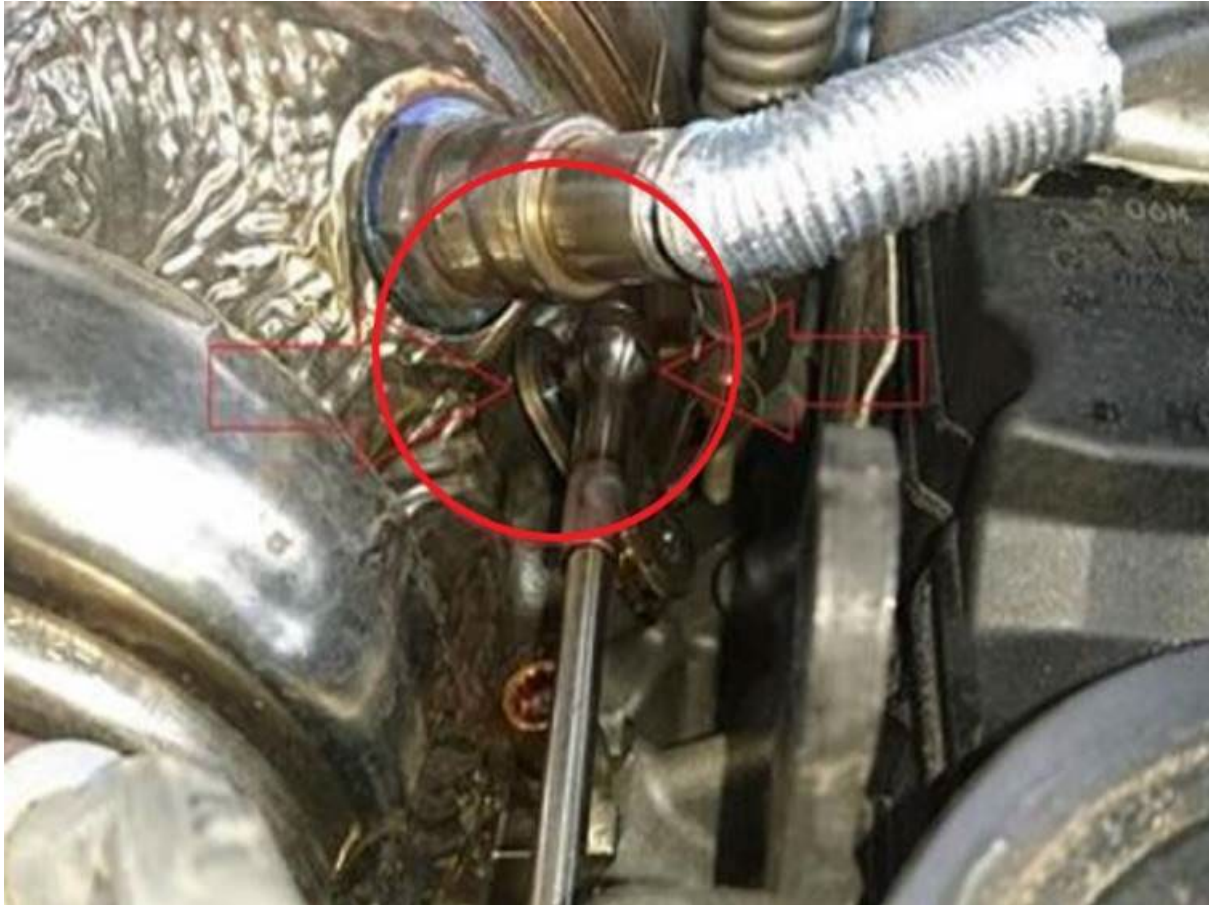
The customer complaint can be reproduced. Slight play at the turbocharger wastegate flap linkage causes a rattling noise when the engine speed tails off.

Please update the engine control module J623 (address word 0001) using the software code below.
