Technical Service Bulletin

39 Oil leak at sealing cap on rear final drive, sport differential

39 23 51 2064024/3 February 6, 2023. Supersedes Technical Service Bulletin Group 39 number 22-47 dated April 29, 2022, for reasons listed below.

Model(s)	Year	VIN Range	Vehicle-Specific Equipment
SQ5	2020 – 2021	All	V8 with Sports Differential
S4, S5, S5 Cabriolet, S5 Sportback, RS 5, RS 5 Sportback, A6, S6, RS 6 Avant, A7, S7, RS 7, A8, SQ5, SQ5 Sportback, SQ7, SQ8, RS Q8	2021

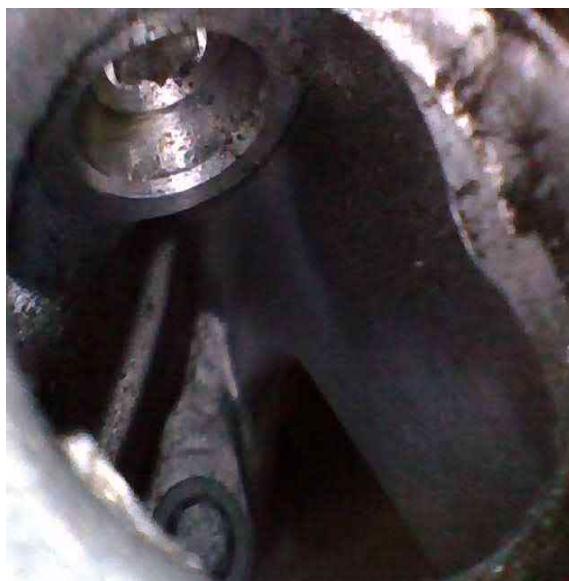
- An oil leak is confirmed from the top of the differential near the output flanges.
- One or both of the sealing caps are missing from the pressure limiting valves (Figures 1 - 3).

Figure 1. Missing sealing cap viewed with a pocket mirror.

If the leak can be confirmed to be from a missing sealing cap, then perform the following repair.

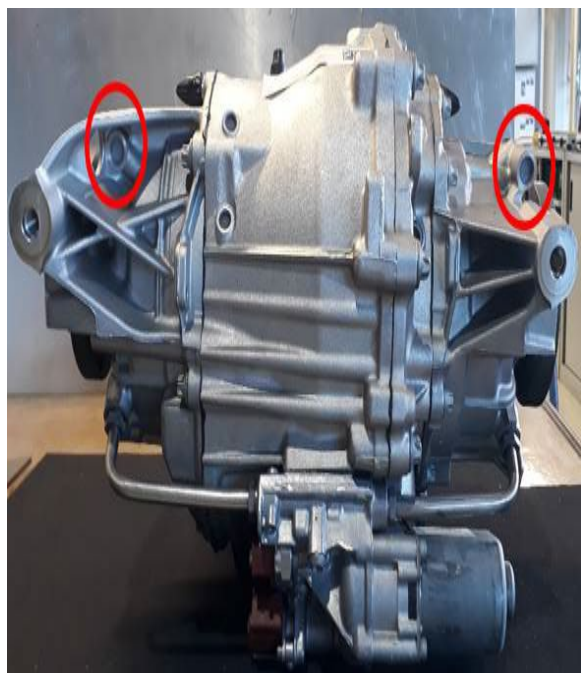
Figure 2. Location of sealing caps on the OD3 differential.

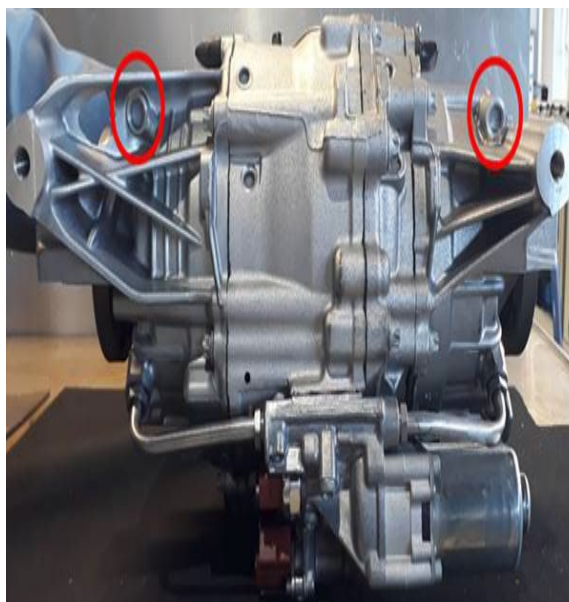
Figure 3. Location of sealing caps on the OBX differential.

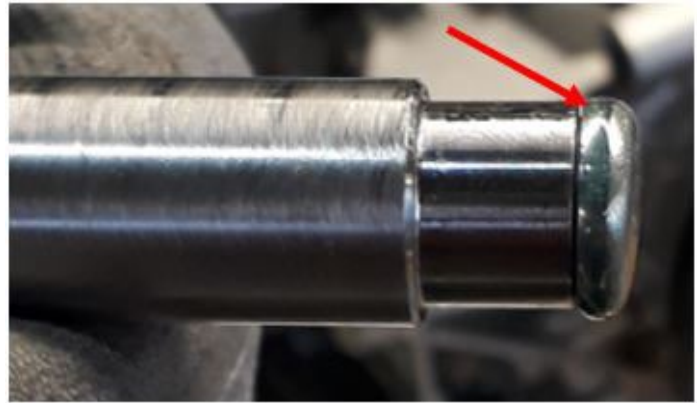
Figure 4. Sealing cap on a drift.

3. Place the new sealing cap on a drift and coat it lightly with locking fluid around the outside edge (red arrow Figure 4).

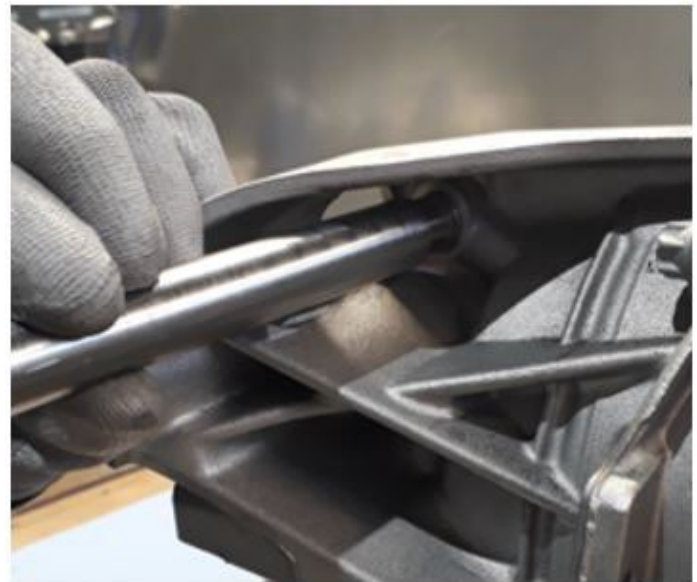
Figure 5. Installing sealing cap

4. Knock sealing cap onto pressure limiting valve using a drift and soft-faced hammer at a right angle to machined surface of housing until it reaches its stop. When it reaches its stop, a dull sound can be heard and a spring-back effect can be felt at the hammer (Figure 5).

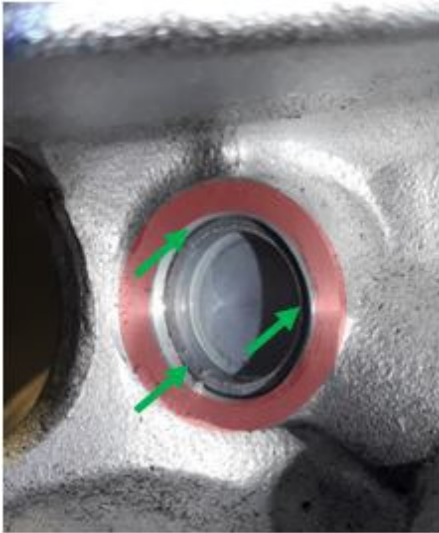
Figure 6. Measurement locations.

5. Remove excess locking fluid with a clean cloth.
6. Perform a visual check to see whether the sealing cap has been installed evenly around the entire circumference.
7. Perform a check measurement with a caliper gauge. The measurement from the machined surface of the housing (the red area in Figure 6) to the upper collar of the sealing cap (green arrows in Figure 6).

This measurement must be performed in three locations at intervals of 120° and a minimum dimension of 1.00 mm and a deviation of no more than 0.3 mm must be ensured.

In the event of deviations from the minimum dimension or the maximum deviation being exceeded, the sealing cap can be knocked carefully in with the drift and soft-faced hammer if necessary.

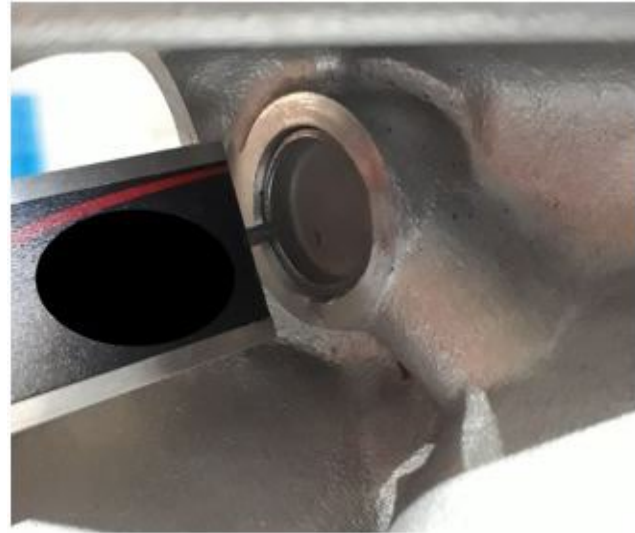
Figure 7. Performing measurement.

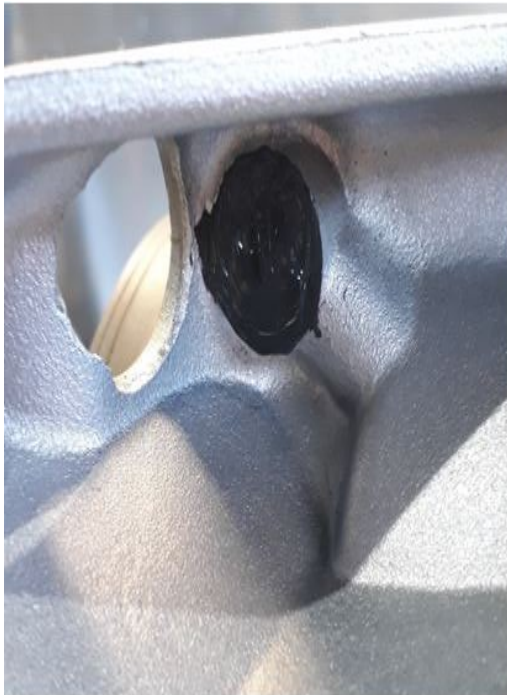
Figure 8. Silicone adhesive sealant example 1.

9. After a drying time of at least 30 minutes, clean the area around the sealing caps of the pressure limiting valves (both sides) using a clean cloth (lightly coated with brake cleaner if necessary).
10. Both sealing caps must be bonded over the entire surface using the silicone adhesive sealant. A layer of skin forms and then hardens (Figures 8 - 9). A drying time of at least 30 minutes must be ensured before reinstallation into the vehicle.

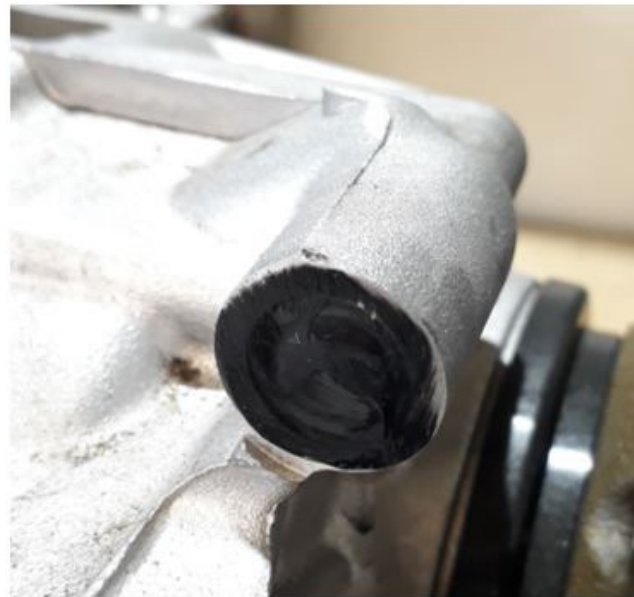
Figure 9. Silicone adhesive sealant example 2.
