Technical Service Bulletin

60 Panoramic sunroof noises

60 23 62 2054203/5 February 6, 2023. Supersedes Technical Service Bulletin Group 60 number 20-40 dated March 12, 2020, for reasons listed below.

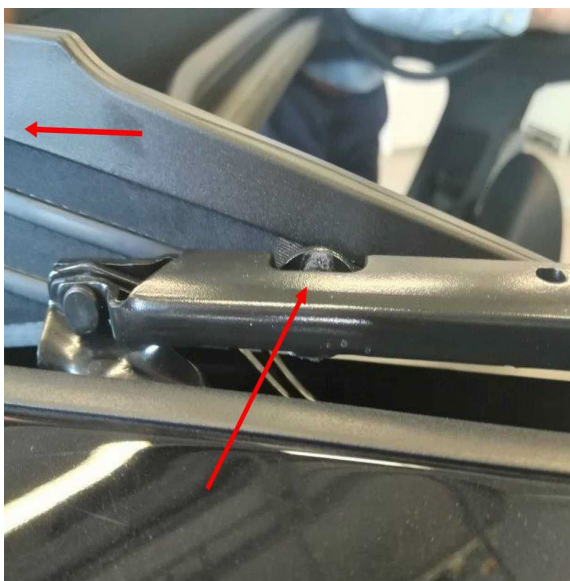
2. Figure 3 shows the left slide and tilt mechanism. The upper left arrow points to the front of the vehicle. The lower arrow points to the first mounting point of the glass panel.

Figure 3. The left side of the slide and tilt mechanism.

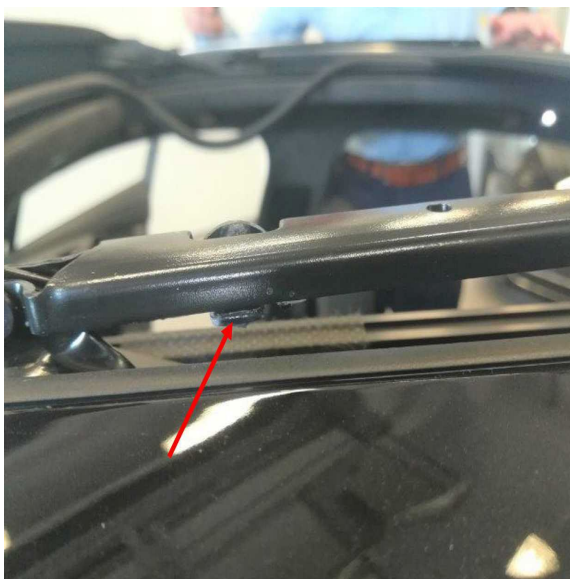
Figure 4. Lug to be lubricated on slide and tilt mechanism.

3. There is a lug under the first mounting point (Figure 4, red arrow). This point has to be lubricated with G 060 567 A2 lubricant.

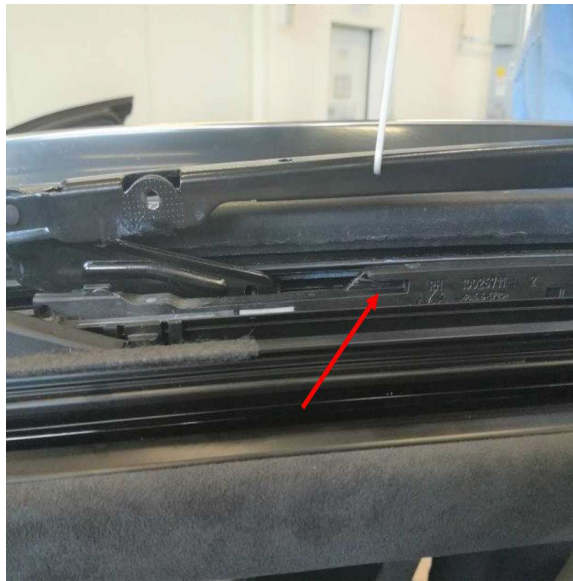
Figure 5. The groove in the slide and tilt mechanism.

4. Figure 5 and 6 shows the right slide and tilt mechanism from the inside. The groove indicated by the red arrow should be lubricated with G 060 567 A2 lubricant.

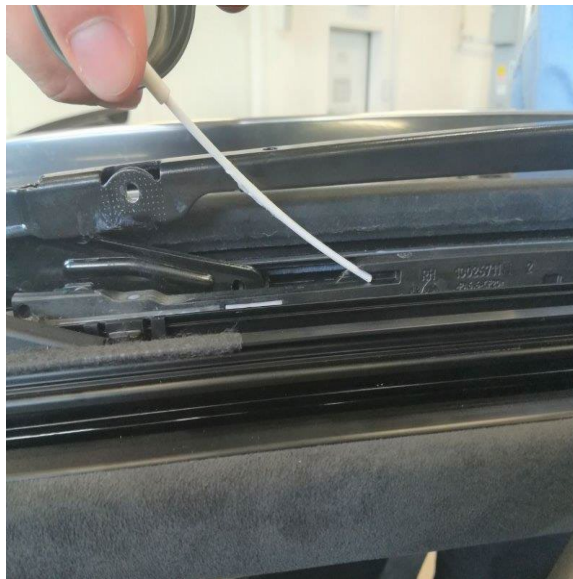
Figure 6. Lubricating the groove in the slide and tilt mechanism.

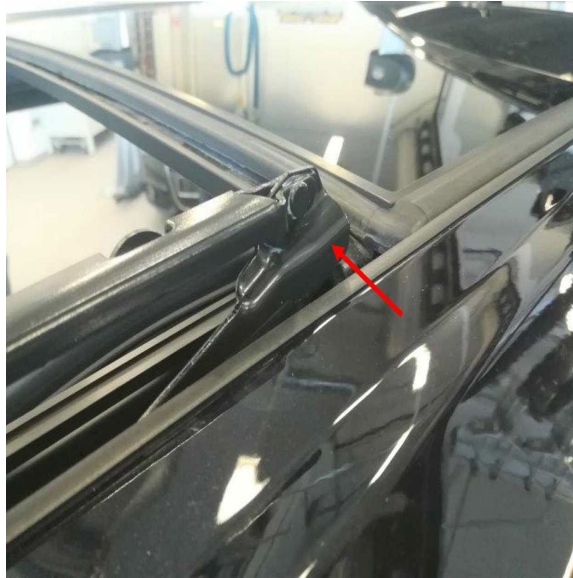
Figure 7. Section of slide and tilt mechanism to be lubricated.

5. Figure 7 and 8 shows the rear section of the left slide and tilt mechanism that must be lubricated with G 060 567 A2 lubricant. The outer area of this bracket will be lubricated (see red arrow).

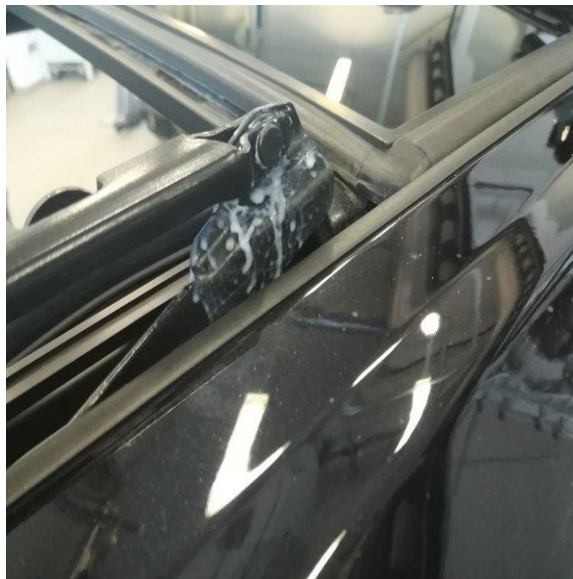
Figure 8. The bracket after lubrication.

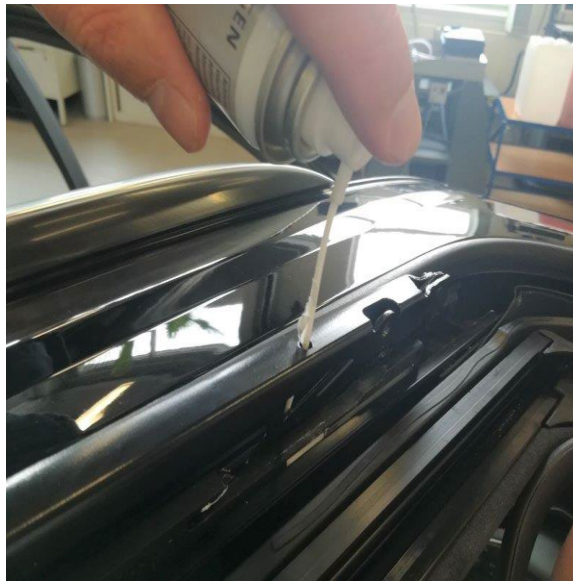
Figure 9. Accessing the channel through the arm of the slide and tilt mechanism.

6. Figure 9 and 10 shows the left front slide and tilt mechanism. The channel that must be lubricated can be accessed with the spray tube through the first hole in the arm as shown.

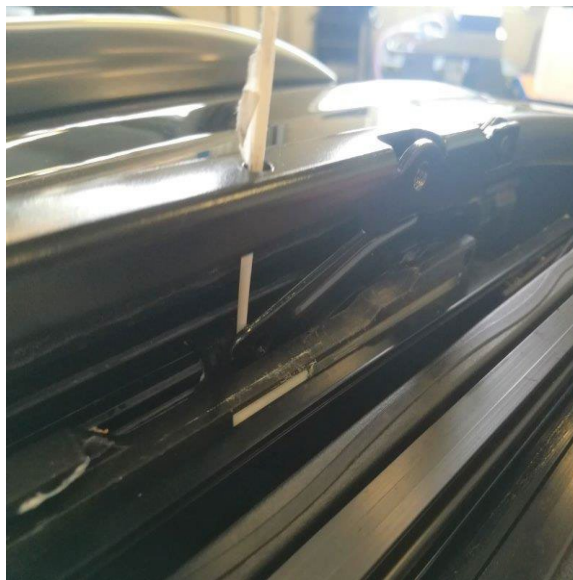
Figure 10. Close up view of the lubrication of the channel under the arm of the slide and tilt mechanism.
