Technical Service Bulletin

70 Noises from door trim panel(s)

70 23 80 2064546/4 February 6, 2023. Supersedes Technical Service Bulletin Group 70 number 23-79 dated January 17, 2023, for reasons listed below.

Model(s)	Year	VIN Range	Vehicle-Specific Equipment
e-tron GT, and RS e-tron GT	2022 – 2023	All	Not Applicable

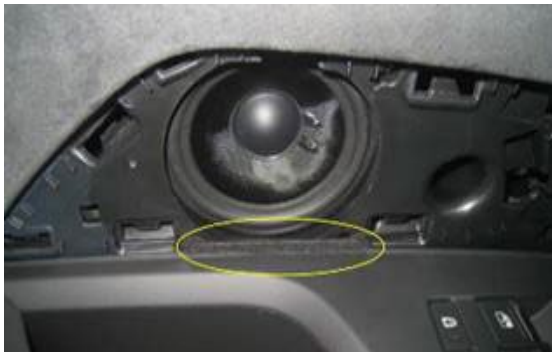
Figure 1. Felt strip section applied to opening in door panel.

- Remove the midrange speaker trim. Using felt tape (533867910A), apply a section to the lower part of the opening for the trim in the door panel.
- Ensure that this section of felt will not be visible when the speaker trim is reinstalled (Figure 1).

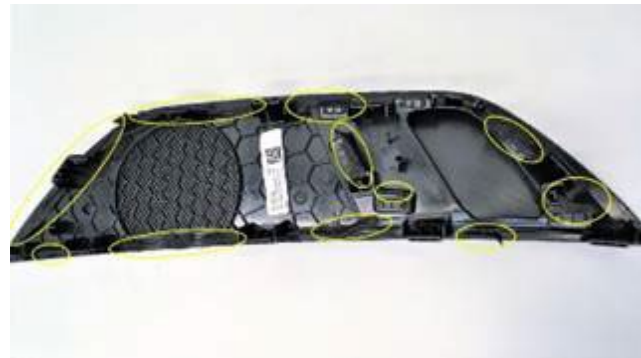
Figure 2. All tabs on the midrange speaker trim that require felt tape.

All of the tabs on the speaker trim that engage the opening in the door panel will need to have felt tape applied to each of them (Figure 2).

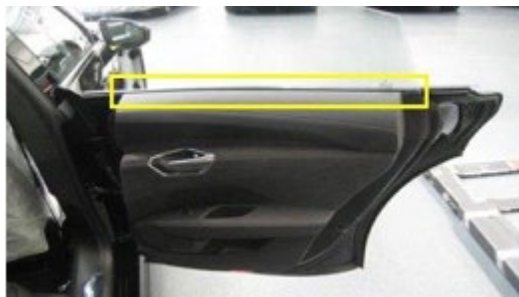
Figure 3. Apply fleece tape to the trim panel mounting strip.

- Bond fleece tape (D373125A2) into mounting strip. To do so, position fleece tape at edge of fastening strip and fold it over towards inside. Then press it on across entire surface (Figures 3-5).

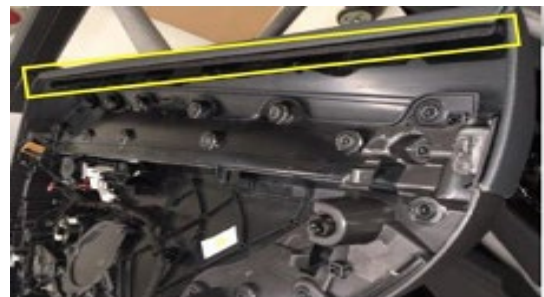
Figure 4. Fleece tape applied to mounting strip.

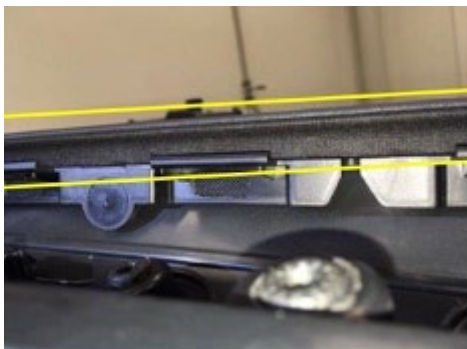
Figure 5. Fleece tape bonded to mounting strip.

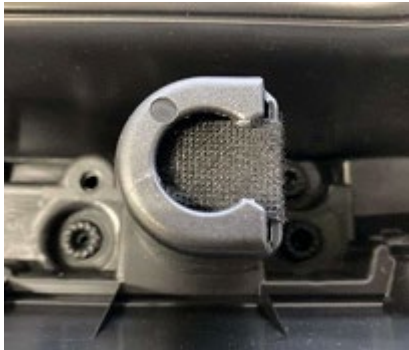
Figure 6. Door clip with fleece tape applied.

- Apply fleece tape (D373125A2) to door trim panel clips and to body mounting points to reduce play (Figures 6-7).

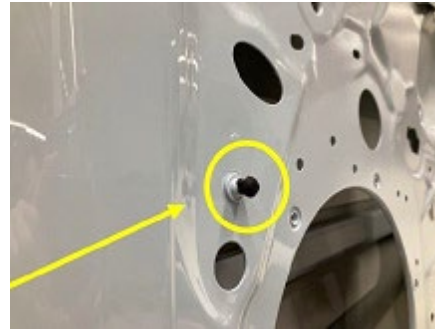
Figure 7. Door mounting point with fleece tape applied.

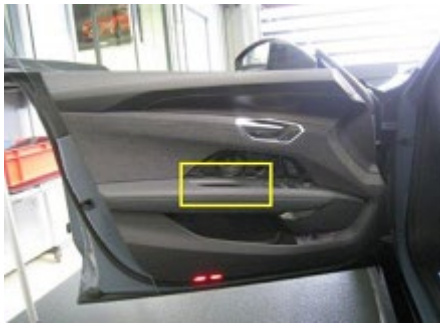
Figure 8. Isolate pull handle from armrest.

- Isolate the door trim panel pull handle from the armrest by applying fleece tape (D373125A2) or special lubricant (G052172A1) in the areas of contact (Figures 8-9).

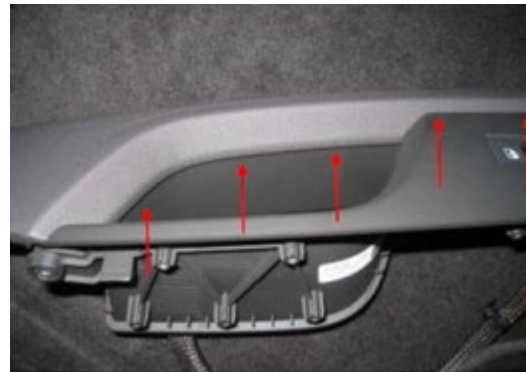
Figure 9. Apply fleece tape or special lubricant to isolate pull handle from armrest.

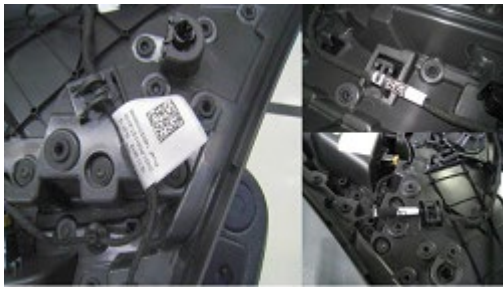
Figure 10. Repositioned part label.

- Secure the door wire harness and/or part labels by repositioning them and/or applying fleece tape (D373125A2) (Figures 10-13).

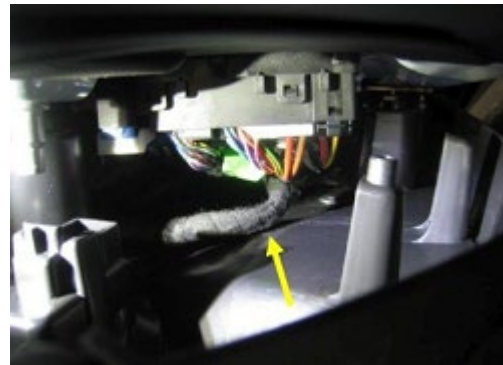
Figure 11. Wire harness contacting door trim panel.

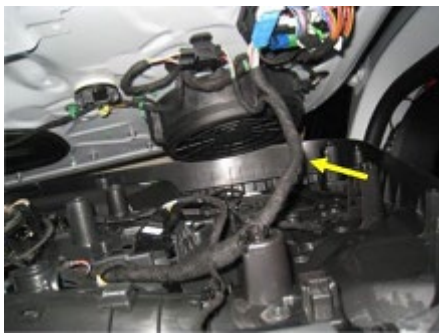
Figure 12. Wire harness not secured properly.

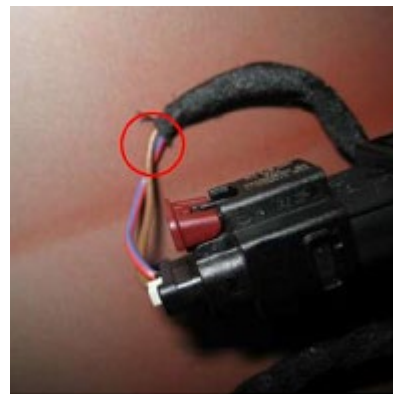
Figure 13. Wire harness contacting body.

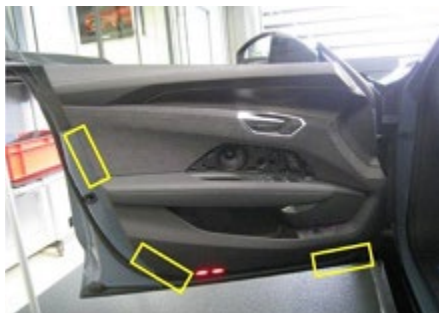
Figure 14: Apply felt tape to edge of trim panel.

- Apply felt tape (533867910A) to edge of door trim panel or on the existing piping strip in area of close contact. (Figures 14-15).

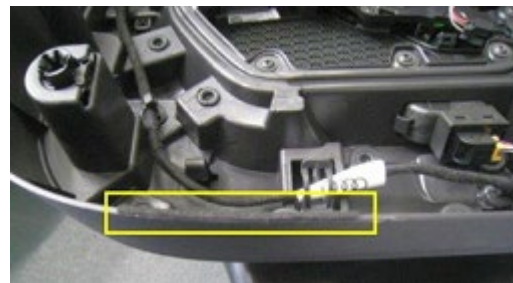
Figure 15. Felt tape installed on trim panel.

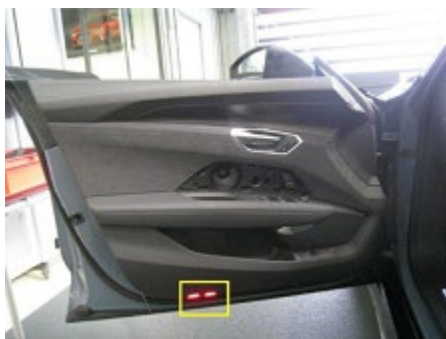
Figure 16. Apply fleece tape to trim panel light and wiring.

- Wrap cable for door trim panel light assembly with fleece tape (D373125A2) as far as to the connector. Also apply fleece tape to light assembly to reduce play in mounting (Figures 16-18).

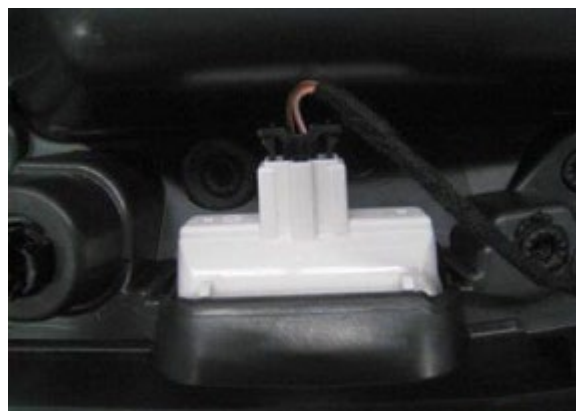
Figure 17. Wrapping light wire harness with fleece tape.

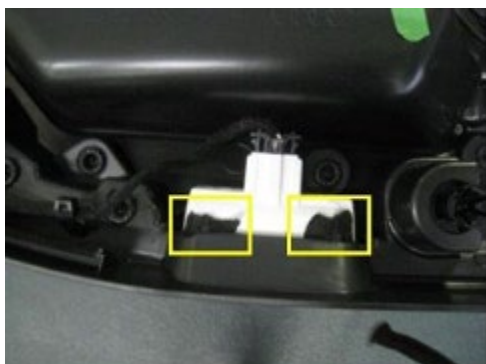
Figure 18. Fleece tape applied to light assembly.

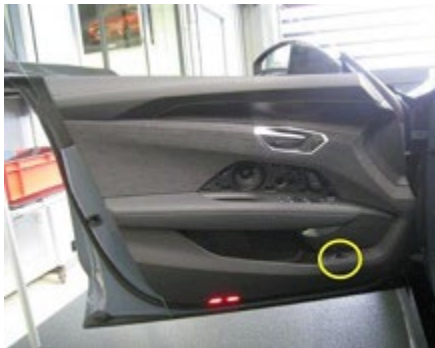
Figure 19. Bend retaining tab of power rear lid switch.

- Carefully bend open retaining tab of power rear lid switch for a more secure fit (Figures 19-20).

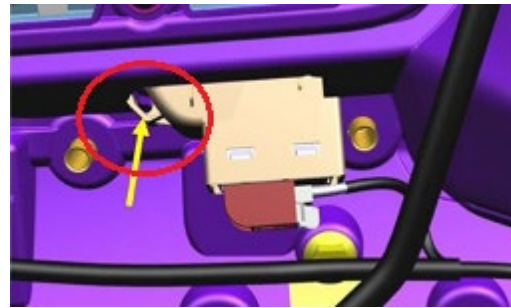
Figure 20. Bend open retaining tab of lid switch.

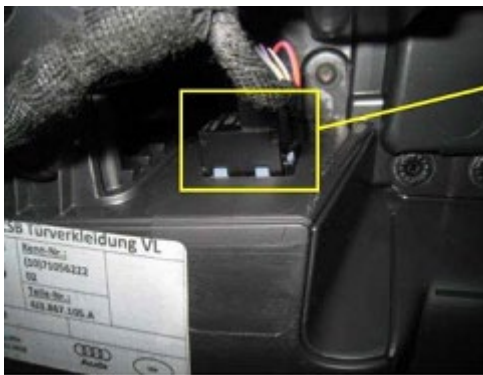
Figure 21. Apply fleece tape to pocket lighting.

- Apply fleece tape (D373125A2) to the retaining tabs of the diffuser of the door pocket lighting (Figures 21-22).

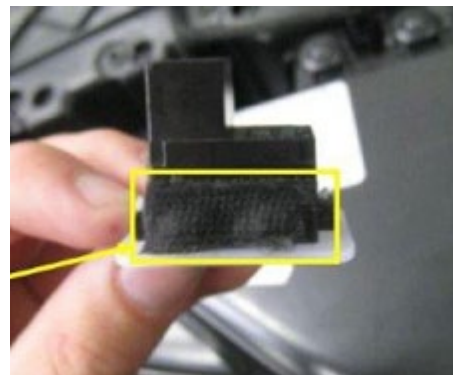
Figure 22. Fleece tape applied to diffuser tabs.
