90 Driver Assist Systems various improvements (DTC C12D5FA, B200FF9, B107A16, intersection assist arrows flicker)

90 23 99 2069244/1 February 2, 2023.

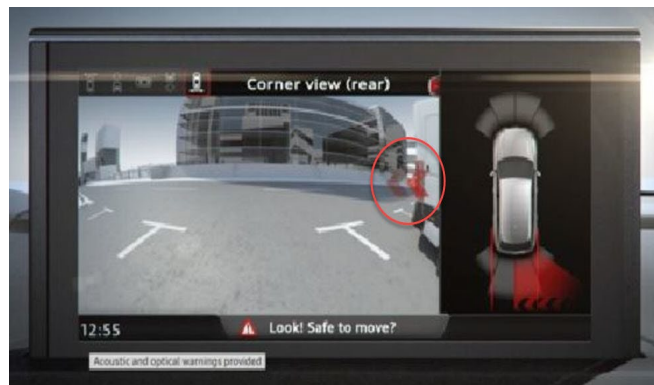
- The intersection assist arrows flicker for a short period after the vehicle is started (figure 1).

Figure 1: RCTA/Intersection assist arrows.

The complaints listed have been observed with prior versions of the control unit software.

The optimized software for the affected control units was implemented in production in model year 2023.
