# TECHNICAL SERVICE BULLETIN

Technical Service Bulletin: 410-1598

Forest River is alerting you to an issue involving certain 2021-2023 Columbus Fifth Wheel recreational vehicles. Please see the information below which describes the issue and provides you with details on the steps you should take to have your vehicle repaired.

# TECHNICAL SERVICE BULLETIN 410-1598 REMEDY INSTRUCTIONS

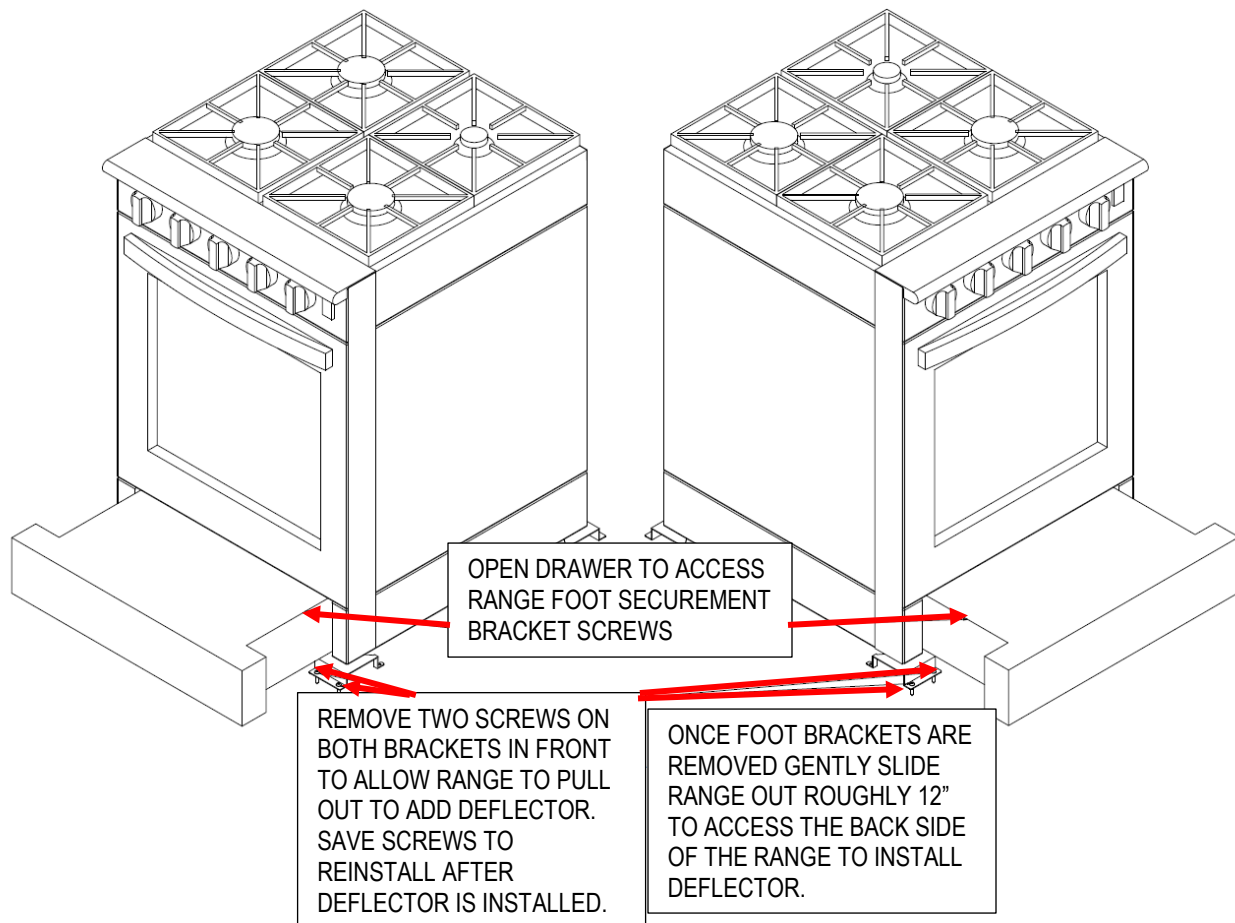
The backsplash may warp from the heat of the range.

STEP 1: PULL OUT THE DRAWER UNDER THE RANGE TO ACCESS THE SCREWS OF THE FRONT RANGE FEET BRACKETS;

STEP 2: REMOVE THE TWO SCREWS FROM EACH RANGE FRONT FOOT BRACKETS TO ALLOW RANGE TO BE MOVED AWAY FROM THE WALL ABOUT 12" OR SO TO ALLOW ACCESS TO THE TOP SCREWS ON THE BACK OF THE RANGE. BE SURE TO SAVE THESE SCREWS FOR REINSTALLATION AFTER PLATE IS INSTALLED;

STEP 3: USE CAUTION WHEN SLIDING THE RANGE OUT NOT TO DAMAGE THE LINOLEUM ON FLOOR WITH THE FEET OF THE RANGE;

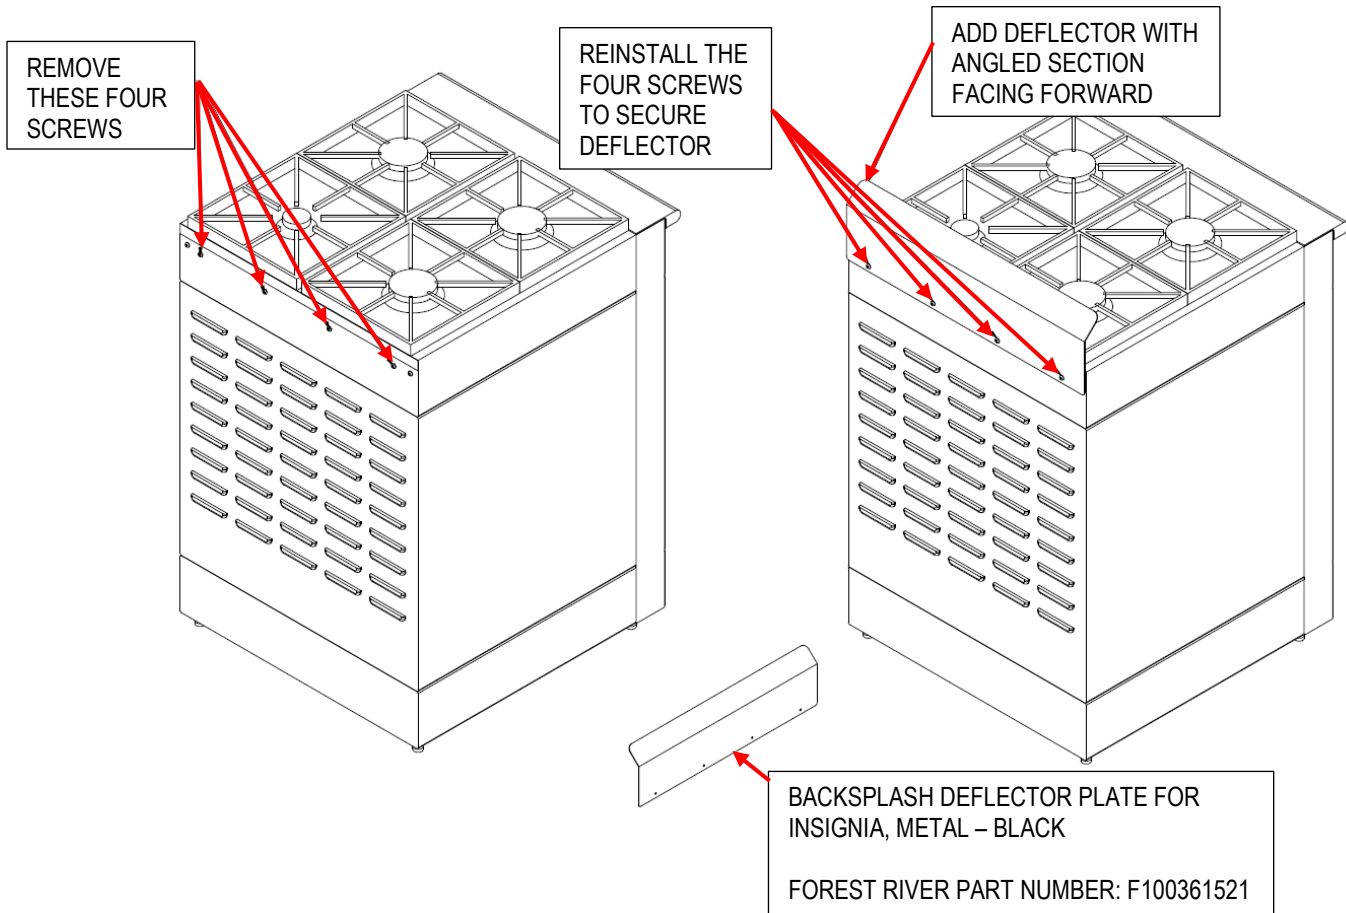
Concern:  
 Install a deflector to help prevent warping of the backsplash from the heat of the range.

STEP 4: REMOVE THE FOUR CENTER SCREWS (LEAVING THE OUTER 2 SCREWS) ON THE REAR TOP EDGE OF THE RANGE;

STEP 5: ORIENT THE DEFLECTOR PLATE WITH THE ANGLED SECTION TO THE TOP AND FACING TOWARDS THE FRONT OF THE RANGE AS SHOWN IN THE DIAGRAM BELOW;

STEP 6: LINE THE HOLES IN THE DEFLECTOR PLATE WITH THE 4 HOLES THAT YOU JUST REMOVED THE SCREWS FROM AND REINSTALL THE SCREWS TO HOLD THE HEAT PLATE ON TO THE BACK OF THE RANGE;

STEP 7: CAREFULLY SLIDE THE RANGE BACK INTO PLACE AND REINSTALL THE RANGE FRONT FOOT BRACKETS WITH THE SAME SCREWS THAT WERE REMOVED;
