Preliminary Information

PIT5839C Radio System Settings Lost or Returning to Default Values

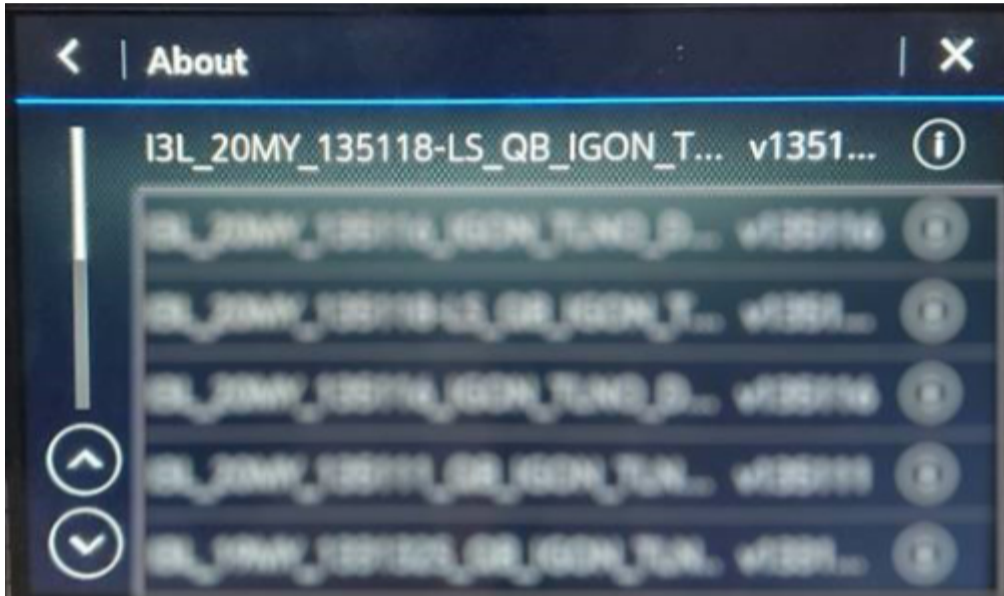
1. Verify the radio software version as this issue only pertains to version V135118. On the radio display, select Home, Settings, About. On this page will be what appears like a long file name. In the middle of this file name will be 135118.

- If the version is V135118 proceed to Step 2.
- If the version is numerically less than V135118 then this PI does not apply. Refer to SI for diagnostics.
- Tip: Before resetting the radio, please record the customer’s stored Favorites so that they can be re-entered afterward. Once selected it is important to wait for the radio to complete this process and reboot itself before the ignition is turned off.
