Bulletin No.: PIP5874A

PIP5874A 3.0L LZ0 Diesel Exhaust Backpressure Valve Part Restriction

Brand:	Model:	Model Years:	VIN:		Engine:	Transmissions:
			from	to		
Chevrolet	Silverado	2023	All	All	3.0L LZ0	All
GMC	Sierra	2023	All	All	3.0L LZ0	All

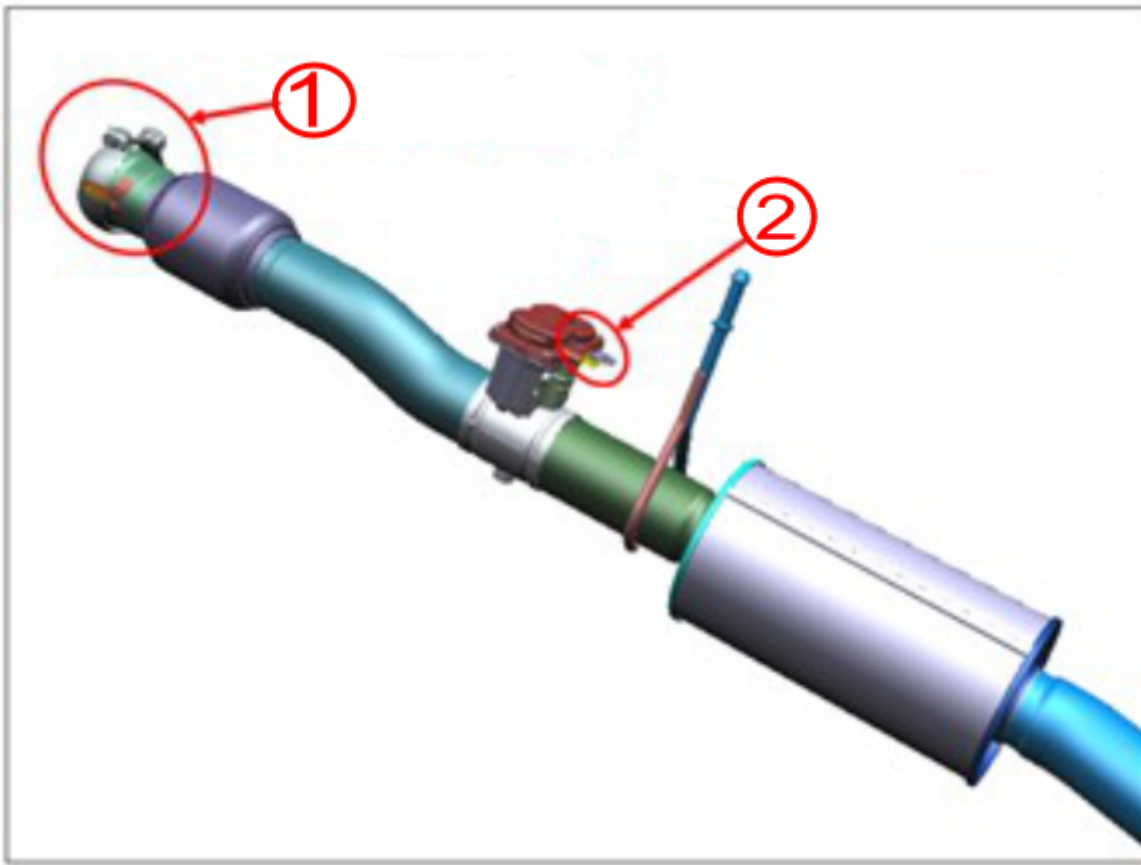
- 1) Remove the clamp and separate the rear exhaust pipe from the Nitrogen Oxide catalytic converter as shown in the illustration below (1), keeping the exhaust backpressure valve harness connector connected (2).

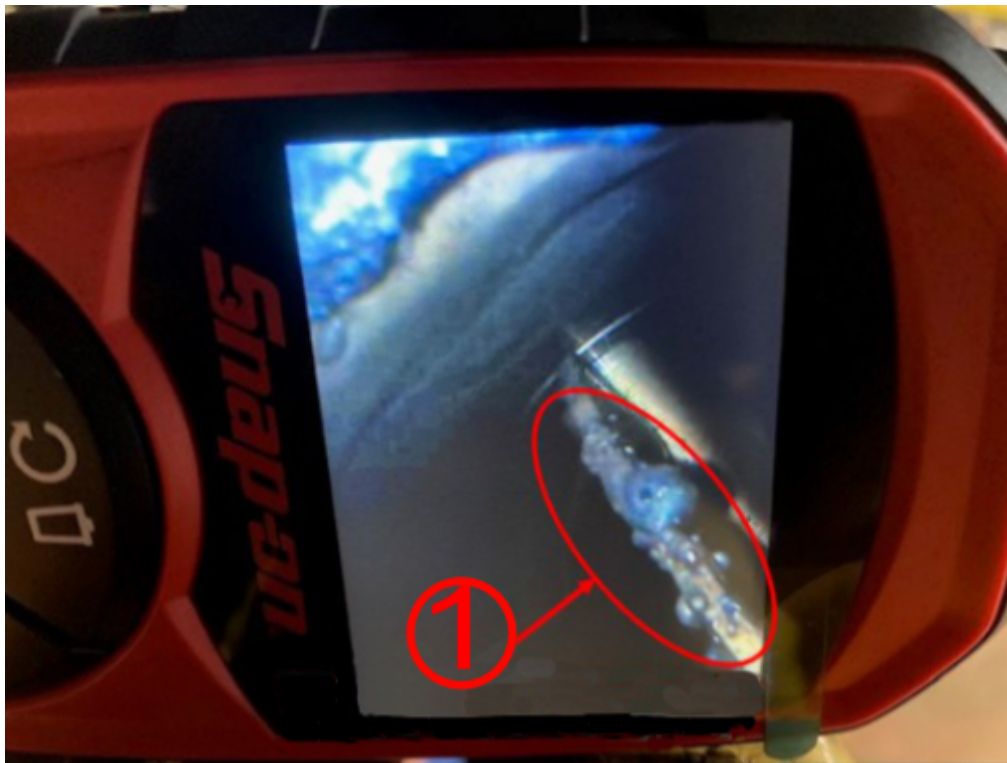
3) Note whether the valve moves smoothly through its entire travel and look for welding slag on the valve's flap as seen in the picture below.

4) If welding slag is found capture the image or take a picture of the bore scope's screen as well as the exhaust pipe's identification label (Illustration below) and submit the pictures in a field product report per bulletin 02-00-89-002 (Canadian dealers refer to bulletin 10-00-89-006). Replace the M122 Exhaust Pressure Control Valve Actuator (currently available only by replacing the exhaust from the clamp back). There is no need to continue with the remainder of the PQC template **(only if welding slag is present)**.

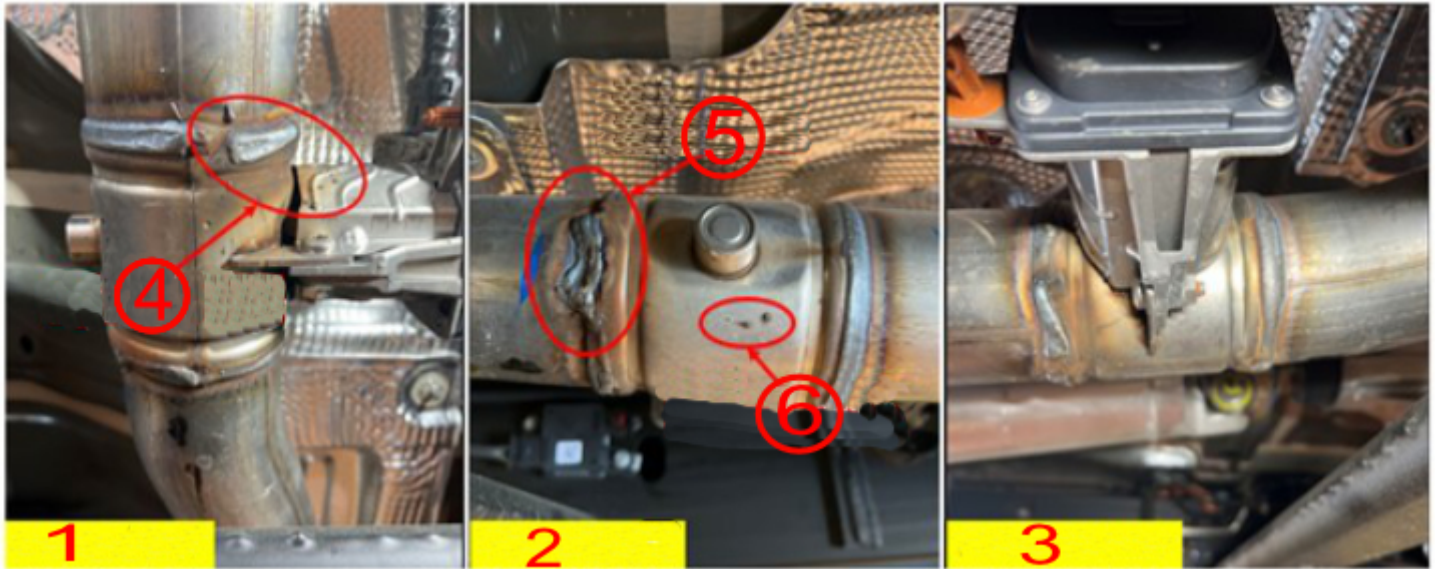
The pictures below are examples of improper welds you may see.
