Preliminary Information

PIP5829A MIL Illuminated With DTC P0299 and/or Cold Start Rattle Noise From the Engine Compartment

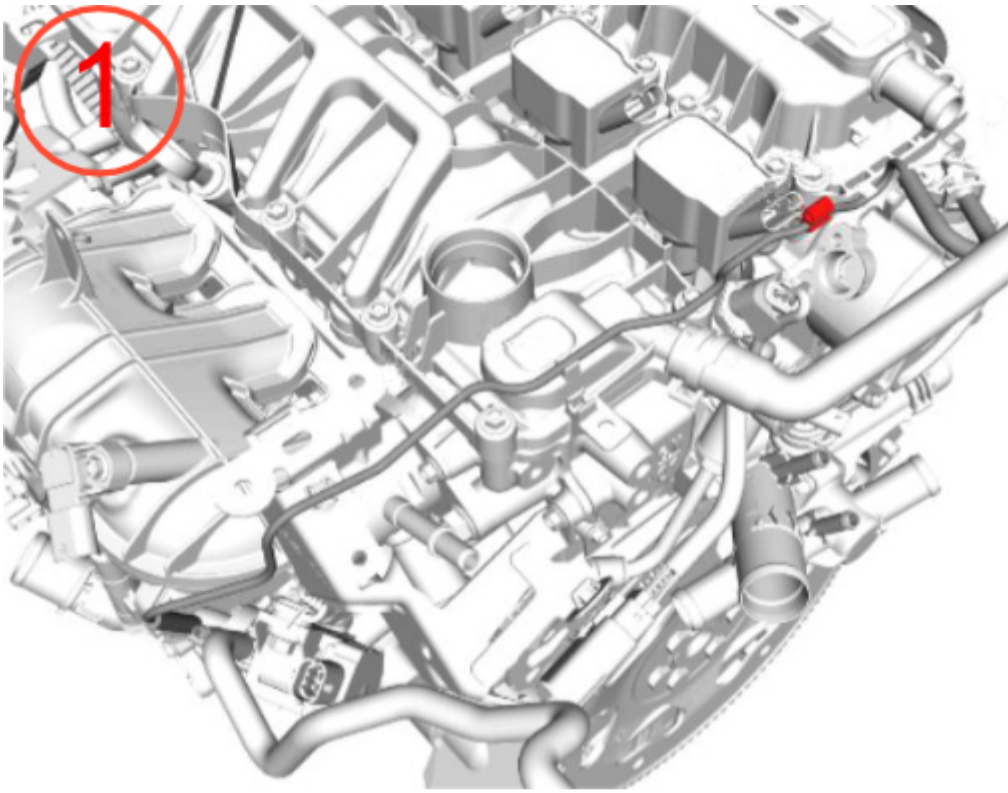
Disconnect the Turbocharger Wastegate Solenoid Vacuum Supply Hose (shown in fig 1 below) from the Turbocharger Wastegate Solenoid Valve.

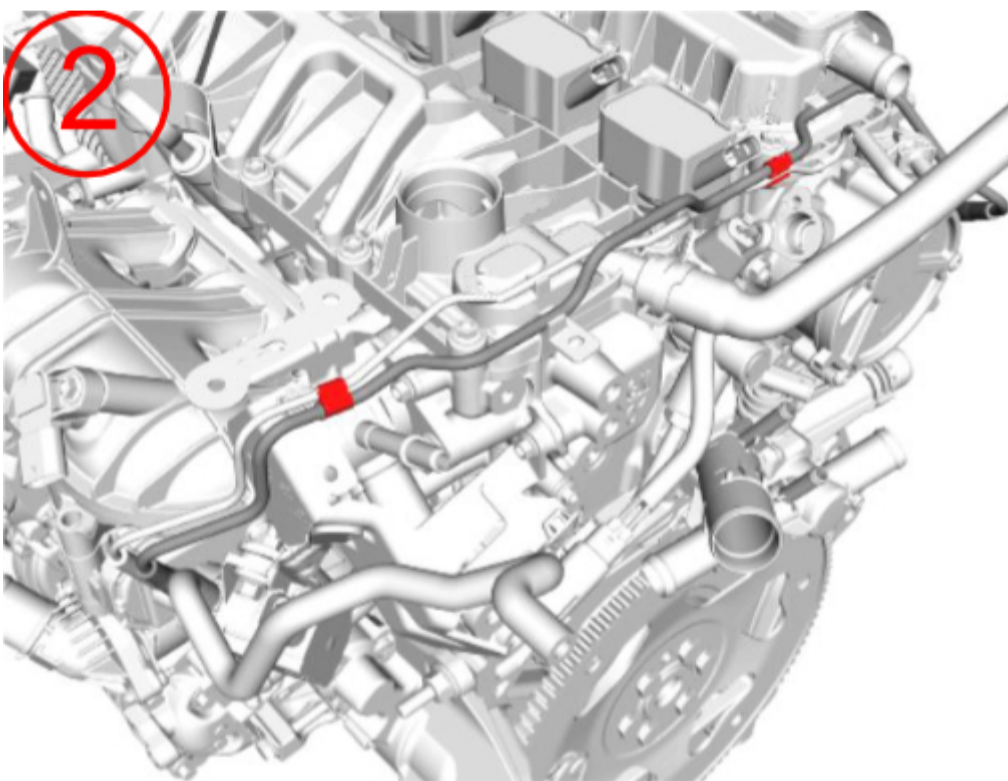
Disconnect the Turbocharger Wastegate Solenoid Actuator Supply Hose (shown in fig 2 below) from the Turbocharger Wastegate Solenoid Valve.

Connect the EN-23738-A Vacuum Pump to the Turbocharger Wastegate Solenoid Valve Actuator supply port.
