Preliminary Information

PIT5386H Back Up Alarm Inoperative and needs to be Connected During PDI

Equipped with Back Up Alarm (RPO 8S3)

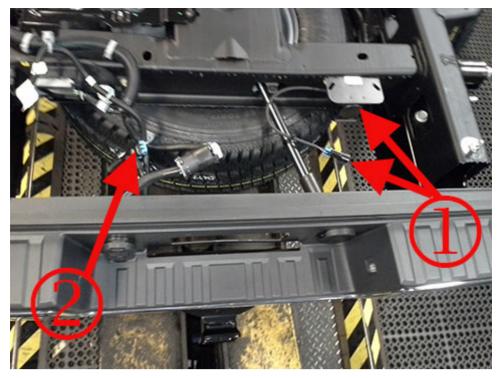
During the PDI it may be noticed that the backup alarm is inoperative. Trucks equipped with the Back Up Alarm (RPO 8S3), the alarm will be intentionally left disconnected from the assembly plant.

- 1. Back Up Alarm/Connector
- 2. Chassis Harness Alarm Connector

- For 2020 and later 3500 Chassis Cab models (31003, 31043, and 31403) the back up alarm is not installed on the truck's frame and it has been left loose inside the cab from the assembly plant. It is the upfitters responsibility to mount the back up alarm and splice into the reverse circuit. The labor op listed below does not apply to these vehicles because no additional work is needed during PDI. Refer to the latest revision of UI Bulletin 175 (https://www.gmupfitter.com/technical-bulletins/) for more information
- For All Other Trucks, the alarm is located on the right rear of the frame, and the chassis harness alarm connector is located on the left rear of the frame. Route the harness up and over the spare tire hoist tube and connect to the backup alarm.
