Preliminary Information

PIT5868B Poor Heater Performance On Drivers Side

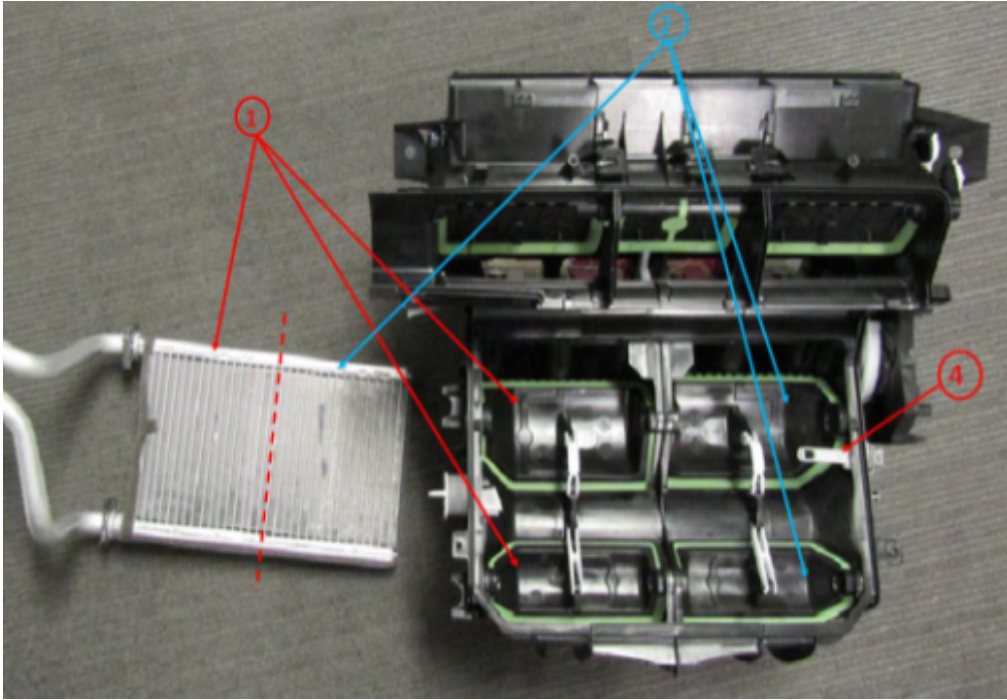
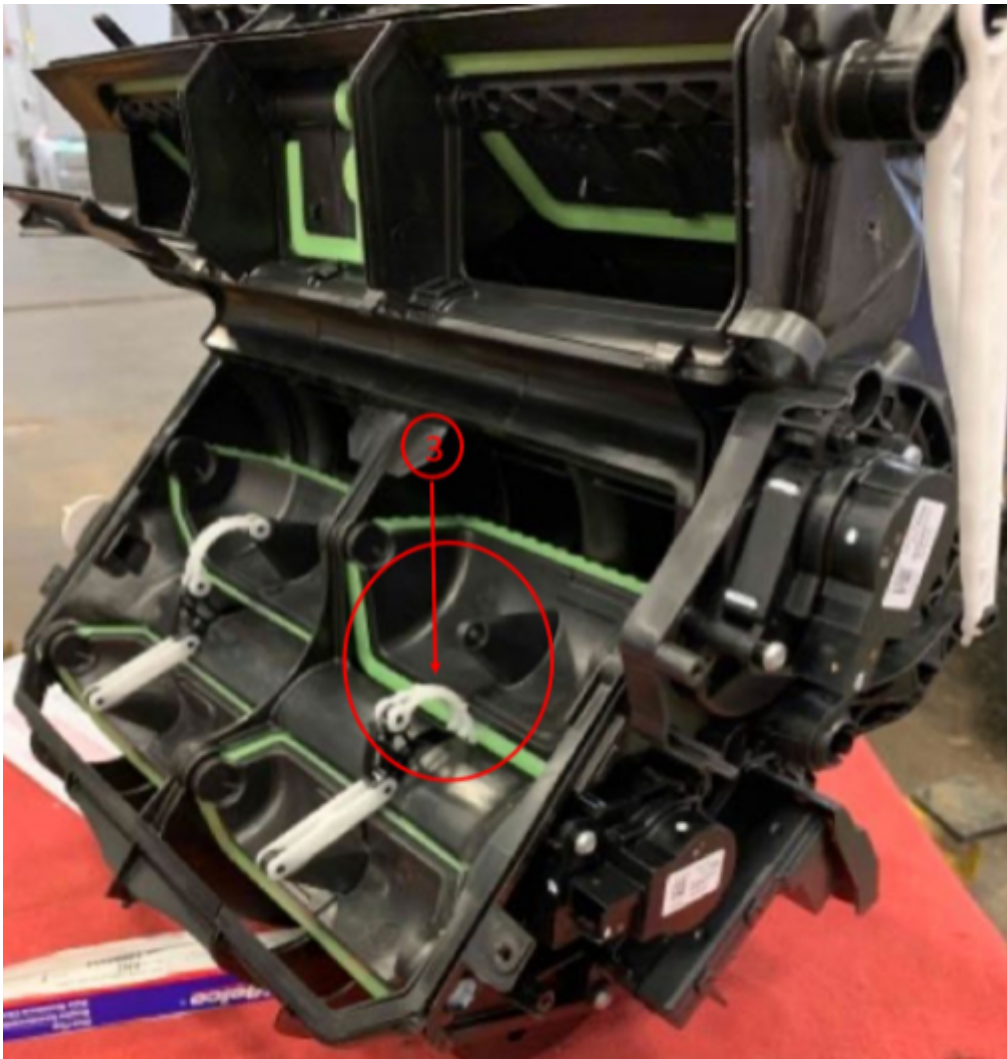
Involved Region or Country	North America
Condition	Some customers may comment on lower heater performance from the driver side HVAC vents when compared to the passenger side. In some cases, the driver side center dash vent will have the lowest temperature.
Cause	<p>The cause of this condition could be one of the following:</p> <p>Cause 1: The heater core may have become plugged. When the heater core begins to plug, it affects the driver side center vent first.</p> <p>Cause 2: Both single and dual zone HVAC cases utilize two temperature doors per side (a total of four doors), shown below. In the photo below, call-out 1 shows the passenger side temperature doors and heater core. Call-out 2 show the driver side temperature doors and heater core. Call-out 4 shows the evaporator air temperature sensor location in relation to the driver side temperature door which will be helpful later in this document. Inside the HVAC case, there are four white links which connect each of the four temperature doors. In some cases, one of these white links can become disconnected inside the HVAC case, as shown below (3).</p>
