Preliminary Information

PIP5788B DTC P2635 Set

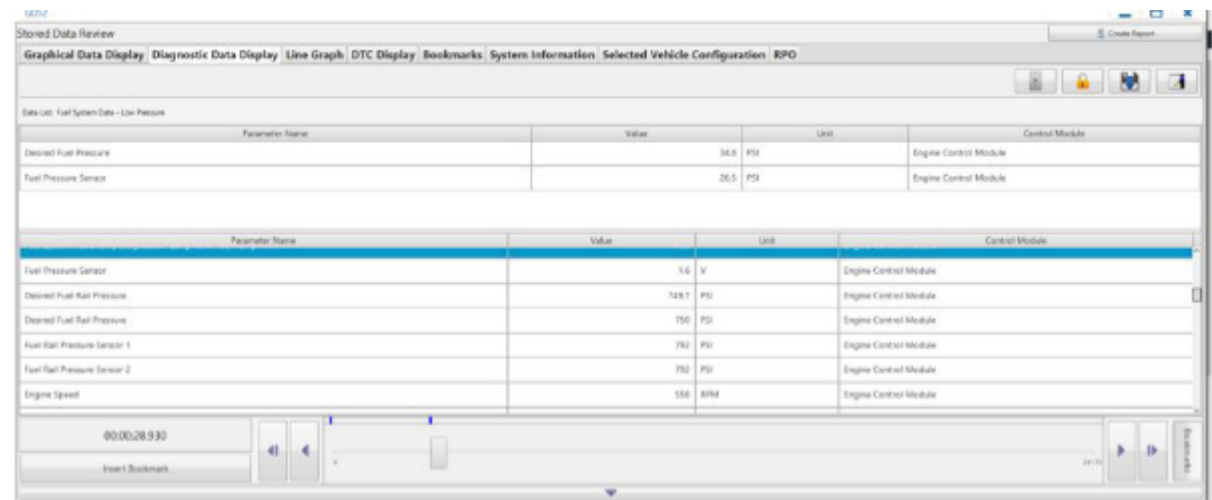
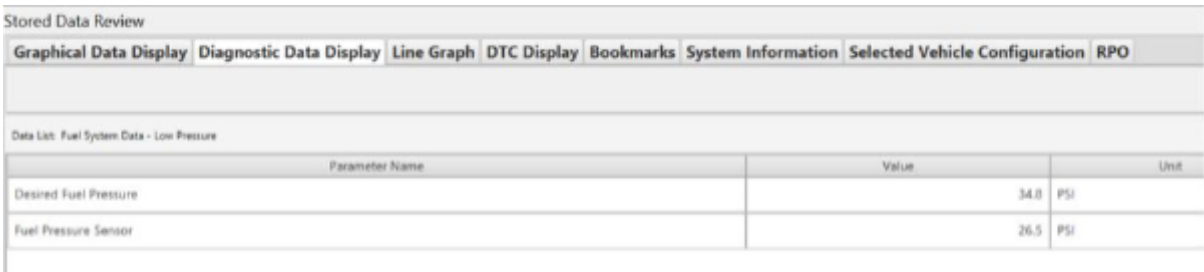
use the freeze frame to duplicate the concern with GSD looking at fuel system data to see what the pressure is at the time of failure

If the DTC sets with low pressure follow the applicable diagnostic flow chart in service information for further diagnosis and repair.

If the diagnostic does not isolate the concern, and the fuel pressure was above desired, replace fuel feed pipe (fuel line between the high-pressure fuel pump and chassis line), clear the codes, and return it to the customer.
