Preliminary Information

PIC6487 Popping Noise When Going Over Bumps or Turning Maneuvers When Parking

Brand:	Model:	Model Years:	VIN:		Engine:	Transmissions:
			from	to		
Chevrolet	Trax Models	2019	All	All	All	All

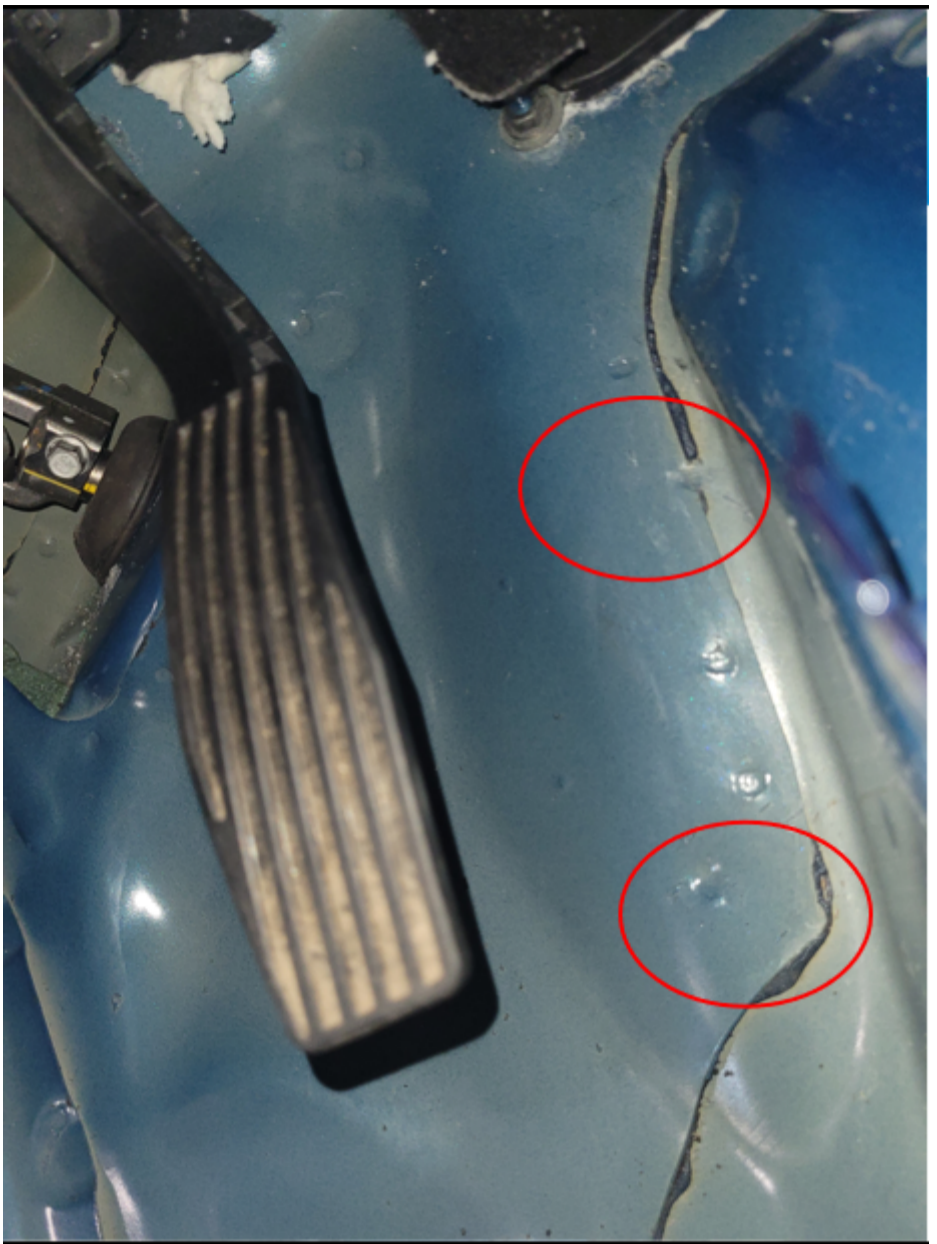
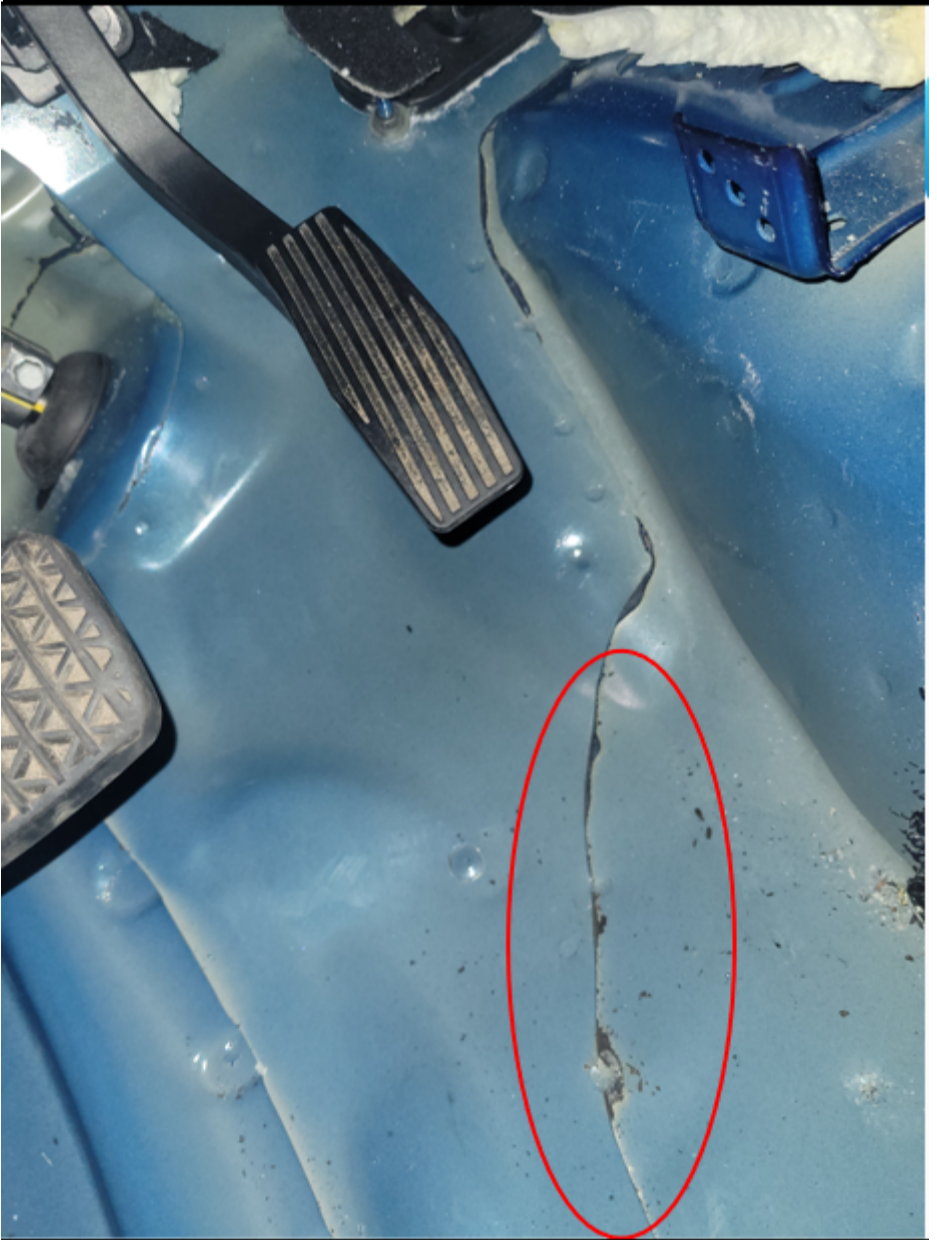
Involved Region or Country	North America
Additional Options (RPO)	For vehicles only built in Mexico VIN begins with '3'
Condition	Customer states they have a popping noise when going over bumps or when making turning maneuvers into a park space or driveway.
Cause	Body panel popping due to missing, incomplete, mispositioned spot welds in panel at driver's foot well where the firewall and floor panels welded together.

If the source of the noise has been isolated to the driver footwell area, the dealer will need to inspect for missing, incomplete or mislocated spot welds (see image below for location of spot welds).
