Preliminary Information

PIT5689E No Restart after an Auto Stop Event / No Crank / Dead Battery / DTC P0562 P0617 P0621 P0622 P0700 P1005 P26E6 P305D P305E P2796 U010E U0102 U0106 U0284 U0285 U0672 U029D U029E U02A1 U02A3 U0623 U111A U111E U1348 U18DE

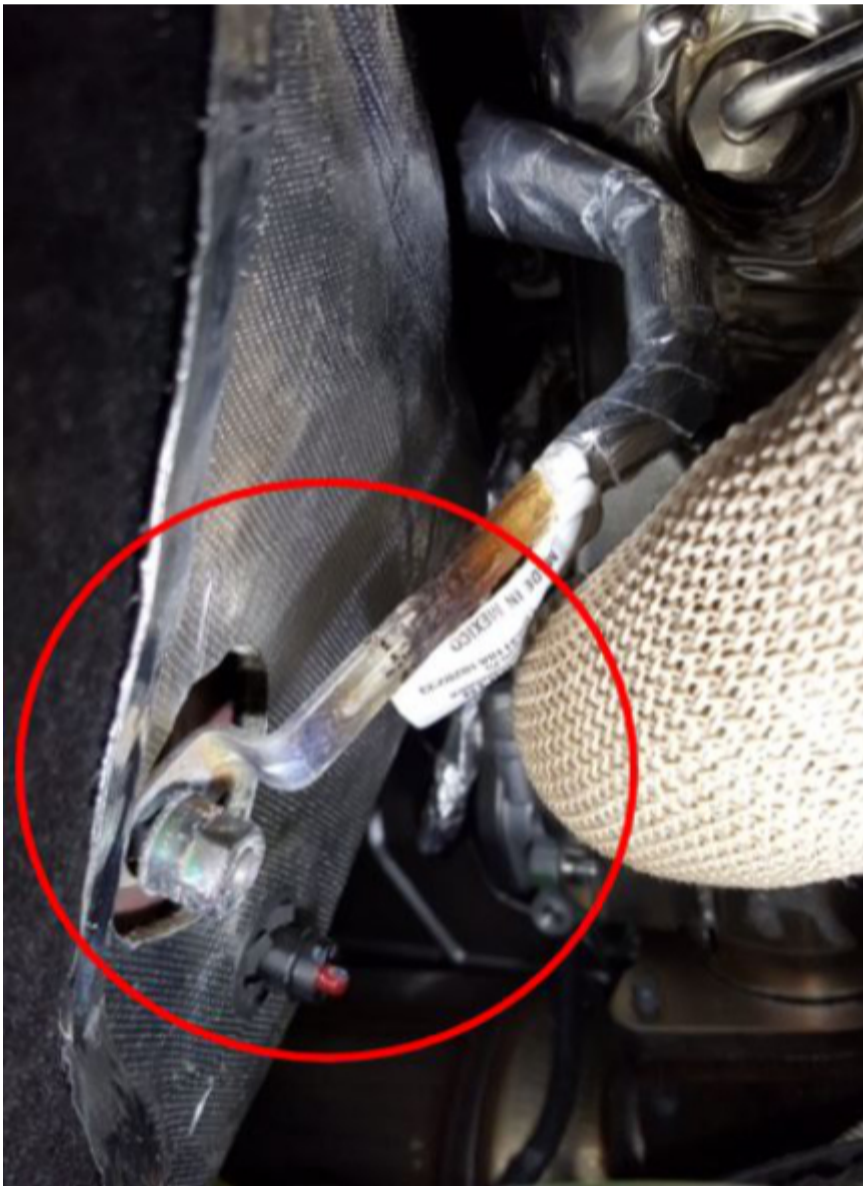
Shown above is ground G132 loose.

Inspect the engine to body ground cable/strap, G132 and G134. Tighten any loose ground connections or replace any damaged ground cable/strap. Ensure that the ground cable/strap is properly orientated to prevent damage to the ground cable/strap caused by powertrain movement.
