Preliminary Information

PIT5832E Diagnostic Tip: Unable to complete the Serial Data Authentication Configuration/ No Start Or Unable To Perform Theft Relearn After Replacing Or Programming A Module / DTC U1962

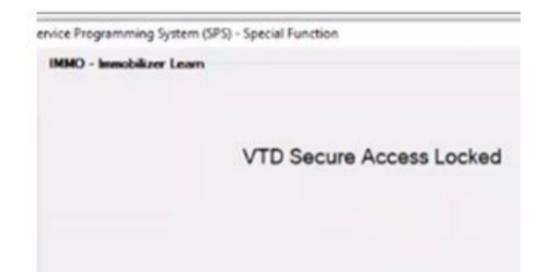
- 1. If a module was replaced, make sure the new module was SPS programmed correctly or the SDAC will fail and not complete correctly.
- 2. If a module such as the BCM is replaced, and the immobilizer learn needs to be completed after replacement, the tech needs to make sure that the SDAC completes correctly, or a pop-up message like the one below will be displayed:

3. If a vehicle will not complete the SDAC, run the SDAC (using the Serial Data Authentication selection in Techline Connect) again. Select the box in SPS controller list in the lower right-hand corner labeled "Serial Data Authentication Configuration".
