## STAR ONLINE PUBLICATION

**Case Number:** S2323000003

**Symptom/Vehicle Issue:** Wind Noise From Windshield Or Front Instrument Panel Area At Highway Speed.

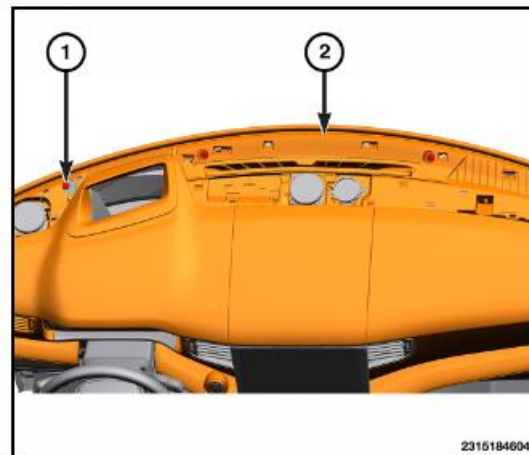
1 - Fence Line Bolts

2 - Instrument Panel

**Discussion:** Inspect the instrument panel fence line screws. These fasteners are at the front of the dash pad at the windshield (Fig 1). Remove the screws 1 by 1 and reinstall to torque specification of 10 n.m or 7 Ft. Lbs.

To access the fence line screws use a trim stick to remove the instrument panel grille cover closest to where the noise was heard during the test drive. Replace the snap in cover. Perform a verification drive to confirm the wind noise is resolved. For further information refer to Service Library service information, 23 - Body / Instrument Panel / PANEL, Instrument / Removal and Installation.
