STAR ONLINE PUBLICATION

Case Number: S2323000005

Release Date: January 2023

Symptom/Vehicle Issue: Second Row Power Seat Binding Or Not Moving With Button Request.

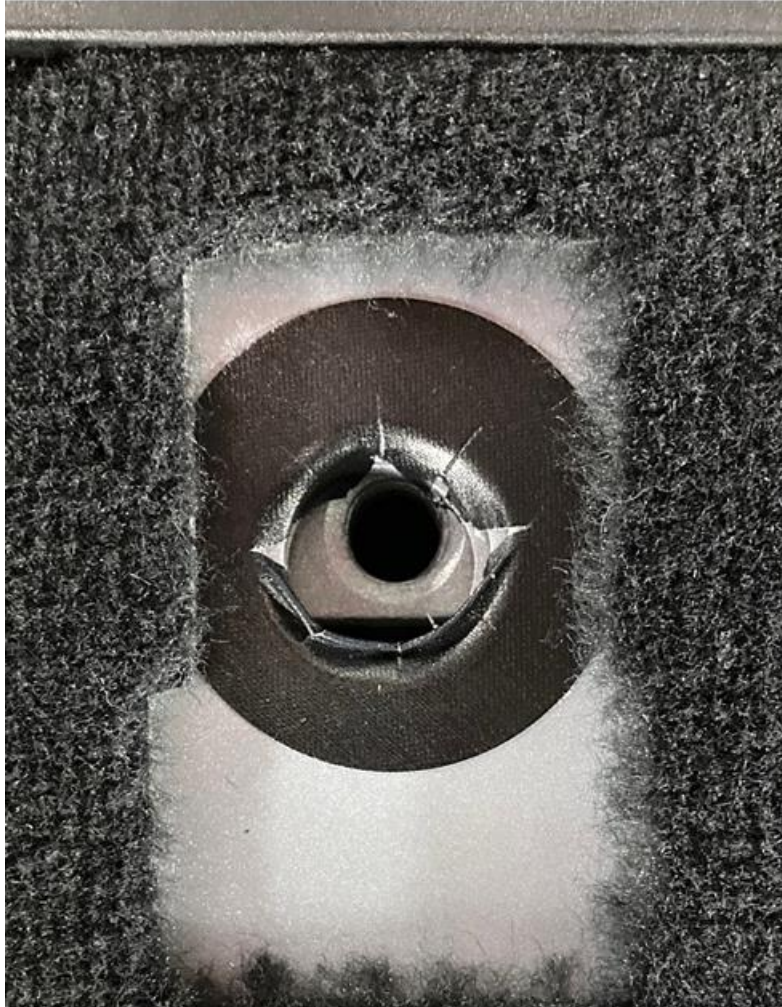
Discussion: Remove seat mounting bolts, lift the seat out of position and inspect the floating cage nuts on the outboard side (Fig 1). The nut should be visible under a black plastic patch (do not remove this material) and move freely with a screwdriver in the cage. If the cage nut does not freely move, the seat may experience binding when the mounting fasteners are torqued. If the nut does not freely move complete the below steps.

Fig 1 Seat Floating Cage Nut
Do not remove the black tape patch material

1. Remove the seat. Refer to Service Library 23 - Body / Seats, Second Row / SEAT, Second Row / Removal and Installation.
2. Use screwdriver or hand start the fastener into the cage nut.
3. Apply pressure fore-aft and cross car to break free any paint in the cage causing the nut to bind. Do not remove the black water management patch covering the cage nut hole.
4. Reinstall the seat. Follow torque sequence and specification in the service procedure. Refer to Service Library service information, 23 - Body / Seats, Second Row / SEAT, Second Row / Removal and Installation.

5. Verify seat is functioning without lazy or binding condition when released.
