STAR ONLINE PUBLICATION

Case Number: S2323000008

Symptom/Vehicle Issue: Buzz Squeak Or Rattle Noise From Left Side Driver Door Area.

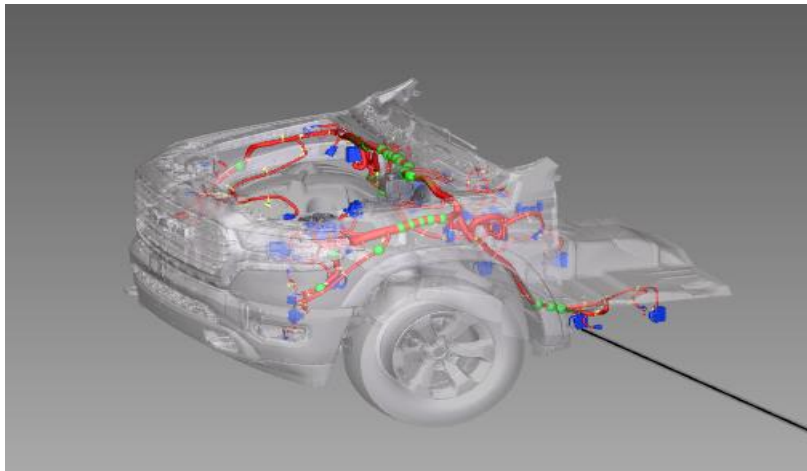
Discussion: Inspect the left side chassis harness and inline connector for proper routing and retention in frame clips. A chassis harness not fully installed in the mounting clips could be causing this noise. Repair or replace any missing or damaged clips and brackets.
