## STAR ONLINE PUBLICATION

**Case Number:** S2323000009

**Symptom/Vehicle Issue:** Water On Interior Trim, Headliner, Edges Of Headliner, And Grab Handles.

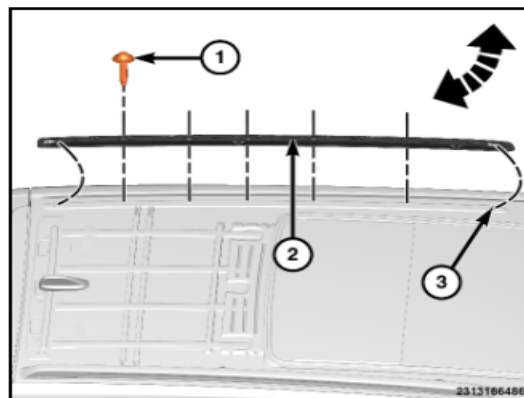
- 1 - Luggage Rack Screws
- 2 - Luggage Rack Rail
- 3 - Roof Studs

**Discussion:** Water seen in the interior after a car wash or rain event could be coming from the roof rack attachment locations. To seal the roof rack rivnuts, remove the roof rack. Apply a seam sealer such as Kent Products High-Tech Clear p10200 (or equivalent) around the rivnut locations. Follow the product's application and cure instructions. Install the roof rack following Service Library Service Info, 23 - Body / Exterior / RACK, Luggage / Removal and Installation.
