Case Number: S2308000005

Release Date: January 2023

**Symptom/Vehicle Issue**: Rear View Camera Loose Shipped Harness Connector Ends Do Not Mate, Connector Ends Are Different

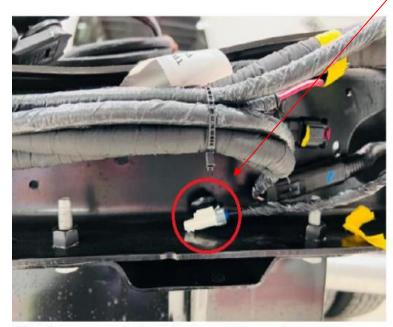
Vehicle harness connector located in the rear cross member

**Discussion:** Rear camera vehicle harness connector and shipped harness seen below for the camera connectivity do not mate in some cases. Some vehicle harness packages have **connector ends that may differ and do not mate to the shipped (KIT 68399008AD), see below.**
