## STAR ONLINE PUBLICATION

**Case Number:** S2323000012

**Symptom/Vehicle Issue:** Water Leak On Right Side Of Lift Gate.

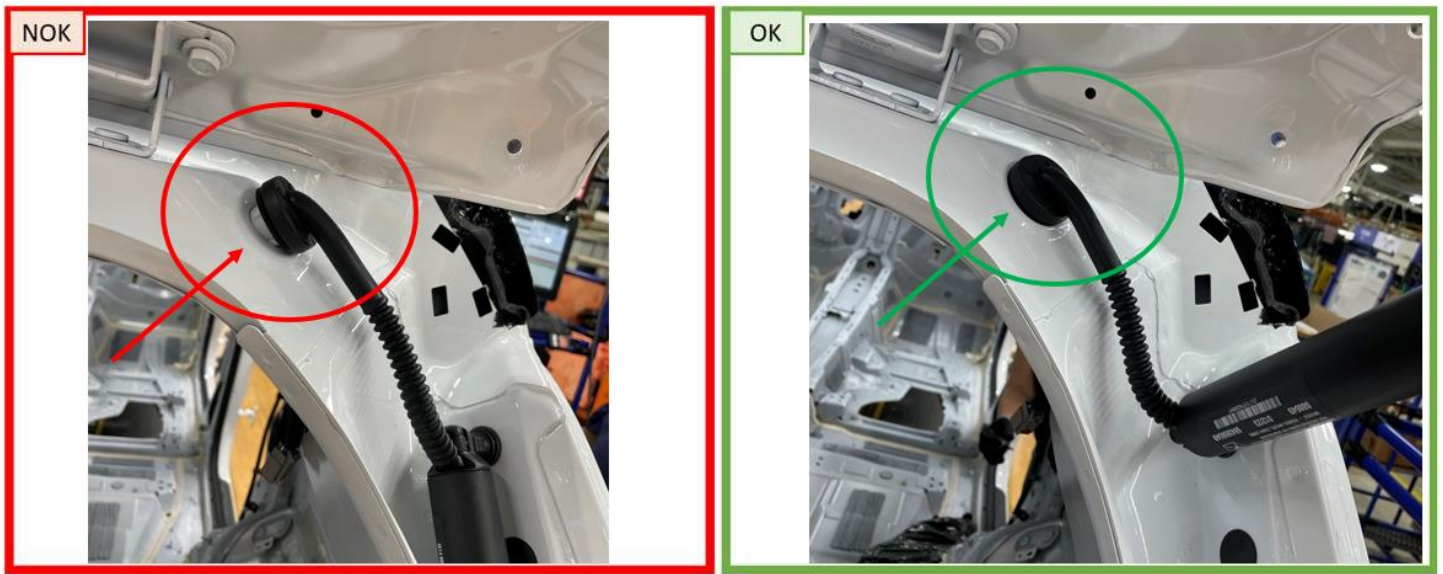
**Customer Complaint/Technician Observation:** Lift gate floor is wet after a rain or carwash.

**Discussion:** Inspect the power lift gate harness grommet located in the gate opening. The grommet should be fully seated. If it is not, press firmly on the grommet to seat it flush in the opening. See the below image.
